Report on the investigation of

Young Lady

Dragging anchor 5 miles east of Teesport and

Report No 3/2008
February 2008

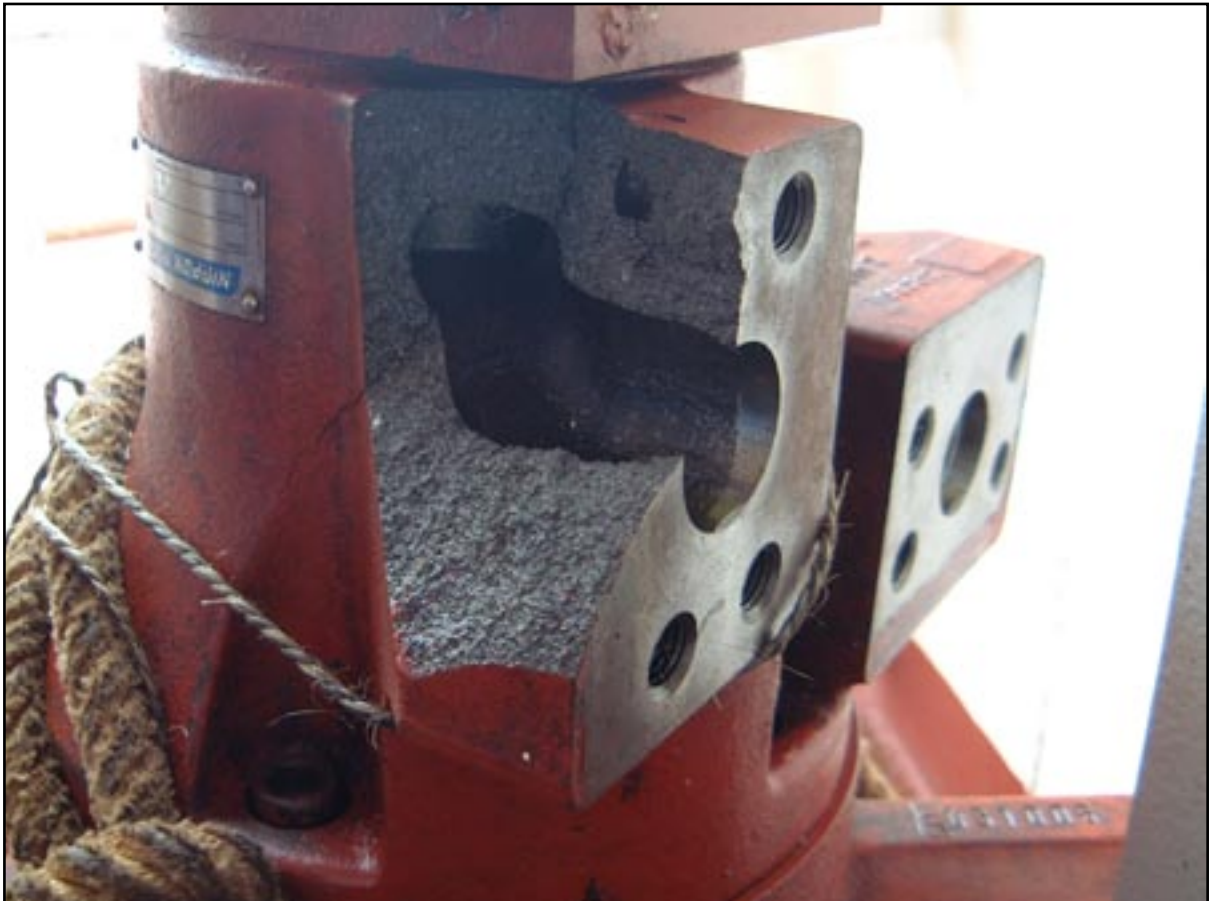
Figure 7

Damage to the port windlass hydraulic motor unit

It was not until 1330, when the crew had replaced the port windlass hydraulic motor, that it was possible to take the weight off the bitter end, remove the pin and finally slip the cable. *Young Lady* made ground to the north-east and awaited further instructions.

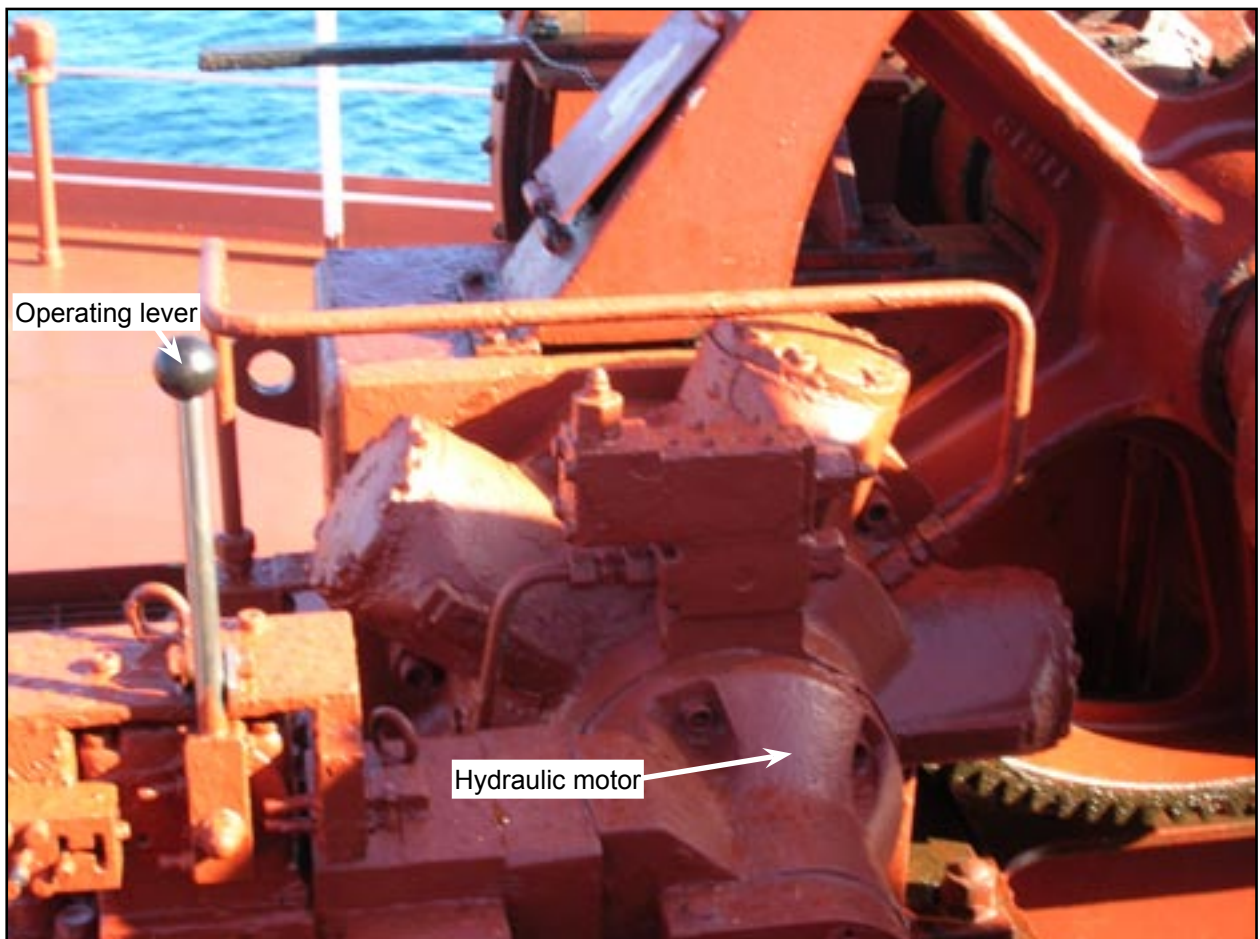
Figure 14

The hydraulic system was fitted with two in-line relief valves designed to operate when a hydraulic pressure of 240 Kgf was reached. One relief valve was fitted to guard against shock loads, and the other relief valve was fitted to guard against a gradual increase in hydraulic pressure encountered during the heaving operation. There was no relief valve fitted within the hydraulic motor itself.

Port Windlass Hydraulic motor

In April 2007, a defective hydraulic seal on the port windlass hydraulic motor led to a new motor being ordered and fitted. To facilitate the motor replacement, the crew designed and manufactured a tripod arrangement to hold the motor in position while replacement was carried out. The defective motor was later repaired on board by the crew, and became an unofficial spare. Fortunately, the availability of the spare motor and the tripod arrangement allowed the failed windlass motor to be replaced on the morning of 26 June 2007.

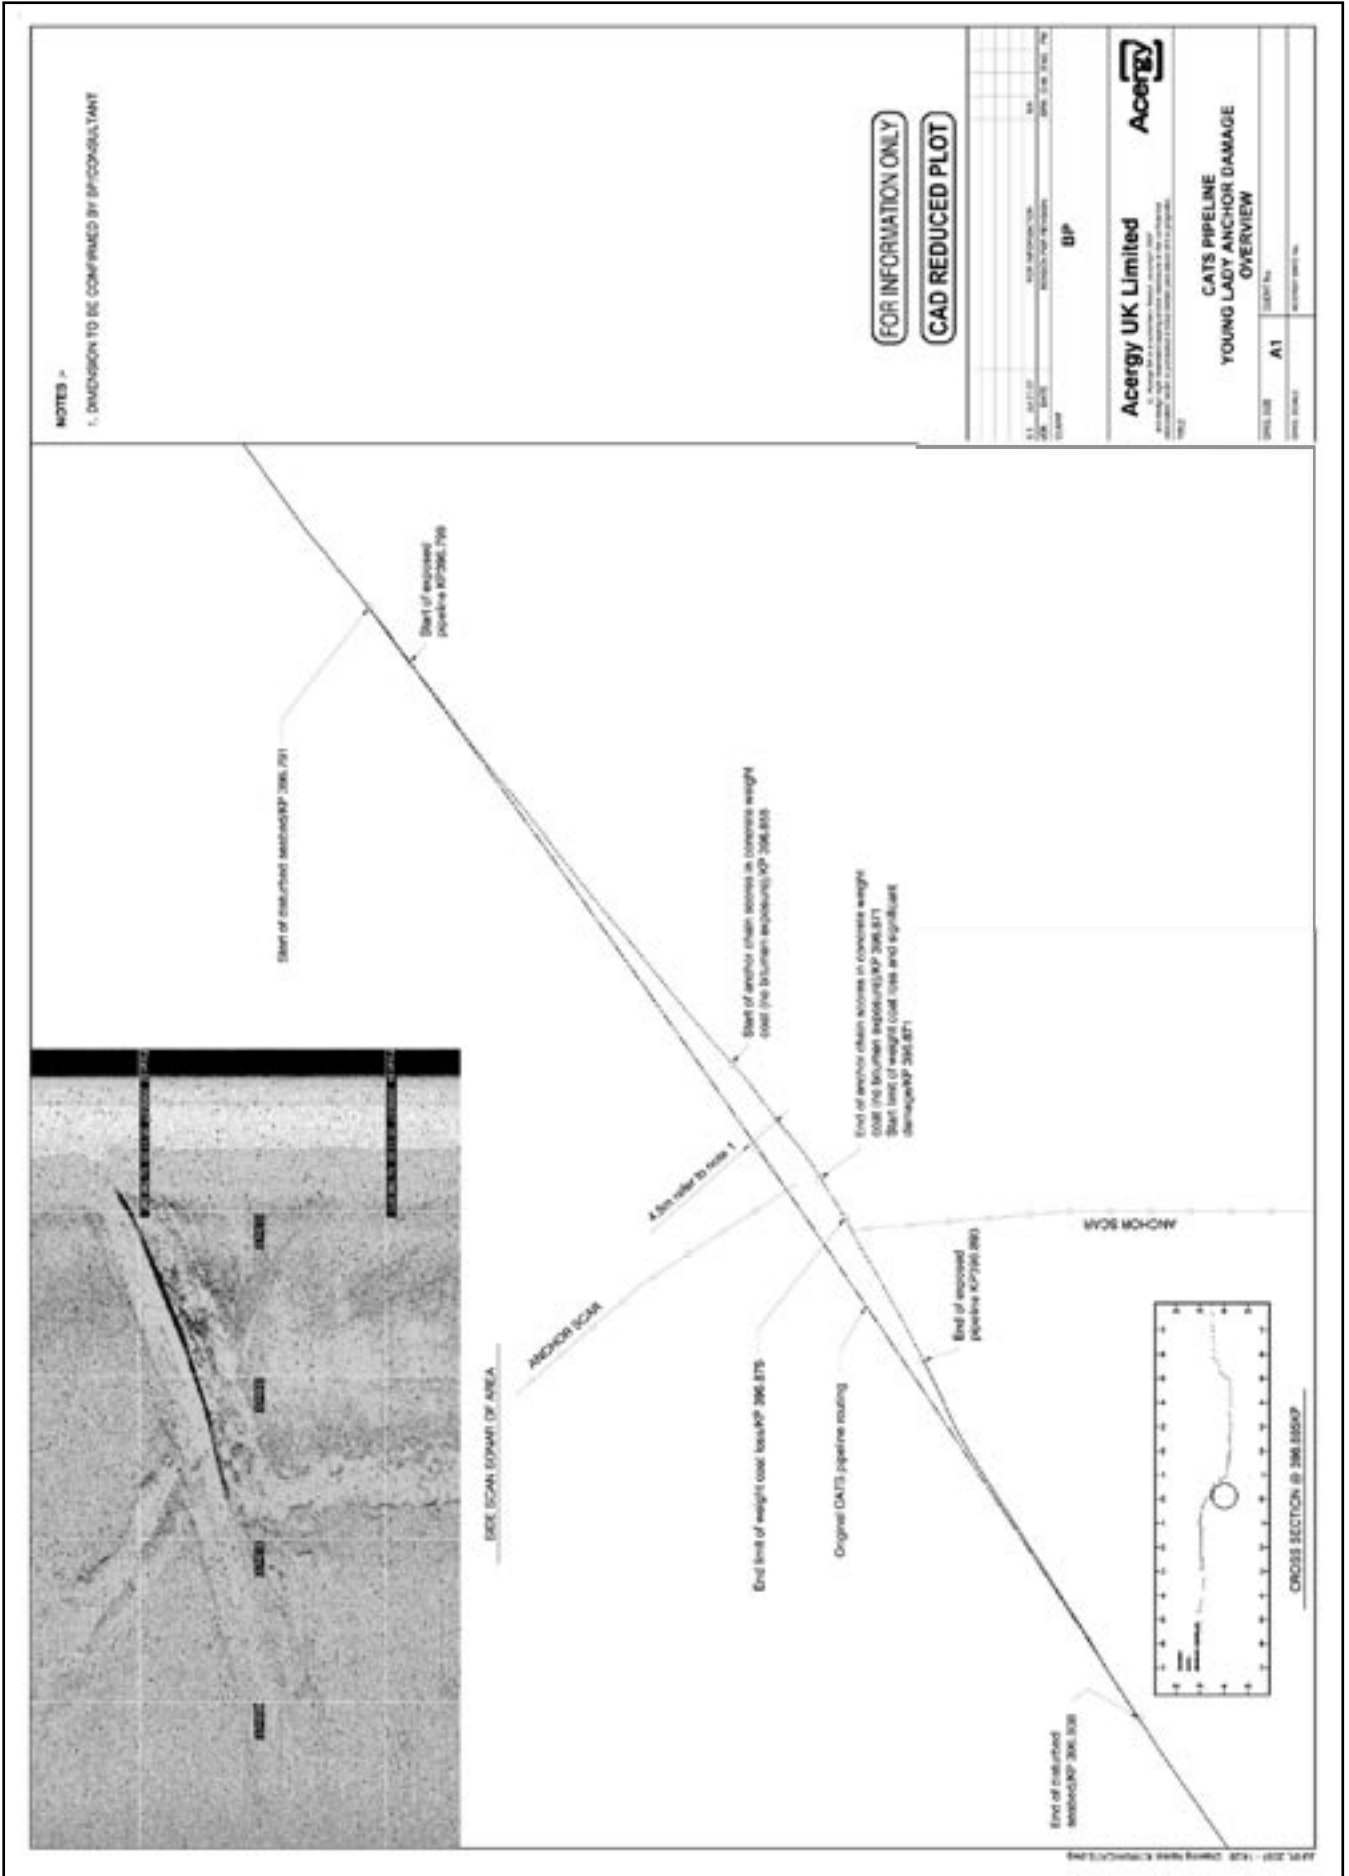
Figure 16

A side scan sonar image was able to identify a trench in the sea bed north of the pipeline running in a south-easterly direction, and a second trench south of the pipeline, running in a south-south-easterly direction (**Figure 16**). The trenches were consistent with the approach of *Young Lady's* anchor, and its track once she broke free of the pipeline.

Profile of CATS Pipeline in relation to sea bed

The full damage assessment, conducted by ROV and diver survey, indicated that the pipeline had been lifted 1.5m, moved laterally at the point of contact by 6m in a south-easterly direction, and had been partially exposed over a length of about 170m. The concrete protection had been removed at the point of contact, and impact damage was identified on the steel pipe.

By the end of July 2007, BP had completed the repair assessment. Primary damage was to the concrete coating, but there was sufficient concern about the damage to the pipeline itself to require the installation of a repair sleeve, which was carried out in August. The pipeline was covered and protected where it lay, and production was restarted in September 2007.

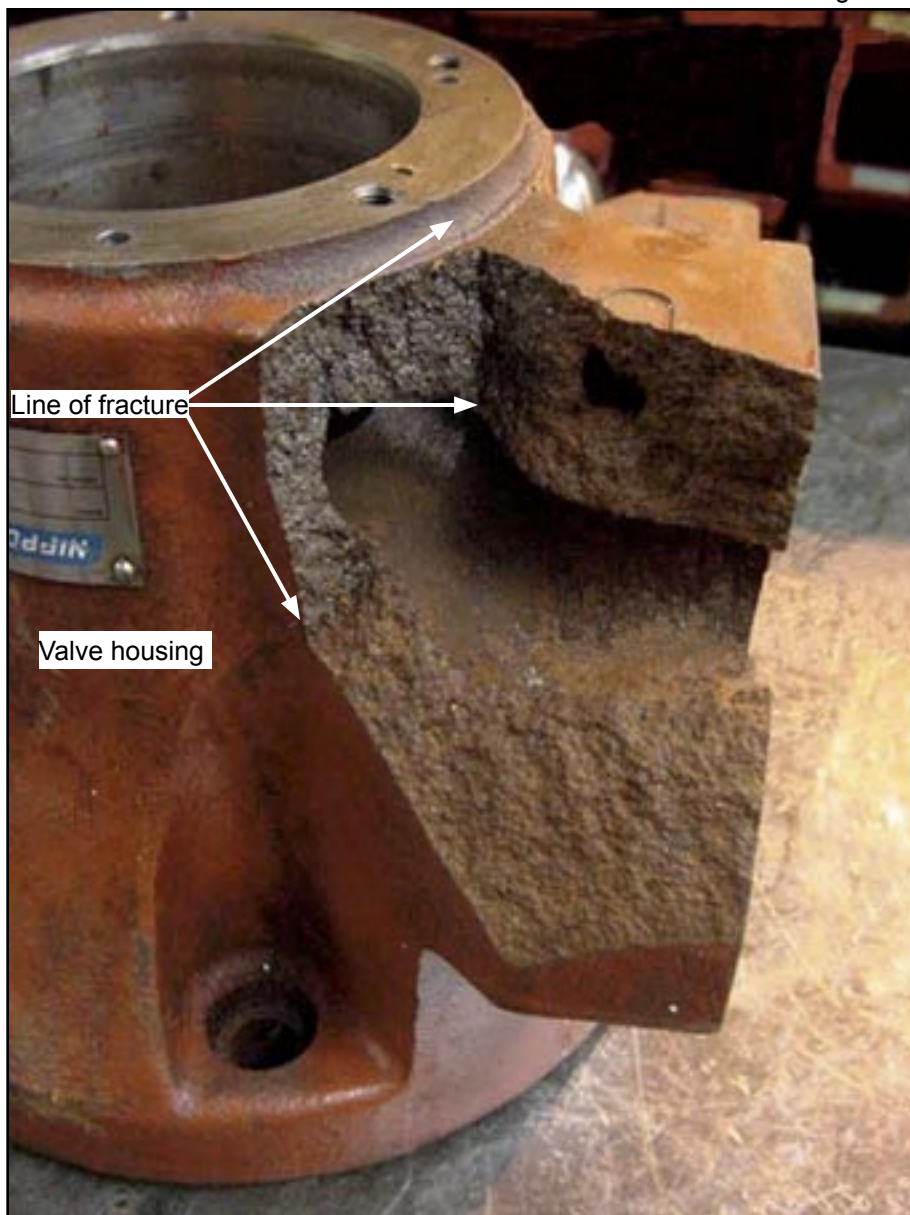
Figure 19

Comparison of the required and the actual capacities showed that there was little reserve power over and above the minimum required. When confronted with the weather conditions of 25 June, and when due consideration is given to the advice provided by the classification society, the potential risk of windlass failure was significantly greater than that faced under normal operating conditions.

Damage to motor casing

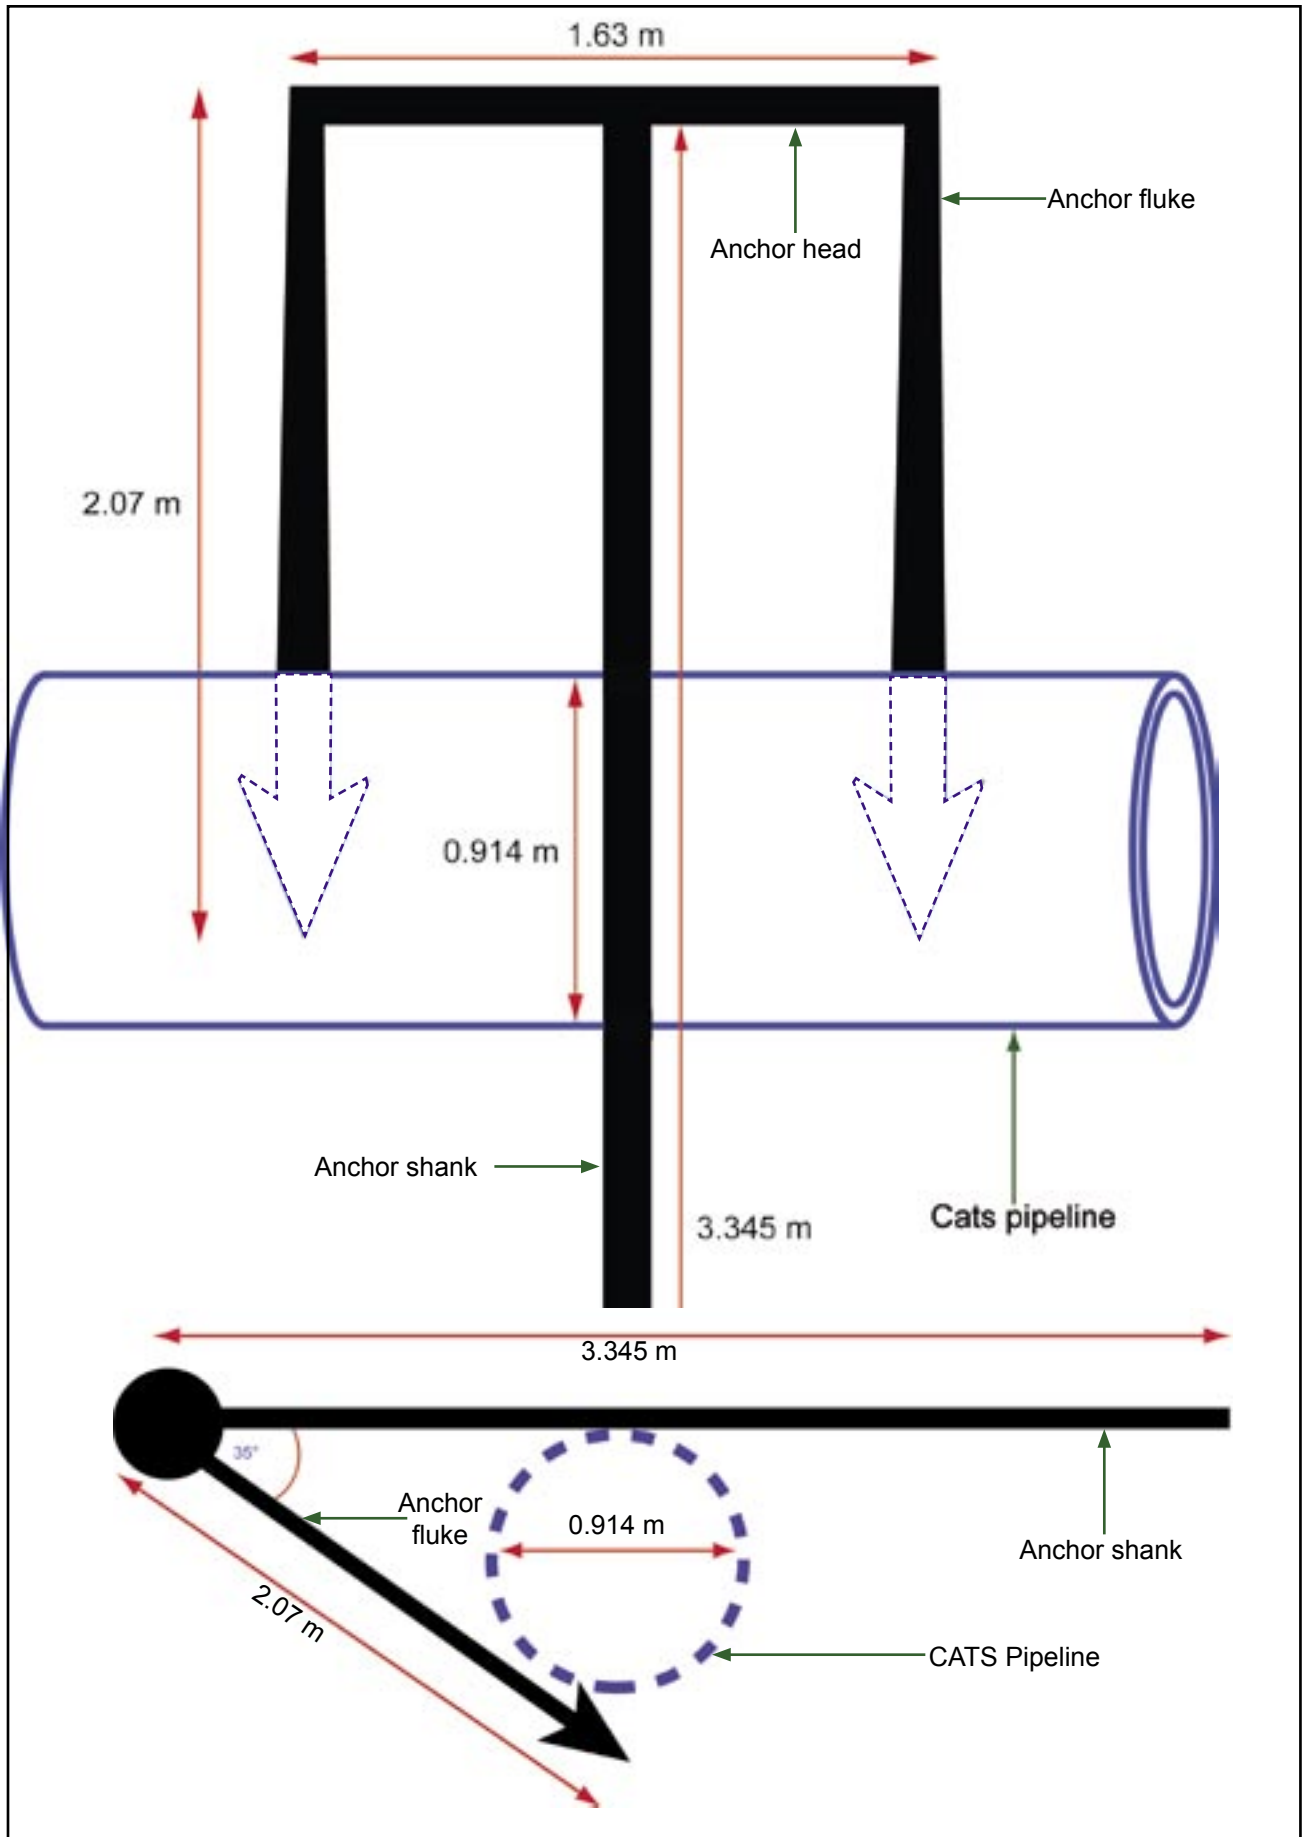
Had the hazard been included, then the need to match the risk assessment to the local environment would have been identified. In this case, the proximity of a large vessel anchorage, the moderate holding ground, and the warnings in the Admiralty Sailing Directions about the tenability of the anchorage in north or north-easterly gales would have been considered. Although the CATS pipeline had been routed clear of

Plan view and elevation diagrams representing *Young Lady's* anchor snagging the CATS pipeline

the main anchorage area, it had been positioned to the south of the anchorage. The pipeline was, therefore, in the path of any vessels dragging anchor in poor weather, an occurrence so common that, on the night of this accident, the dragging of *Young Lady's* anchor failed to trigger an adequate response from Tees Ports Control.

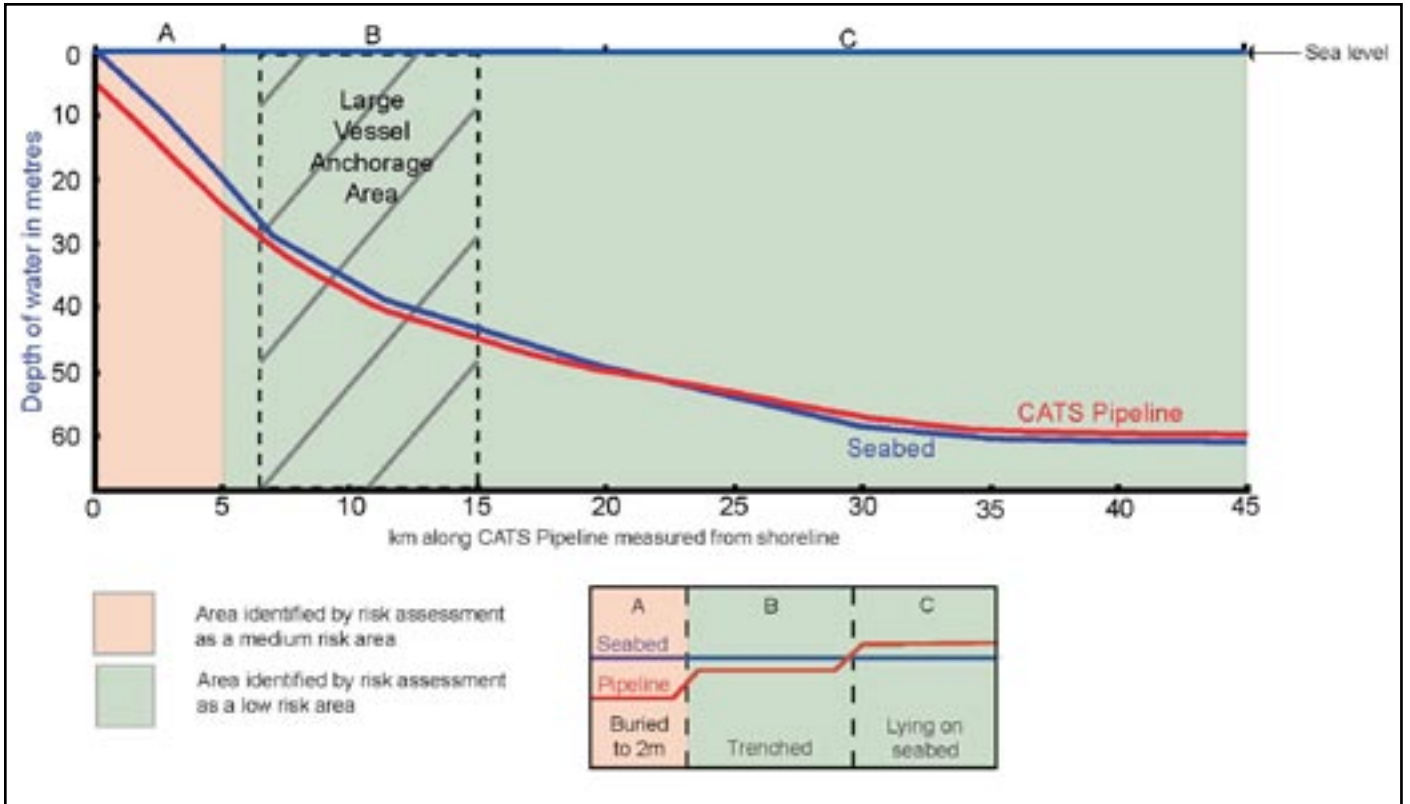
CATS Pipeline in relation to the seabed
