# THE FORMER SSI STEELWORKS, REDCAR: PRIORITY AREAS WITHIN SSI LANDHOLDINGS CONTRACT 3

Contract 3 Site Condition Report

REPORT NO. Redcar Steelworks-AUK-XX-XX-RP-GE-0001-02-SSI3\_GI\_SCR

AUGUST 2018

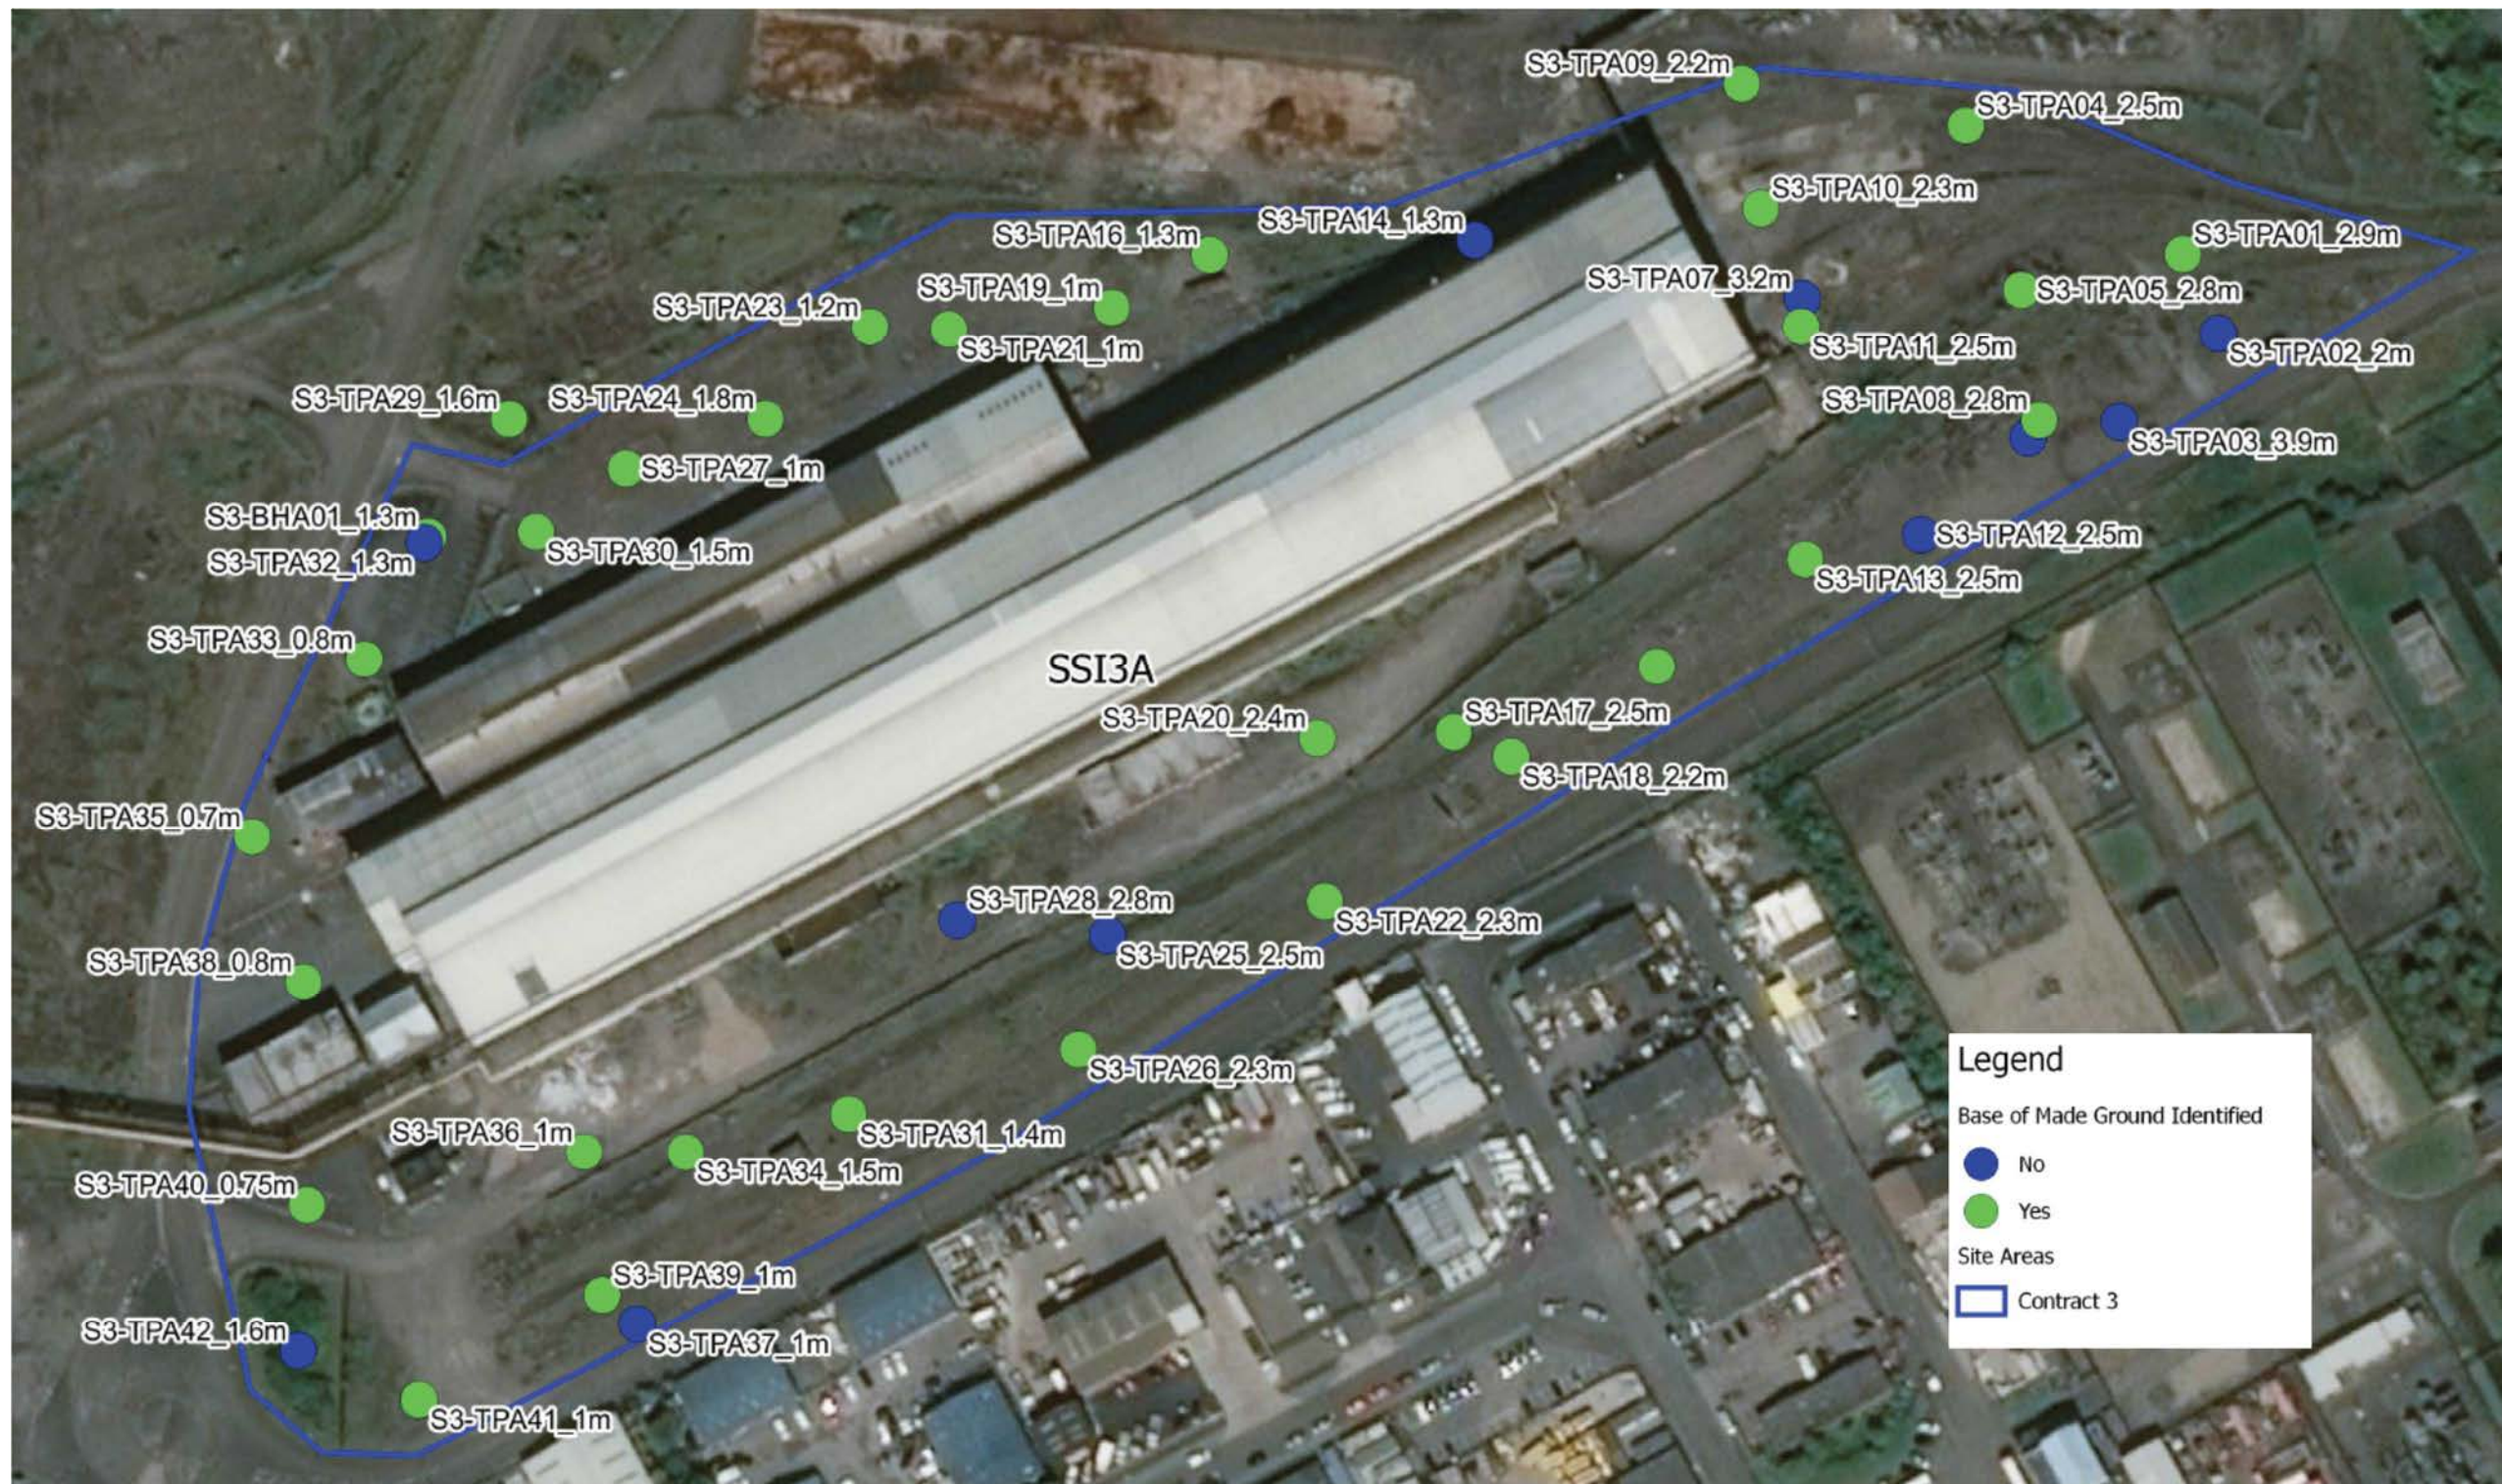
SSI3A Figure 3 – Depth of Made Ground Encountered

Within Areas A and B Made Ground was encountered in all intrusive locations and proven to a thickness of at least 4m and 3.8m bgl respectively. The base of the Made Ground was not proven in 21 locations on Area A and 27 locations on Area B, therefore, greater thickness of material may exist across the site. Made Ground was generally thicker in the east of SSI3A and far north of SSI3B. Figures showing the distribution of the thickness of Made Ground is presented as SSI3A\_Figure 3 and SSI3B Figure 3 below and in Appendix C.

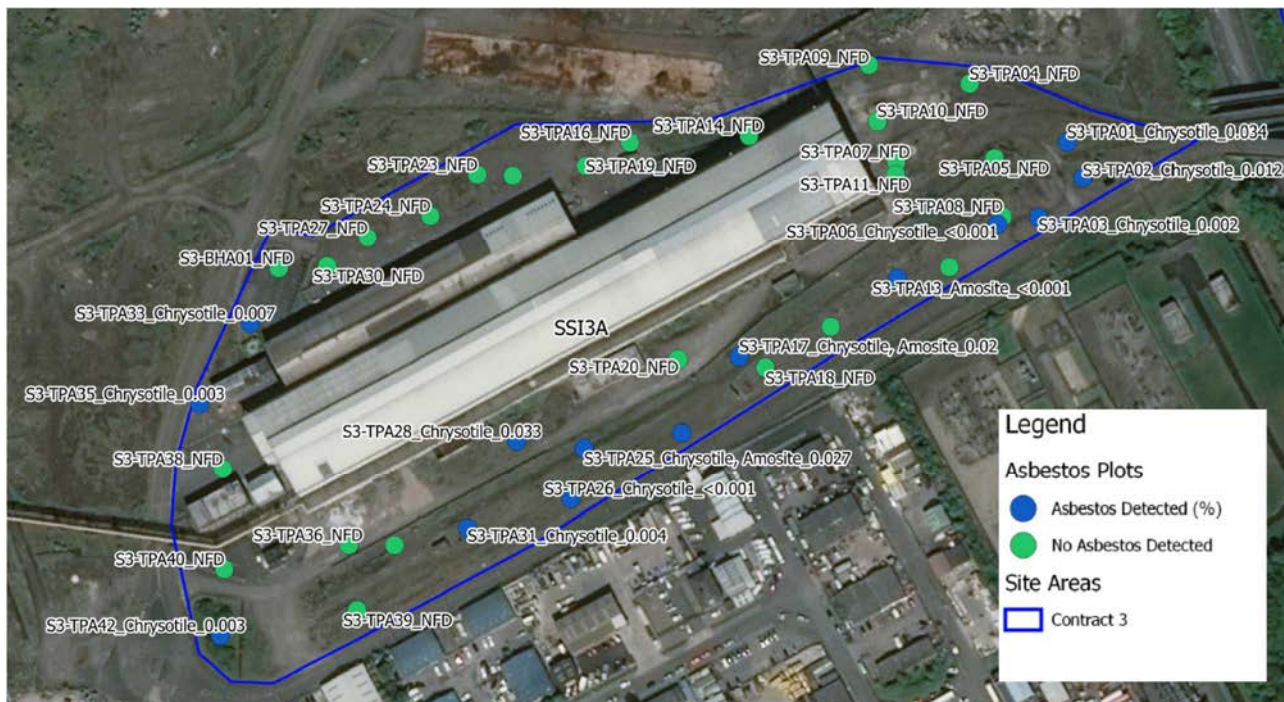
SSI3A Figure 6: Summary of Asbestos Testing

Asbestos fibres were identified in the following locations associated with the Made Ground, the distribution was noted to be primarily across the southern half of the site south to the TLRS; the distribution and quantification of asbestos across Area A is presented on Figure 6 below and in Appendix C.

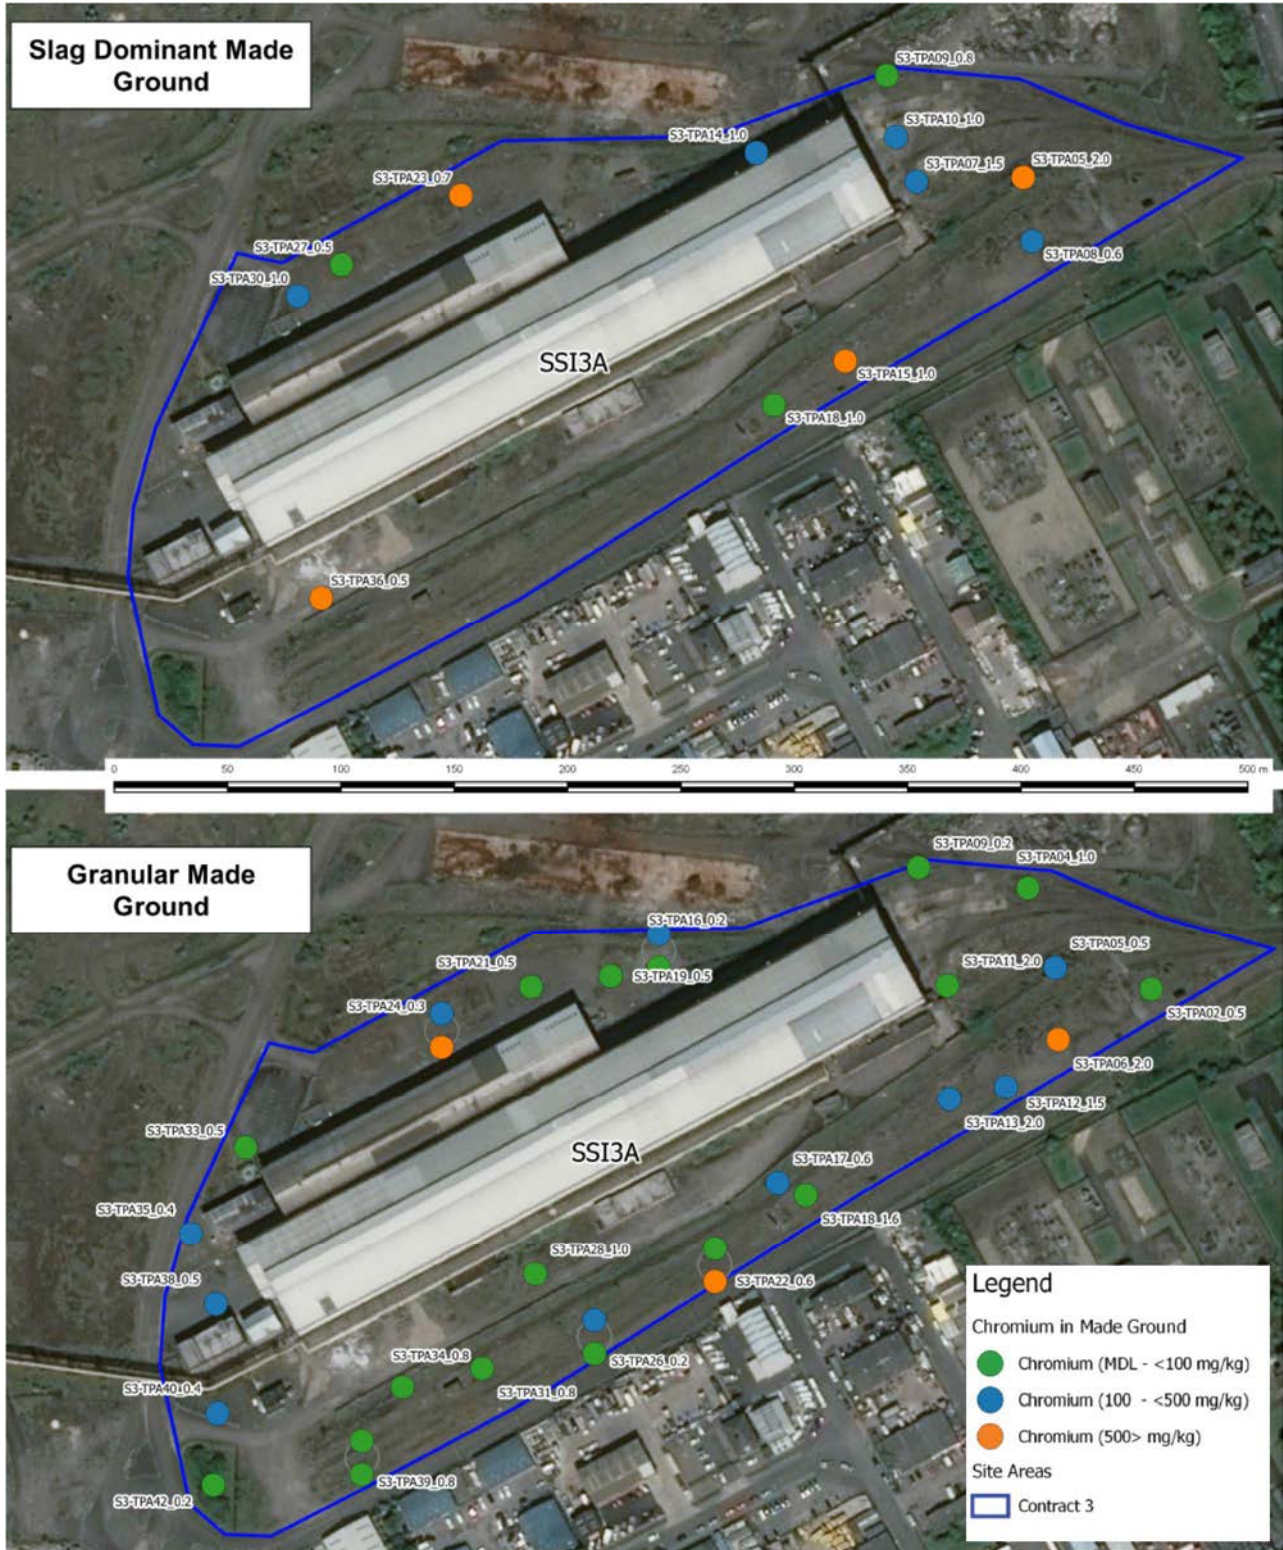
SSI3A Figure 7: Chromium in Made Ground

With the exception of hexavalent chromium which was not measured above the method detection limit (MDL) the metals analysed were detected in the majority of the soil samples taken from the Made Ground. Statistical analysis indicates that the metal and inorganic ion distribution across the site within the three types of Made Ground deposit (slag dominant deposits, granular and cohesive Made Ground) are relatively consistent within the same order of magnitude. The highest metal concentrations were identified in the slag dominant Made Ground. Concentrations of copper, lead, and vanadium were notably higher in slag dominant deposits, aluminium in granular Made Ground, and cadmium in cohesive Made Ground. A distribution plot for chromium is presented as SSI3A Figure 7 below and in Appendix C; further plots for lead, and vanadium as SSI3A Figures 8 and 10 in Appendix C.

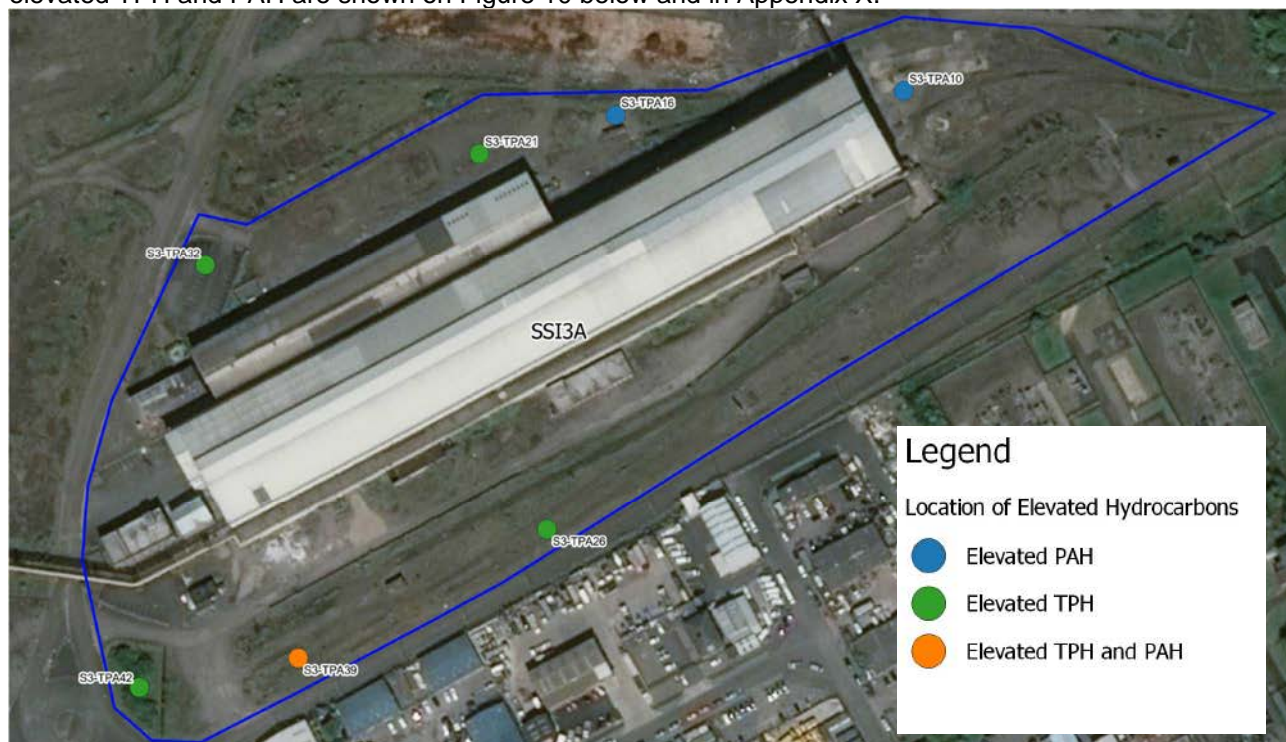
SSI3A Figure 10: Locations of Elevated TPH

The TPH was noted to be associated with rail sidings at the former TLRS and is considered likely to result from historic placement of Made Ground material prior to the construction of the current structure. The locations of elevated TPH and PAH are shown on Figure 10 below and in Appendix X.

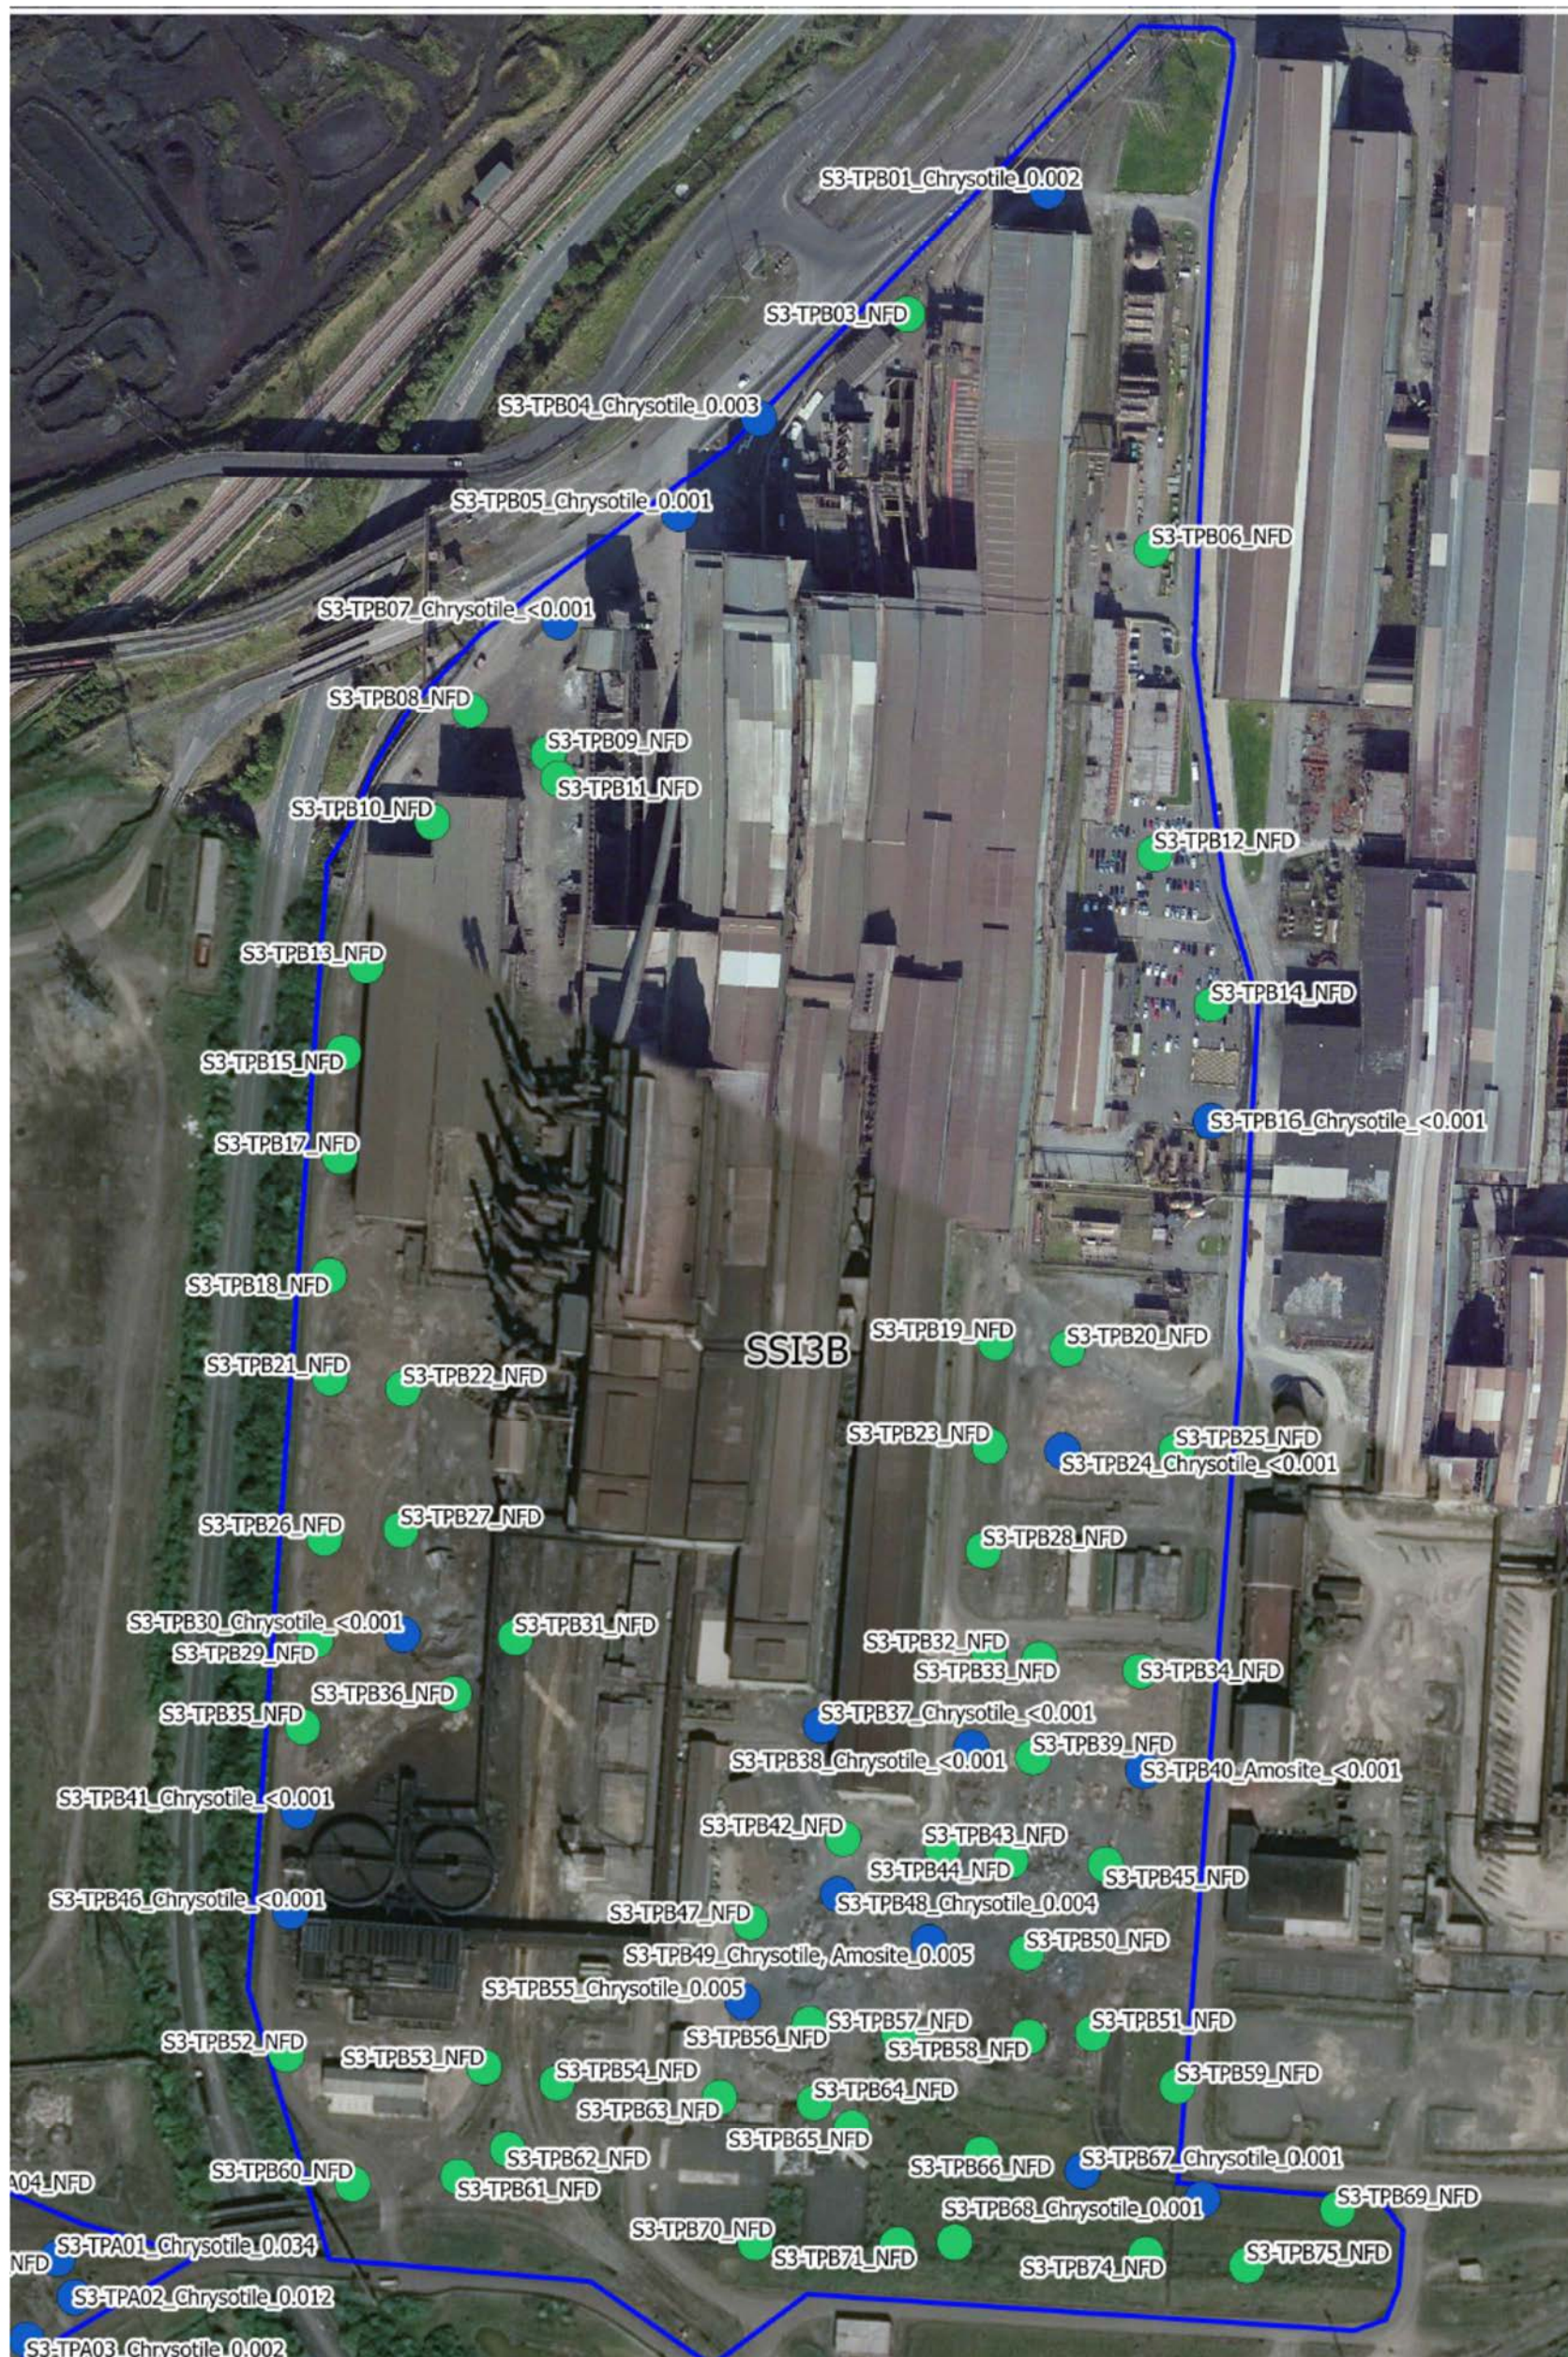
SSI3B Figure 6: Summary of Asbestos Testing

Asbestos fibres were identified in the following locations associated with the Made Ground, the distribution was noted to be primarily across the south eastern third of the site and northern boundary. The distribution and quantification of asbestos presented on SSI3B Figure 6 below and in Appendix C.

Note, given the age of the structures on site, it is likely that asbestos containing materials (ACM) have been used in the building construction., Assessment of the presence of ACM in buildings is outside of the scope of this report, and further surveys should be carried out ahead of any refurbishment or demolition works.

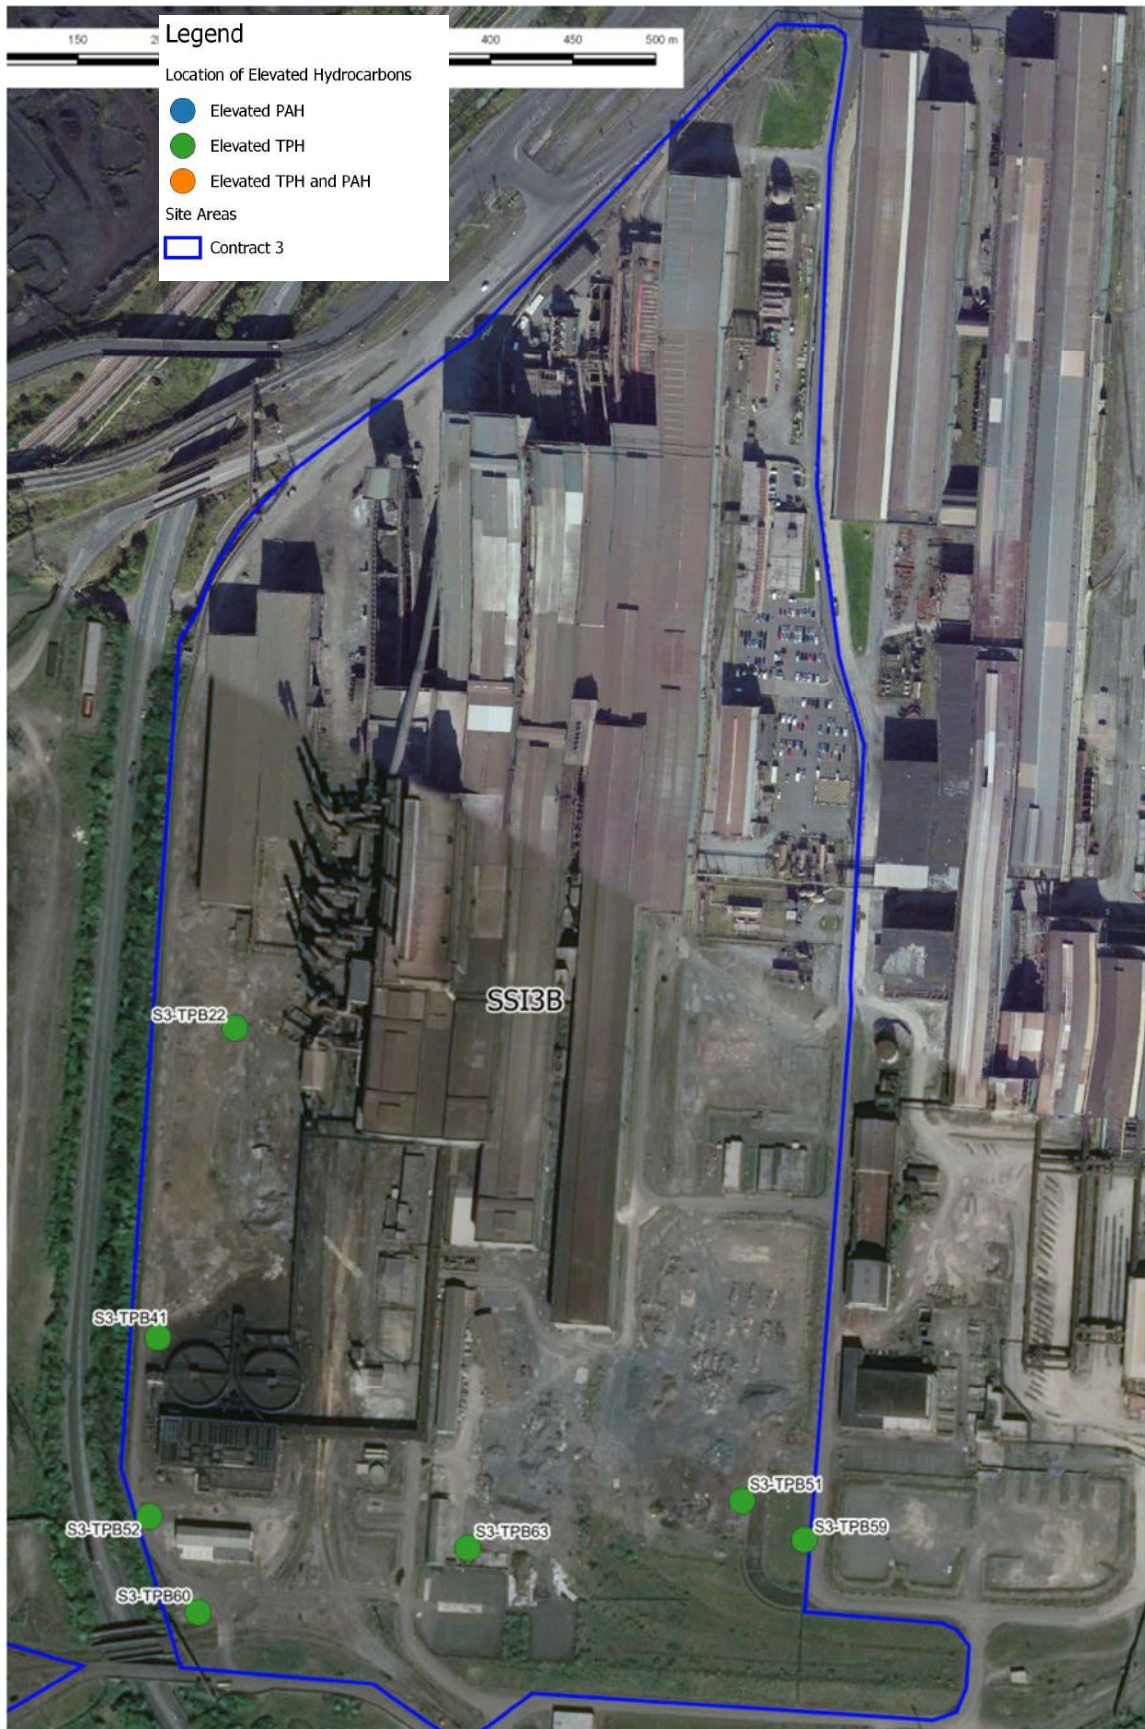
SSI Figure 10: Location of Elevated Hydrocarbon Detections

Based on the type of TPH fractions identified and the position of the trial pits the hydrocarbons identified in S3-TPB52 and S3-TPB60 are likely to relate to the same source, potentially associated with the slag transporter workshop. The locations of elevated TPH are shown on Figure 10 below and in Appendix C.
