# Net Zero Teesside – Environmental Statement

Planning Inspectorate Reference: EN010103

Appendix 10A: Preliminary Sources Study Report

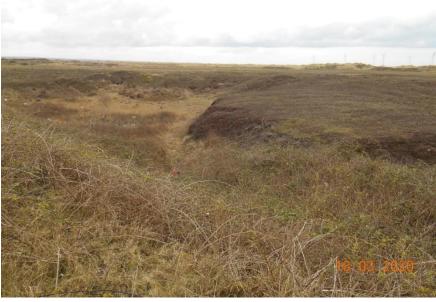
Plates 1, 2 and 3 show areas of steel slag waste, most likely placed during the operation of the Redcar Iron and Steelworks (present between 1929 and 1973) tipped immediately north of the Site across the proposed Onshore CO<sub>2</sub> corridor. These areas of slag extend north to Blown Sands deposits of the natural beach sand and dune habitats, although these areas are also most likely underlain with manmade materials placed between 1856 and 1894, associated with early land reclamation and construction of defences from the North Sea.

Plate 1 – View looking north east showing areas of steel blast furnace waste slag with the existing offshore windfarm visible in the distance.

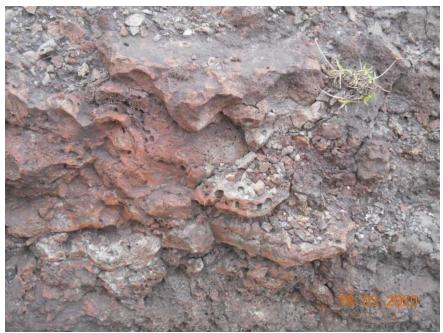
Plate 2 -Typical composition of the fused blast furnace slag.

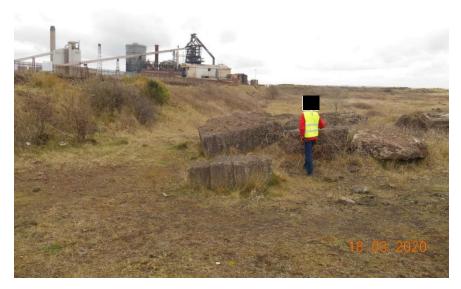
It was noted that there are localised areas of spoil comprising large discarded fused slag and old concrete foundations from previous industrial development across this area, see Plate 3.

Plate 3 – View looking south west showing large concrete blocks thought to be foundations from previous land use within the Main Teesworks Site shown on the foreground, and the former blast furnace on the right-hand side of the photograph which is outside and adjacent to the east boundary of the site.

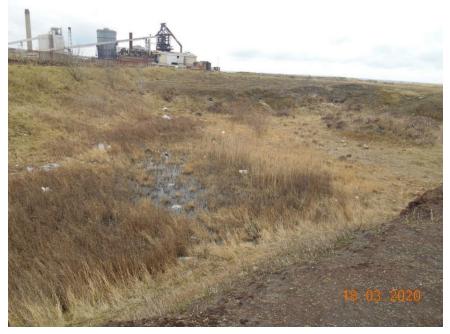
Site were generally dry or marshy, see Plate 4. These ponded areas are shown as different sizes over different dates of OS mapping, suggesting they are influenced by seasonal rainfall.

Plate 4 – View looking south west within the Onshore CO<sub>2</sub> corridor showing marshy pond areas north east of the Main Teesworks Site.

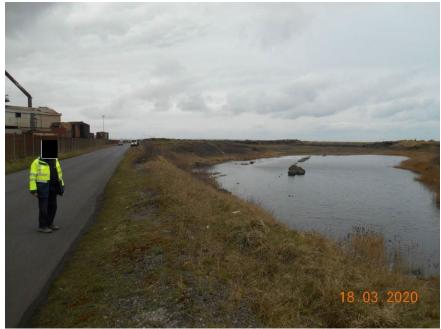
A larger and more permanent pond is present north of the unnamed road adjacent to the north west corner of the of the Main Teesworks Site. The bunded areas around the pond are formed of Made Ground primarily comprising waste slag materials from the former Redcar Iron and Steel Works, shown on Plate 5 below.

Plate 5 – View looking north west along unnamed road and permanent pond.

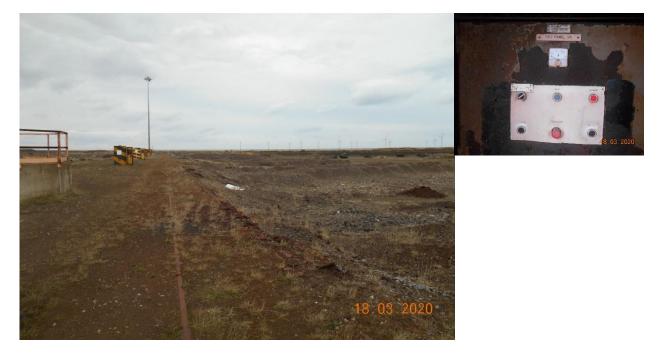
#### Plate 7 – View looking north west along the alignment of the steel torpedo 'pond area'. The tilt operation booths are seen yellow/black on the left handleft-hand side of the photograph (see insert showing Tilt Panel to the right), with running rails for the tippers shown on the edge of the 'pond' areas.

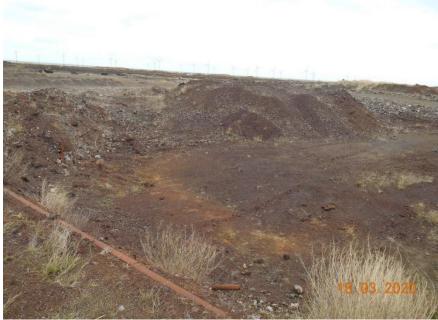
The former 'pond' area is now covered in various spoil heaps of blast furnace slag and crushed concrete, with metal detritus varying in size typical of gravel, cobbles and boulders across the area, see Plate 8. It was noted that there is no or little vegetation present across the former ponds. Land immediately south and south west of the 'ponds' was generally vegetated with grasses and included very large blocks of waste iron assumed to be associated with the practise of tipping of molten iron as described above, see Plate 9 for a typical 'block' observed.

Plate 8 - View looking north showing typical spoil heaps of iron slag waste material.

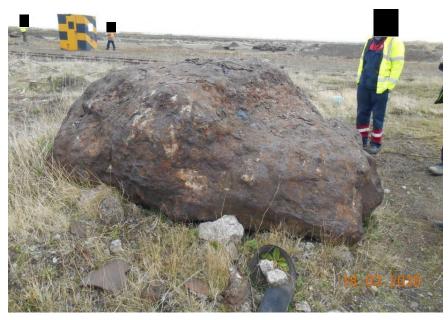
## Plate 9 - Typical example of waste iron blocks discarded across land south of the torpedo pond area. Estimated size 5.0 X 5.0 X 1.5m.

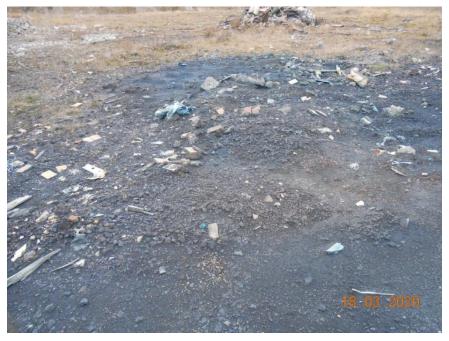
gasification (gas works) processors and also with coke works and manufacturing of coke for steelmaking. However, neither of these of these industries are recorded on historical OS mapping to have been present on the Site, with former Redcar Coke Ovens (RCO) and coke stocking area located some 200m to the west northwest. Therefore, the source of this contamination is unknown. However, groundwater monitoring data from previous ground investigations by others has identified cyanide contamination within groundwater in this area, so the source and extent of contamination should be determined by ground investigation.

#### Plate 10 – Surface soils discoloured blue typical of cyanide contamination.

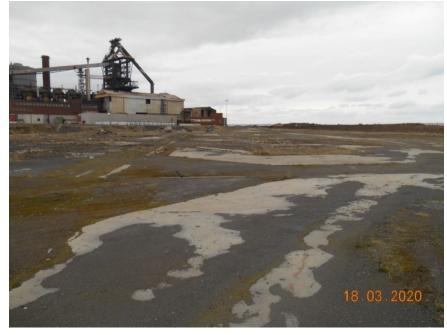
The second area of interest comprises hardstanding and remnants of four hexagonal areas of hardstanding understood to be foundation bases located in the north east corner of the proposed Main Teesworks Site, see Plate 11. These footings are thought to possibly be a result of the initial intention to build a further 2 blast furnaces (outside, and to the north west of the proposed site boundary shown on the left hand side of the photograph) which were subsequently never constructed. It is understood the initial production forecast for the existing plant was originally intended to be three times the actual production capacity, but was scaled down due to economic demand at that time. The circular foundations do not include concrete within the centre as it is understood this would have housed a low collection point required as part of the production process.

# Plate 11 - View looking west- north west showing remnant foundations and hardstanding.

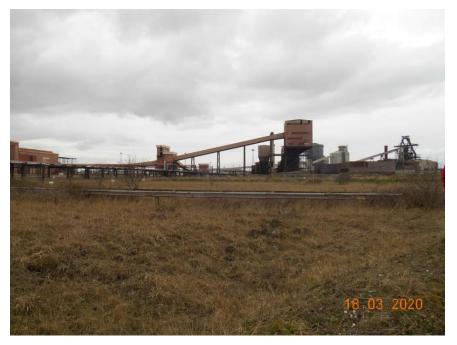
The area of open ground and the Blast Furnace Stockhouse is shown Plate 13. Access below or into any of the structures was not permitted during the walkover due to The CDM Regulations (2015) and Health and Safety restrictions. Safety barriers seen running across the foreground of the photograph delineate known service corridors, particularly for high voltage buried cables.

Plate 13 – View looking west showing area of open ground, Blast Furnace Stockhouse and associated buildings. The Blast Furnace is shown on the right hand side of the photograph which is outside and north west of the proposed site boundary.

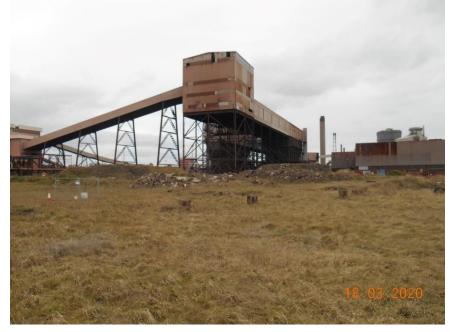
Plate 14 – View looking west showing stockpiles, former refuelling area and historical cut-down structure stanchions.

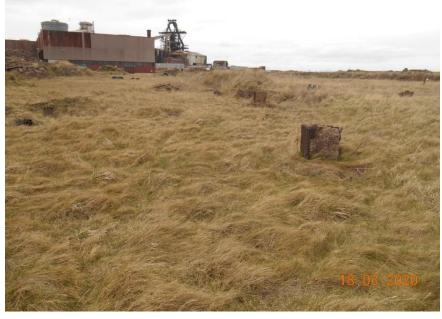
Plate 15 – View looking north west showing cut-down structure stanchions along the alignment of the former Redcar Steel and Iron works Steel Plant building.

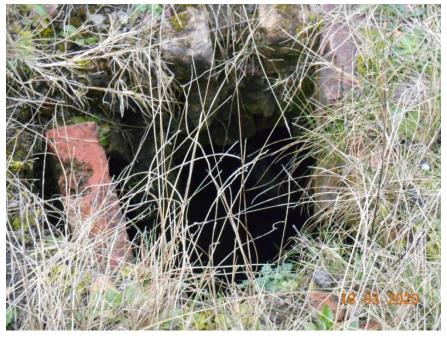
The area of open ground east of the Blast Furnace Stockhouse (see Plate 13) is known be underlain by number of buried structures, caverns and brick lined tunnels, these within the area of Herras fencing shown in the centre of the photograph. These predate the exisitng SSI plant layout and are most likely associated with the earlier former Redcar Iron and Steelworks site (present on site from 1929 to 1973). The buried structures and tunnels may be associated with steel melting hearths and ventilation tunnels with anecdotal evidence suggesting there were ten steel melting heaths on the site, although these are not shown on any historical OS mapping. The

Plate 16 - Surface expression of buried structures and tunnels.

merits of undertaking geophysical investigations including Ground Penetrating Radar (GPR) and/or Resistivity techniques was discussed on site as a suitable for a Phase 1 investigation to aid determination of the location, direction and extent of these across this area. Access into the fenced areas was not permitted during the site walkover due to The CDM Regulations (2015) and Health and Safety restrictions, however there is little visible surface expression of these features as shown in Plate 16.

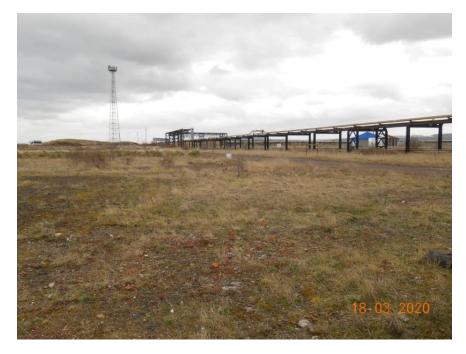
Plate 17 – View looking east south-east showing overhead COG and fuel oil pipelines. The RDL Stores building and associated canteen are located in the north east corner of the central area adjacent to the east boundary of the Site boundary, see Plate 18. It is reported that historically there may have been some storage tanks (contents unknown) west of the structures associated with stores.

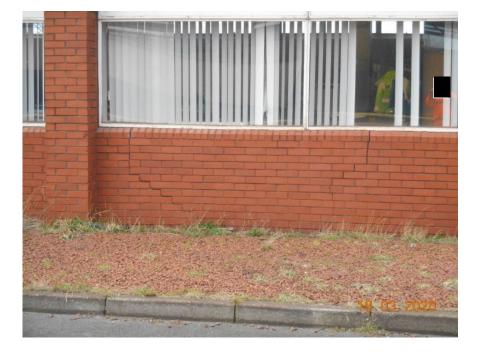
The structures in this area are of brick construction. Waste slag material is present widely across the whole site, with evidence of the expansive nature of this material visible through structure deformation and cracking in the walls of these buildings. Plate 19 shows the STSC offices and Plate 20 shows the Pellet Tunnel building.

# Plate 19 – View looking north showing structure deformation and cracking on the STSC office building.

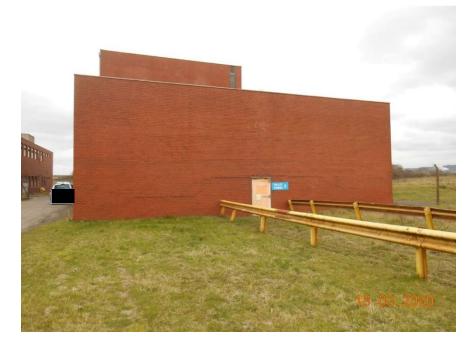
Plate 20 – View looking west showing deformation across the Pellet Tunnel building. It is noted that the extent and direction of the tunnels are not known at the time of this report issue, however STSC have indicated that these records should be available for release. The barriers leading to the structure again delineate the corridor of buried underground services and high voltage cables.

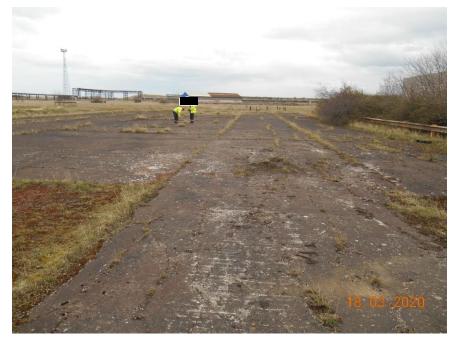
Plate 24 – View looking east southeast showing a hardstanding area. It was noted that the hardstanding surface is 'wavy' and cracked, again providing

## evidence of heave inferred to have resulted from the presence of expansive slag materials below this area.

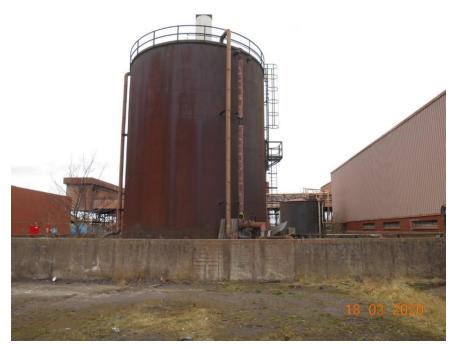
located adjacent to, but outside of the proposed south boundary of the Teesworks Site. The tank is located within a concrete bund which appeared to be of sound construction. The site representative from STSC confirmed that the tank was removed from service prior to SSI purchase of the site but was not fully emptied. It was noted that pipe cladding insulation materials were fibrous in nature and may represent an asbestos risk, see Plate 28. This would need to be established through testing although it is noted that the tanks will most likely be demolished as part of the STSC site clearance works.

Plate 27 – View looking west northwest showing diesel tank and surrounding concrete bund wall.

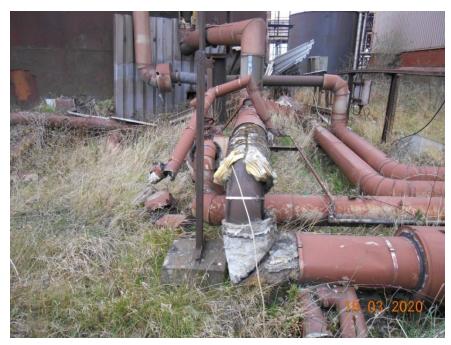
Plate 28 – Diesel tank connections and fibrous pipe lagging.
