# **Technical Appendix 8.2**

## **Contaminated Land Desk Study**

**Falmouth Docks and Engineering Company**

# **FALMOUTH DOCKS DEVELOPMENT CONTAMINATED LAND DESK STUDY**

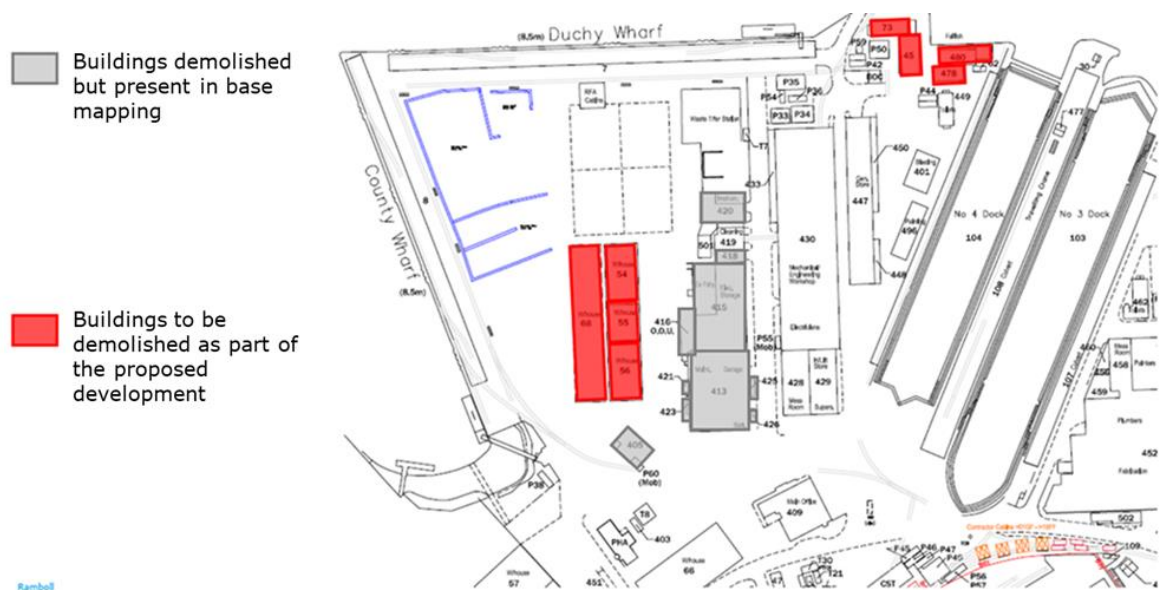
**Drawing 4 – Buildings Proposed for Demolition**

Drawing 4 presents the buildings proposed to be demolished as part of the proposed development, shown in red. Buildings shown as grey are due to be demolished as part of the dock operations under permitted development rights by the Applicant.

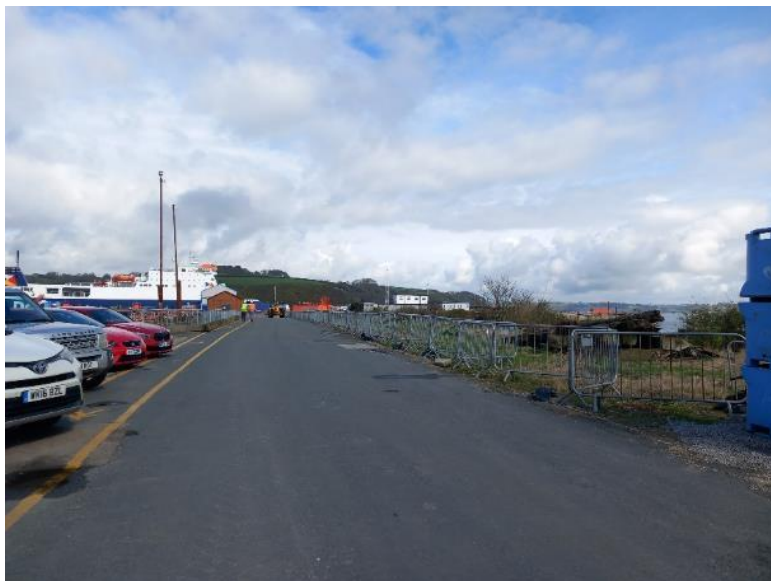
**Photo 1.**

The marine portion of the site consists of the Central Causeway from which the wharves extend; with the Western Wharf (which is currently not in operation) running parallel to the eastern side of the Central Causeway. The Western Wharf is noted to be overgrown and stockpiles of wood / timber have been noted along the length of the wharf (Photo 1). The southernmost part of the Central Causeway consists of a storage area for Falfish wholesale seafood supplier (Photo 2).

View of Central Causeway looking north, with the disused Western Wharf on the east.

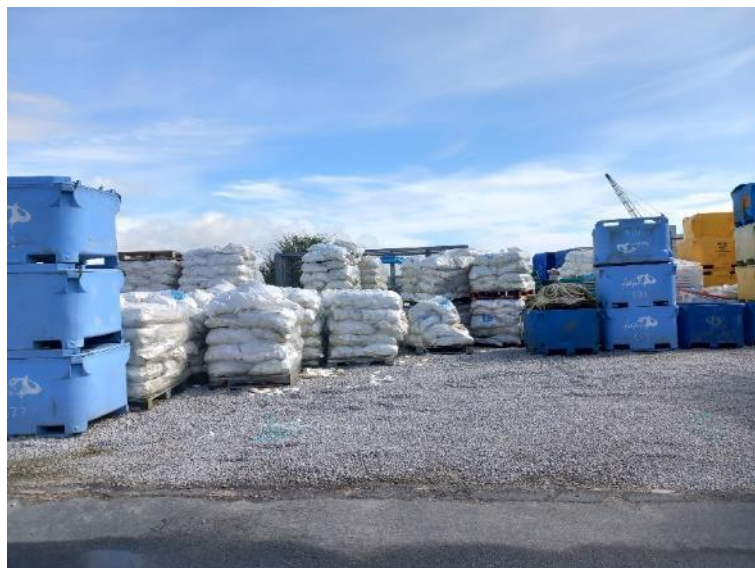
**Photo 2.**

The Falfish storage area located on the southern-most section of the Central Causeway, looking east.

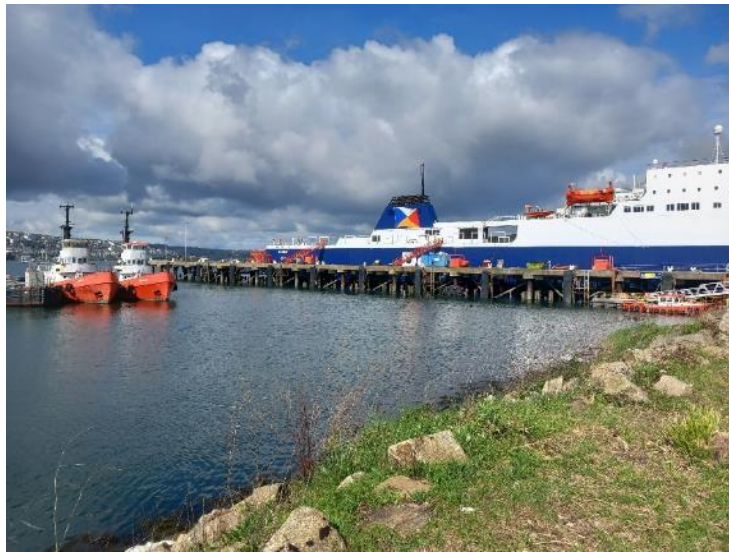
**Photo 3.**

Queen's Wharf (Photo 3) and Northern Wharf (Photo 4) are located at the most northern point of the Central Causeway, and beyond this lies the Carrick Roads estuary. To the north-east of the Central Causeway and south of Northern Wharf, exists an infilled area of reclaimed land which is covered in gravel and concrete hardstanding (Photo 5). It is currently used as a parking area (Photo 6); with welfare units, office facilities, equipment storage and shipping containers of unknown contents (Photos 5, 6 and 7).

View of Queen's Wharf, looking north-west.

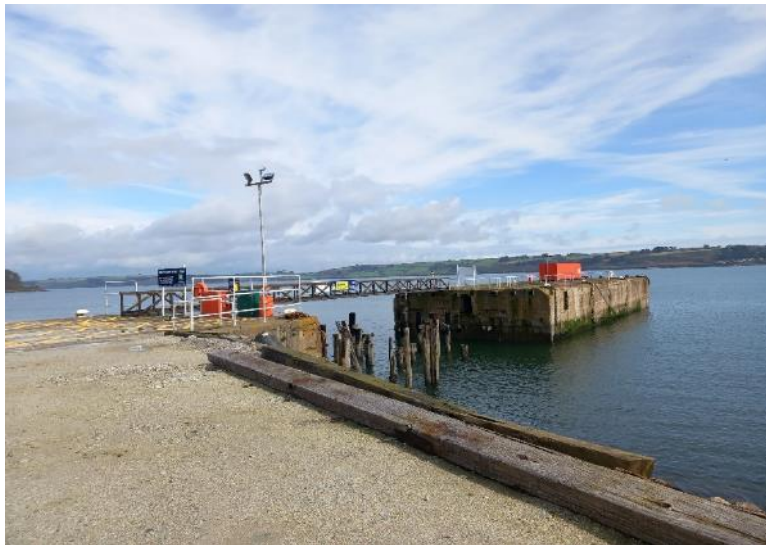
**Photo 4.**

View of Northern Wharf (and the Northern Arm), looking north-east.

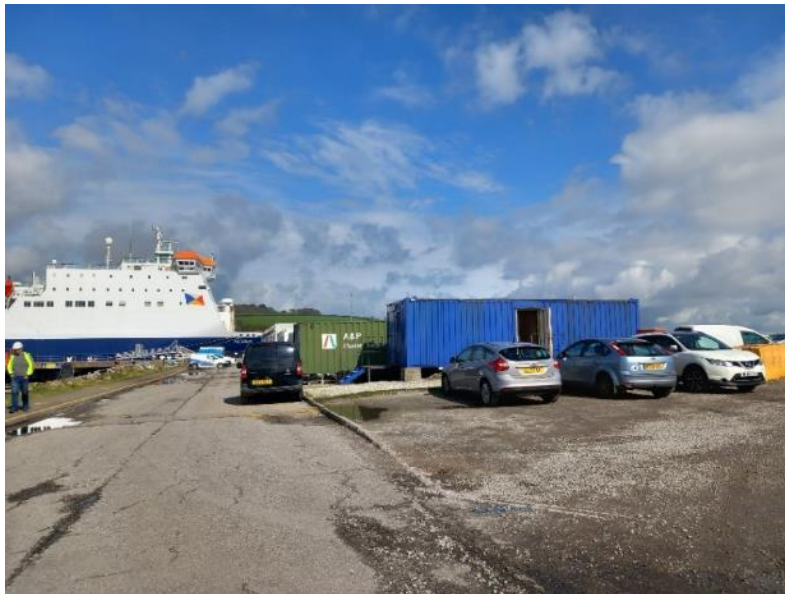
**Photo 5.**

View of the infilled area to the south of the Northern Wharf, looking north.

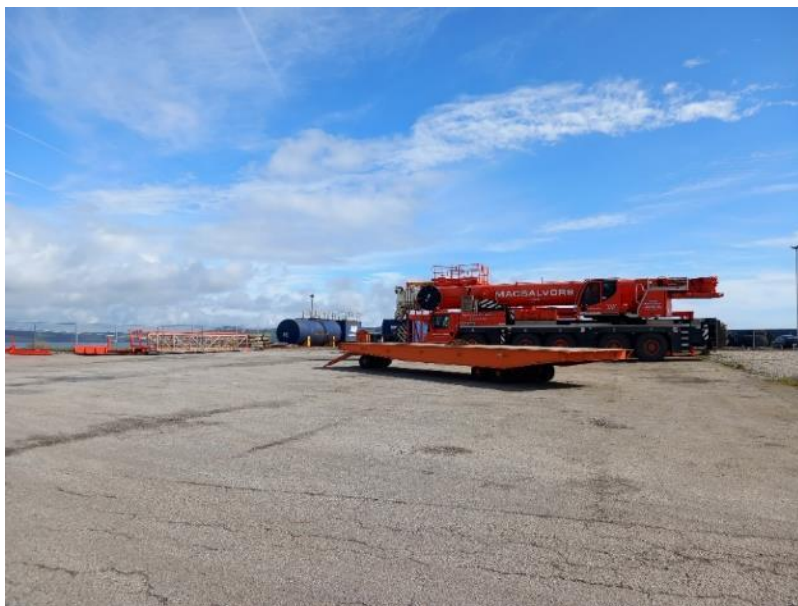
**Photo 6.**

View of the infilled area to the south of the Northern Wharf, looking east.

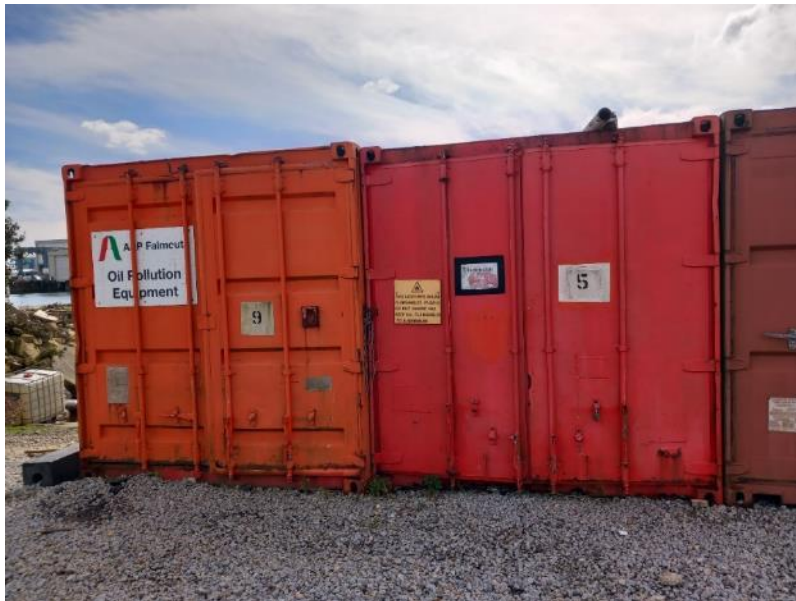
**Photo 7.**

Storage containers with unknown contents located on the infilled area to the south of the Northern Wharf.

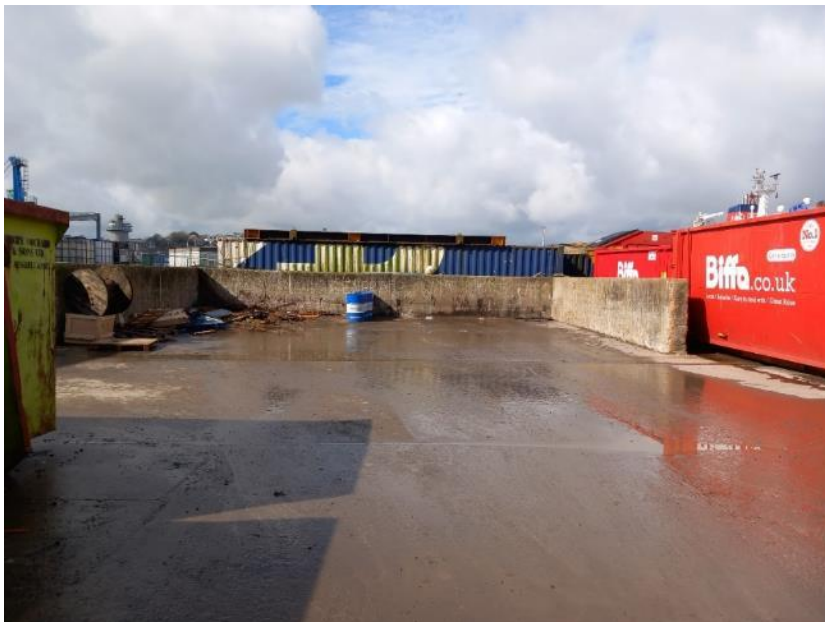
**Photo 8.**

A Waste handling area is also present to the north of the terrestrial portion of the site for general waste (Photo 8). Waste is stored directly on hardstanding which appeared to be in good condition. According to the site contact, the Waste Transfer notes are checked daily.

No visual evidence of staining or leaching from waste storage areas onto unsurfaced ground was noted.

View of Waste handling area and containers with unknown contents.

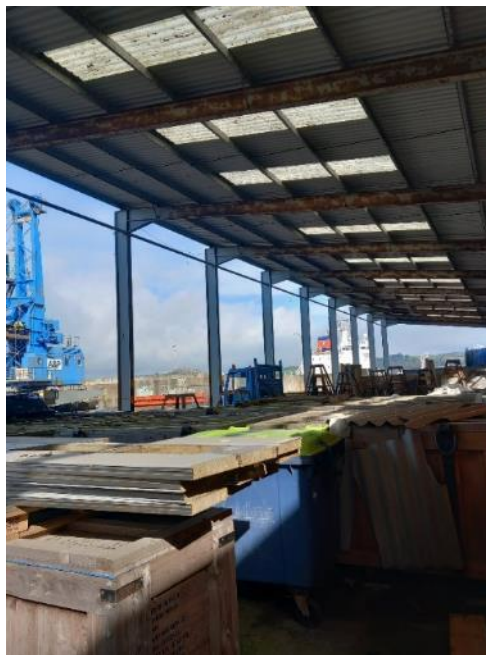
**Photo 9.**

Recycled glass cullet storage area located to the north-west of the terrestrial site.

A recycled glass cullet storage area is present in the west of the terrestrial site (Photo 9). The glass is collected from the wider county of Cornwall and is stored in open bulk cargo bays before it is loaded into cargo vessels on County Wharf.

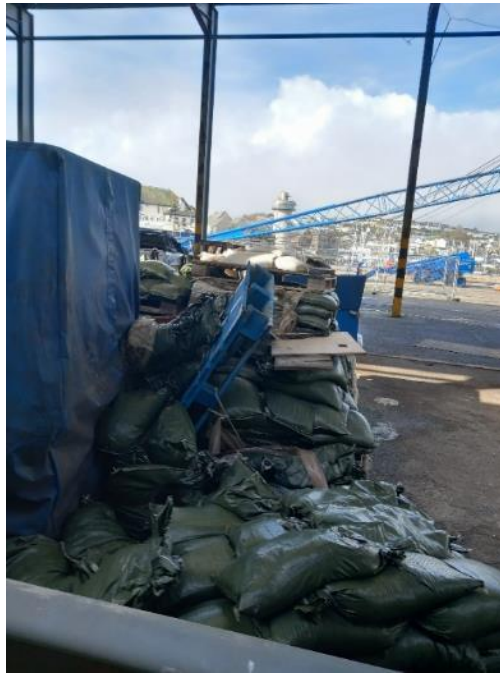
**Photo 10.**

Storage of various materials in Building 68.

- Building 68 is a lean-to located outside of warehouses 54, 55 and 56. It is a storage area consisting of paint drums, a stockpile of grit blast, sandbags, waste skips, and machinery (Photos 10, 11 and 12).
- Building 55 is a warehouse containing various equipment, machinery, and chemicals (Photos 13 and 14) (to be demolished as a part of the main planning application).
- Building 54 is a warehouse containing machinery, paints and chemicals (Photo 15).
- Building 419 is a cleaning room, used to clean machinery and equipment. Machinery and various substances are stored in this room, and three tanks containing corrosive material were recorded during the site walkover (Photos 16 and 17).

Waste paint drums stored on wooden pallets, empty paint containers located in a skip, and a grit blast waste stockpile stored directly on hardstanding were present in Building 68 (Photos 10, 11, and 12).

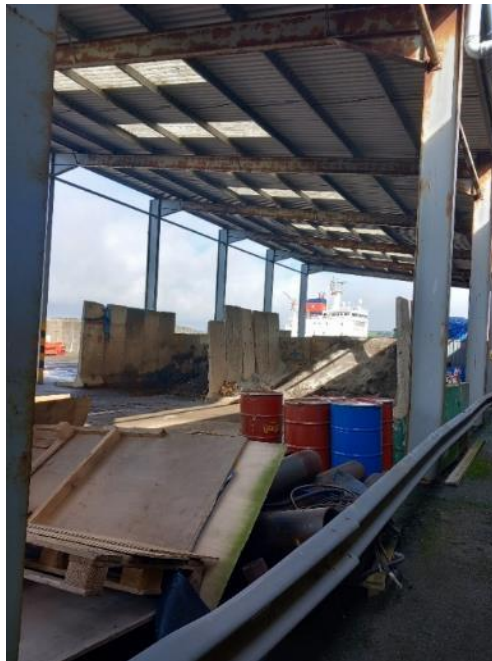
**Photo 11.**

Storage of various materials in Building 68.

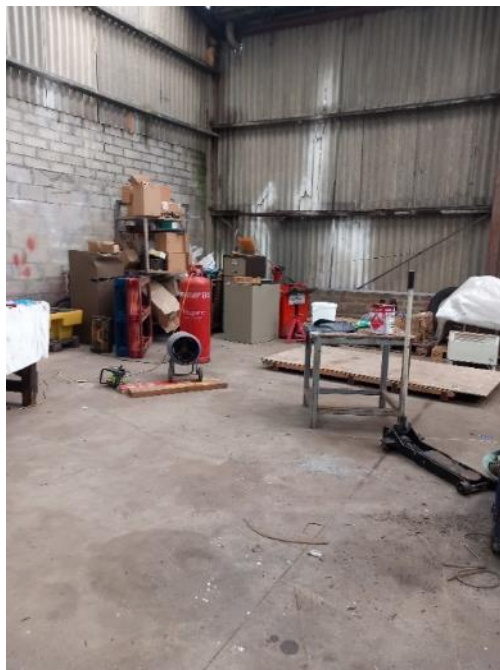
**Photo 12.**

Storage of various materials in Building 68.

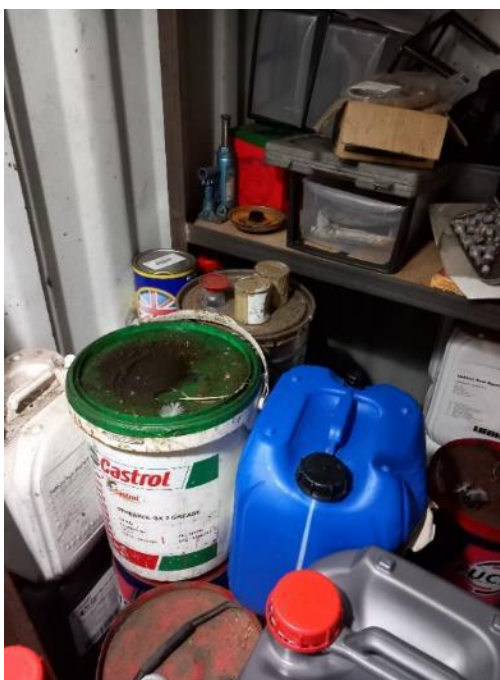
**Photo 14.**

| Item | Location | Containment and other comments |
|---|---|---|
| Engine Oil / Greases / Paints | Building 55 | Approximately 10 containers of a variety of sizes, stored directly on surfacing within the building. No evidence of staining (Photo 14). |

Storage of chemicals in Building 55.

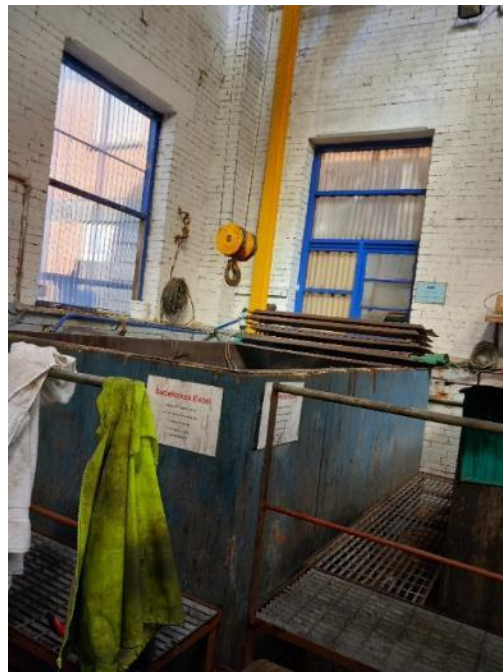
**Photo 16.**

View of Building 419.

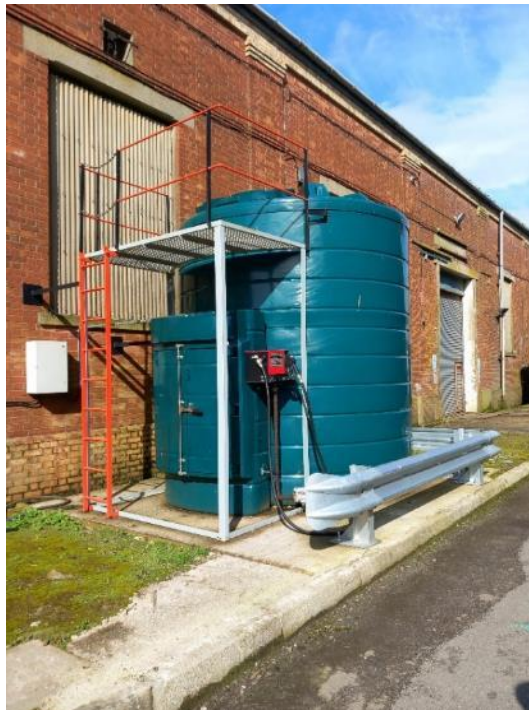
**Photo 18.** Kerosene tank located to the west of Building 428.

| Tank Number | Contents and Capacity | Location | Construction and Containment |
|---|---|---|---|
| 1 | Kerosene<br>Unknown capacity | To the west of building 428 | An integrally bundled plastic tank, observed to be in good condition, located on a concrete slab. No signs of heavy staining observed (Photo 18). |

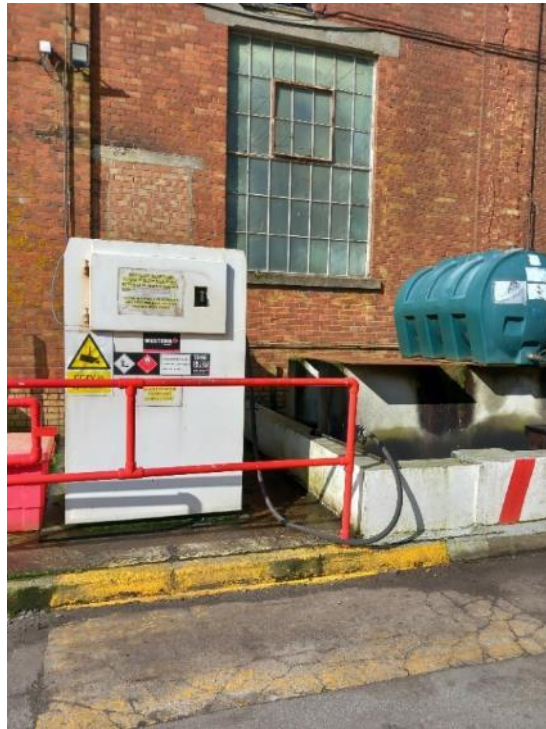
**Photo 19.**

| Tank Number | Contents and Capacity | Location | Construction and Containment |
|---|---|---|---|
| 2 | Diesel<br>4394 L | To the west of building 428 | A metal tank, observed to be in good condition, located on concrete hardstanding. The tank is attached to a pump and an above ground hose located above a concrete bund. Impact protection surrounded the tank. No signs of heavy staining observed, and no hydrocarbon sheen noted in the standing water in the bund (Photo 19). |

Diesel tank located to the west of Building 428.

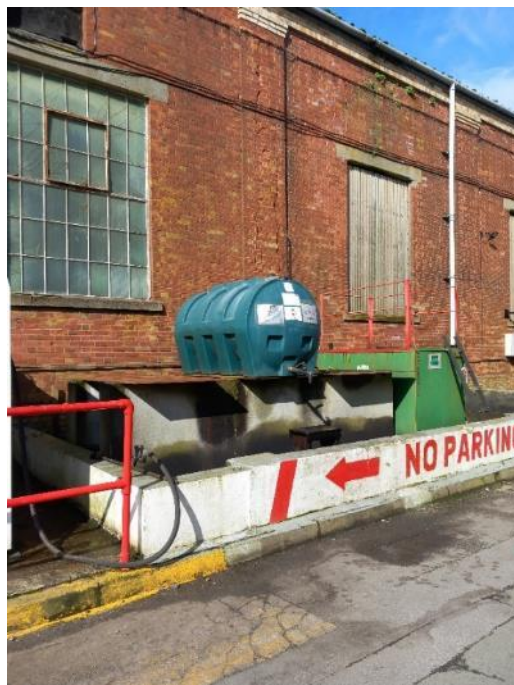
**Photo 20.**

| Tank Number | Contents and Capacity | Location | Construction and Containment |
|---|---|---|---|
| 3 | Hydraulic Oil<br>1000 L | To the west of building 428 | An integrally bundled plastic tank, observed to be in good condition, located above a concrete bund. No signs of heavy staining observed, and no hydrocarbon sheen noted in the standing water in the bund (Photo 20). |

Hydraulic Oil tank located to the west of Building 428.

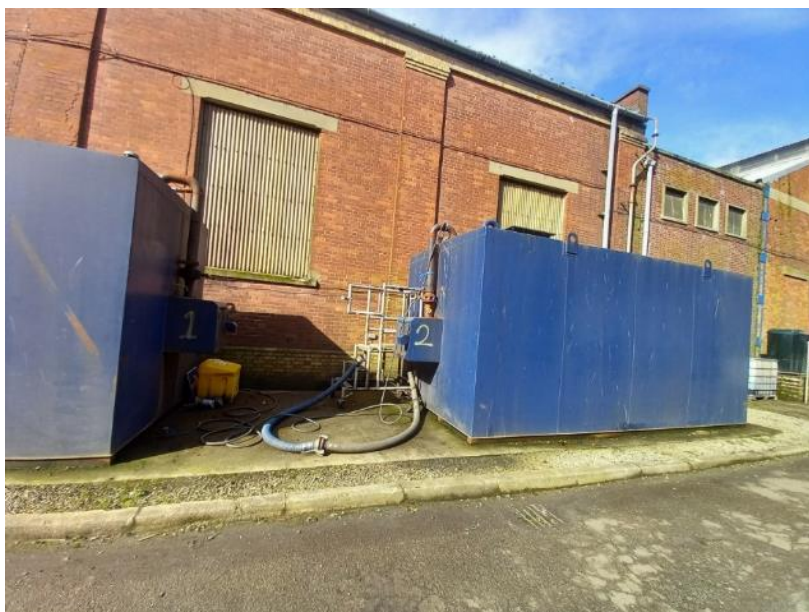
**Photo 22.**

| Tank Number | Contents and Capacity | Location | Construction and Containment |
|---|---|---|---|
| <b>5</b> | 2 x Waste Oil<br>25,000 L each | To the west of building 428 | Two integrally bunded tanks, used for the temporary storage of waste oils and oily water from vessels. These are used to store oil for disposal off-site when the normal procedure of tankering straight into World Fuels for disposal cannot occur. These are both located on hardstanding. No heavy staining was observed (Photo 22). |

Two waste oil tanks located to the west of Building 428.

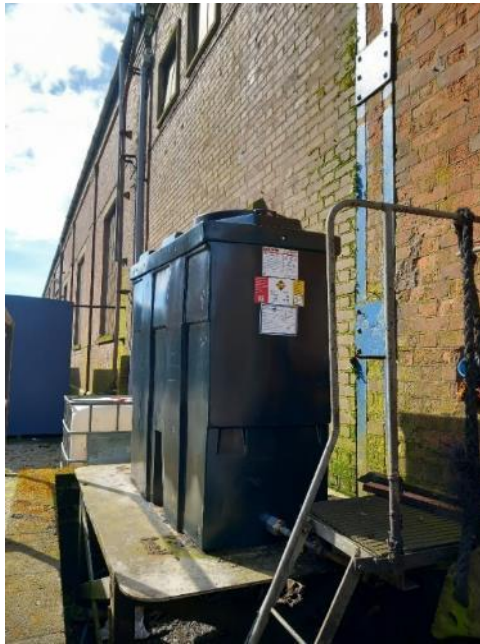
**Photo 23.**

| Tank Number | Contents and Capacity | Location | Construction and Containment |
|---|---|---|---|
| <b>6</b> | Kerosene<br>2000 L | On the external eastern wall of Building 419 | An integrally bunded plastic tank, observed to be in good condition, located in a concrete bund. No signs of heavy staining observed, and no hydrocarbon sheen noted in the bund (Photo 23). |

Kerosene tank on the external eastern wall of Building 419.

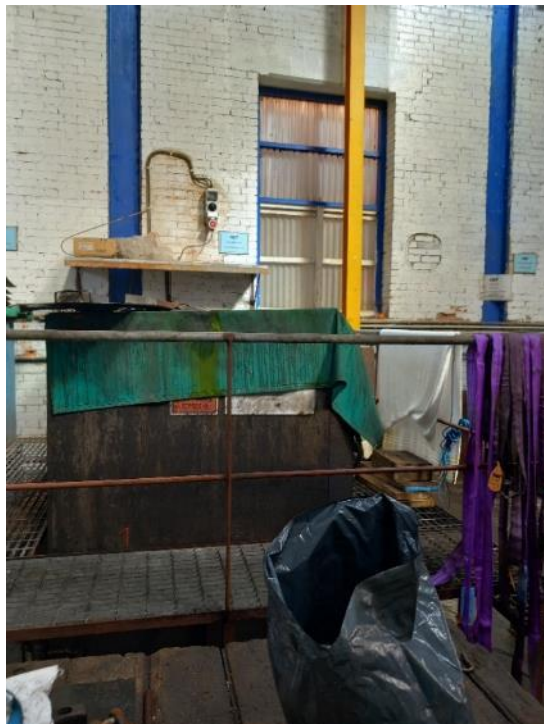
**Photo 24.**

Caustic cleaner tank in Building 419.

| Tank Number | Contents and Capacity | Location | Construction and Containment |
|---|---|---|---|
| <b>7</b> | Caustic cleaner<br>6500 L | Building 419 | An uncovered metal tank, located within a bund in Building 419. Used for cleaning of machinery (Photo 24). |

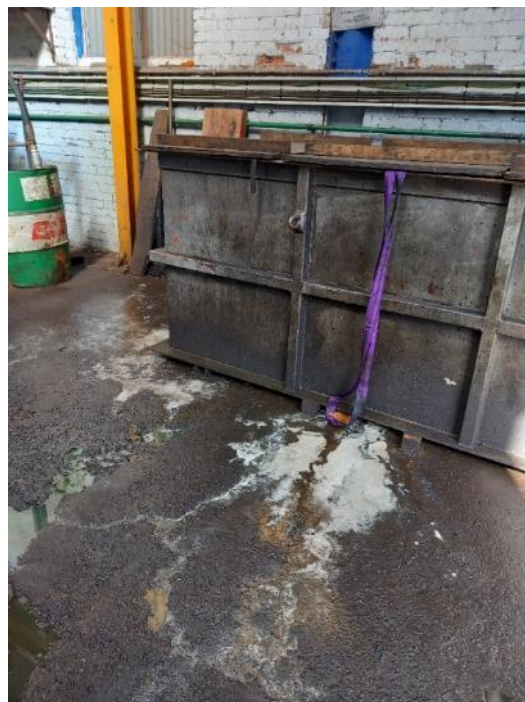
**Photo 26.**

| Tank Number | Contents and Capacity | Location | Construction and Containment |
|---|---|---|---|
| <b>9</b> | Hydrochloric acid<br>700 L | Building 419 | A metal tank with a metal lid, covered in sheeting and located on hardstanding in Building 419. Used for cleaning of machinery. Evidence of acid spills on the floor have been noted (Photo 26). Hardstanding in relatively good condition. Wastewater from the cleaning room is caught in a below ground pit and pumped into IBCs for off-site disposal. |

Hydrochloric acid tank in Building 419.

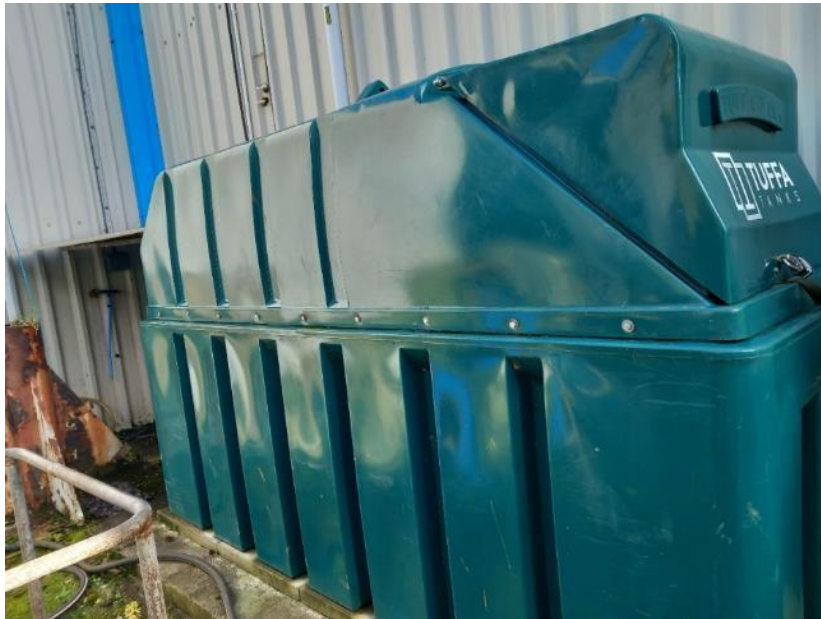
**Photo 27.** Diesel tank to the west of Building 45.

| Tank Number | Contents and Capacity | Location | Construction and Containment |
|---|---|---|---|
| <b>10</b> | Diesel (Falfish)<br>1200 L | To the west of Building 45 | An integrally bunded plastic tank with level gauge, observed to be in good condition, located on concrete hardstanding. No signs of heavy staining observed (Photo 27). |

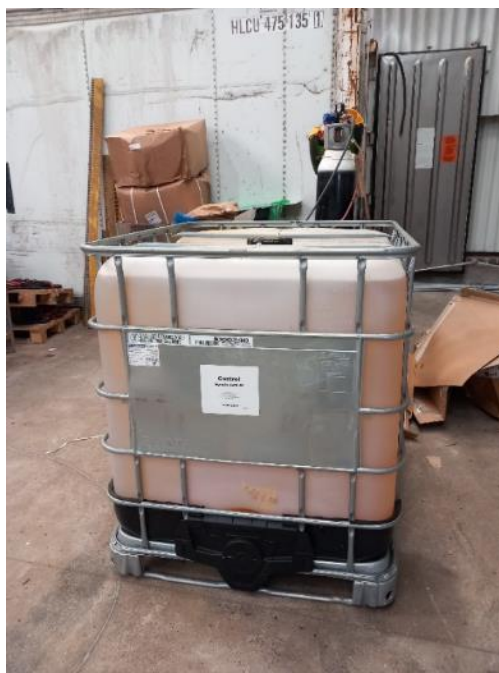
**Photo 28.** Intermediate Bulk Container (IBC) of hydraulic oil located in Building 55.

| Item | Location | Containment and other comments |
|---|---|---|
| Hydraulic Oil | Building 55 | A 1000-litre IBC stored on hardstanding within the building. No evidence of staining (Photo 28).<br>A 208-litre drum stored on wooden pallet. No evidence of staining. |

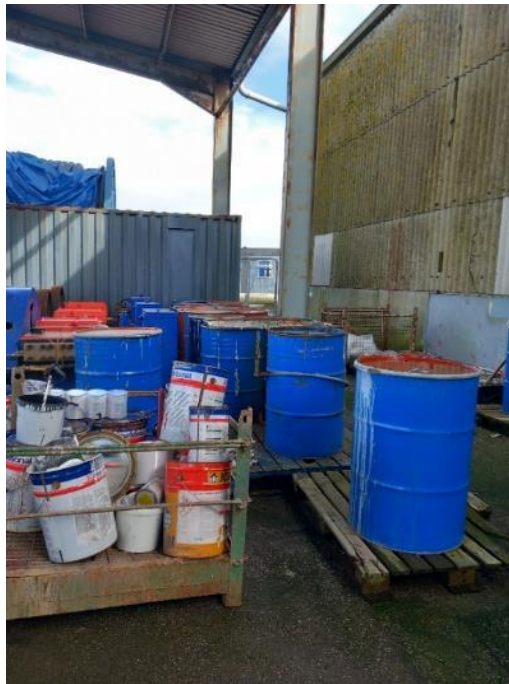
**Photo 29.** Paint drums located in Building 68.

| Paint drums | Building 68 | More than 20 drums of waste paint awaiting collection for disposal stored on wooden pallets with no secondary containment. No evidence of staining (Photo 29).<br>More than 30 smaller containers of paints of various sizes stored on drip trays. No evidence of staining was observed. |

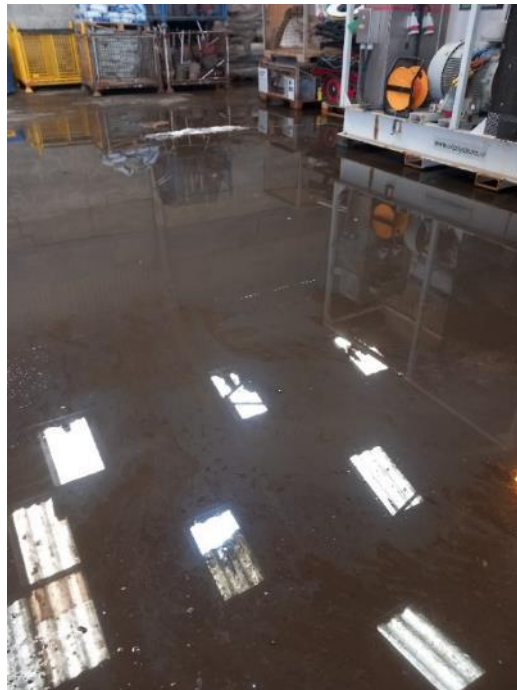
**Photo 30.** Sheen visible in standing water in Building 54.

| Paints / De-ruster / hydraulic oil | Building 54 | Eight containers located in a metal cage with a base. Slight staining to metal. A sheen was present in the surface water inside the building (photo 30). |

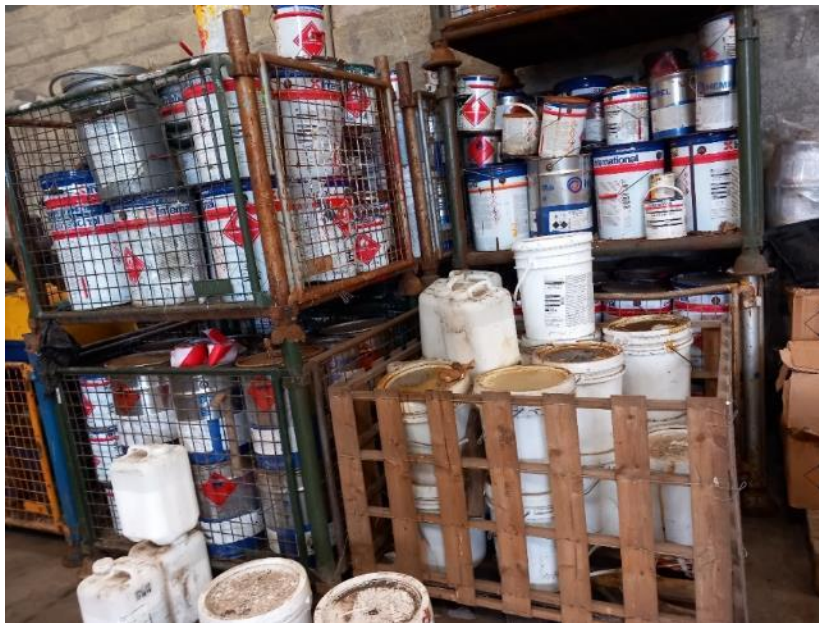
**Photo 31**

| Paints | Building 54 | More than 50 containers of paints in various sizes located on wooden pallets, cages and directly on hardstanding. Some paint staining was observed on floor surfacing (Photo 31). |

Paint containers in Building 54.

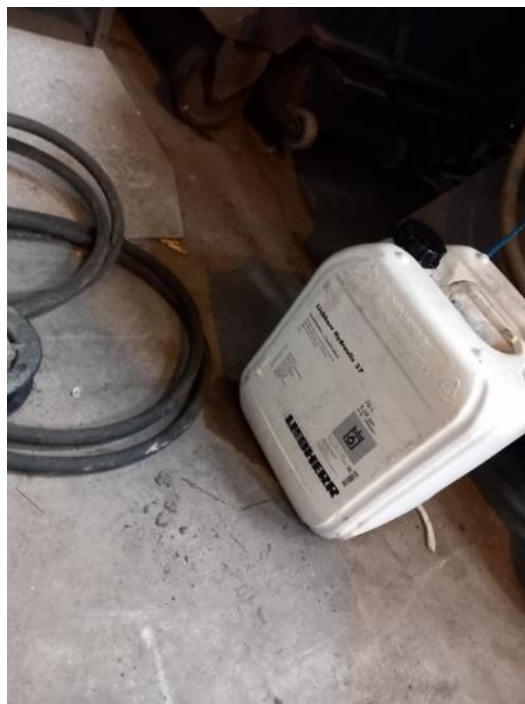
**Photo 32**

| Hydraulic Oil | Building 54 | A 20-litre container stored directly on hardstanding. Some evidence of staining observed on the floor (Photo 32). |

Evidence of hydraulic oil on floor in Building 54.

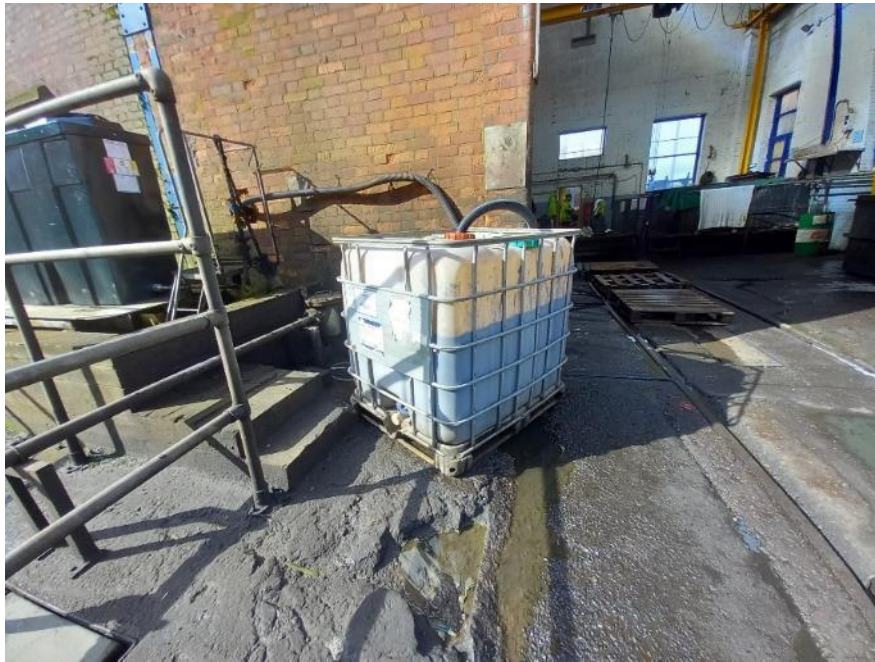
**Photo 33.**

| Wastewater (in an IBC labelled CLP Gear Oil) | Building 419 | A 100-litre IBC, used for wastewater from the cleaning room which is caught in a belowground pit and pumped into the IBC for off-site disposal. Located directly on hardstanding. No evidence of staining was observed (Photo 33). |

IBC containing wastewater outside of Building 419.
