Net Zero Teesside – Environmental Statement

Appendix 12G: Water Vole and Otter Survey Report

**OGCI Clean Gas Project
Redcar**

Water Vole and Otter Survey Report

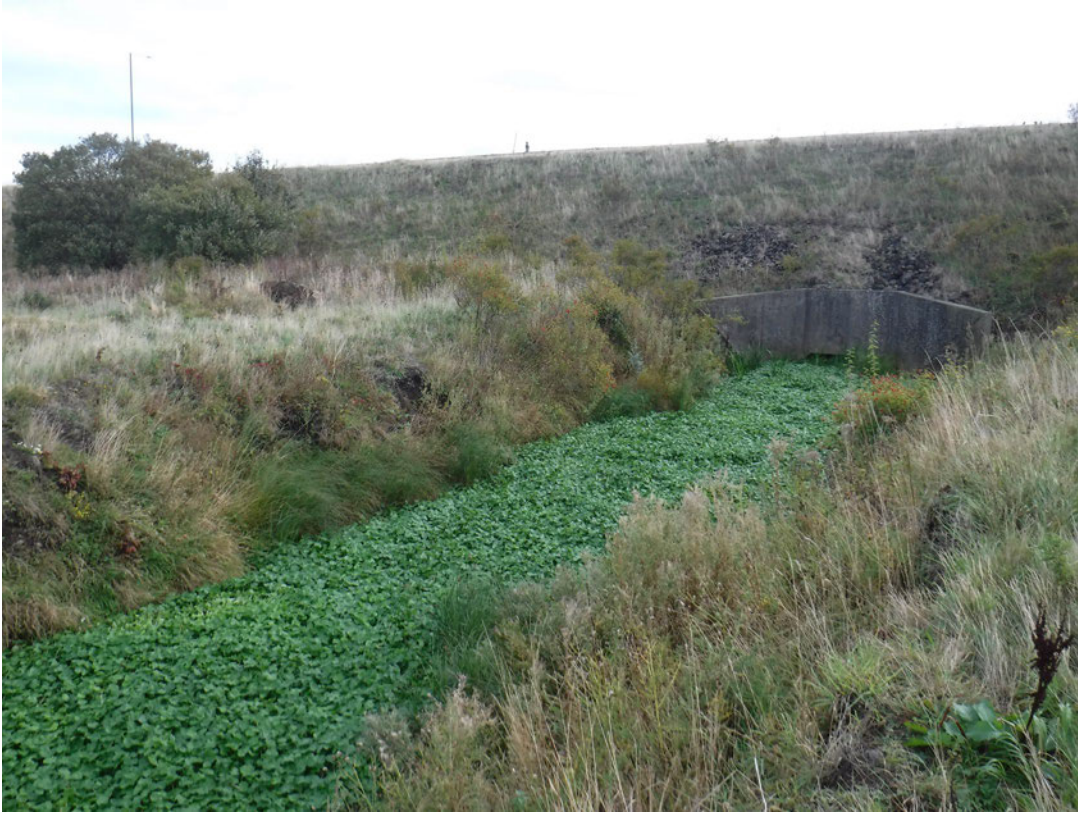
- 3.1.1.1 The Fleet is a ditch with a central position at NZ5732 2448. It is a straight ditch approximately 380 m long and 2 m wide orientated southeast – northwest, bending towards the southwest at its western end with a slight curve at the west end where it meets the road.

- 3.1.1.2 The ditch was holding water at the time of survey with no notable flow noted. The ditch was highly vegetated with aquatic vegetation including marsh marigold *Caltha palustris* and common water starwort *Callitriche stagnalis*. Other aquatic vegetation within the ditch and along the water margin included common reed *Phragmites australis*, *Typha* sp., pendulous sedge *Carex pendula* and false fox sedge *Carex otrubae*.

- 3.1.1.3 The bank substrate is rocky and includes species such as rosebay *Chamerion angustifolium*, bramble *Rubus fruticosus* agg. and great willowherb *Epilobium hirsutum*.

- 3.1.1.4 The ditch is surrounded by ephemeral, tall herb grassland and scrub habitats. The presence of fish was considered likely. Fox scat and rat droppings were visible on the banks of the ditch.

- 3.1.1.5 The habitat within this water body was considered to be of low potential value for water voles and resting otters. No evidence of either species was found in or adjacent to this channel and there was only very limited evidence of the presence of brown rat and bank vole. The substrate throughout the site is “made ground” comprising extremely hard and interlocking industrial waste, ballast and refuse hardcore, making burrow excavation difficult and presenting a high risk of burrow collapse.

Photo 1. Section A – The Fleet culvert – facing east.

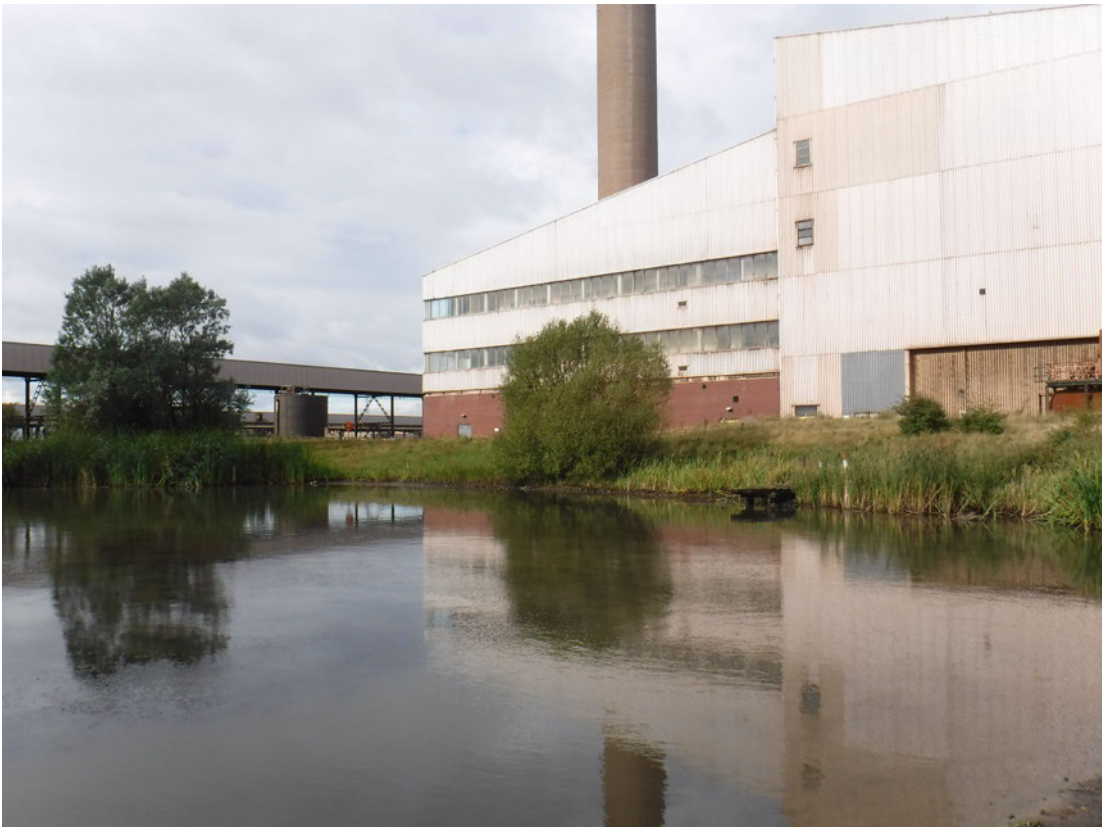
- 3.2.1.1 The Power Station Pond is a small waterbody located at central grid reference NZ5704 2449. It is an irregular shaped pond approximately 95 m long and 25 m wide at its widest point. There is a small island in the southern section of the pond at NZ5704 2445.

- 3.2.1.2 The pond was holding water at the time of survey with no notable flow noted.
- 3.2.1.3 Aquatic vegetation within the pond itself was limited due to wildfowl activity. Other aquatic vegetation along the water’s edge of the pond included large emergent macrophytes such as bulrush *Typha latifolia* and reed canary-grass *Phalaris arundinacea*.

- 3.2.1.4 The pond is surrounded by grassland and scrub habitat. The presence of fish was considered likely.
- 3.2.1.5 The habitat within this pond was considered to be of low potential value for water voles as the bank profile was gently sloping (5-15 degree slope) and the depth was less than 1m with extensive very shallow margins. This pond was also considered to be of low potential value for otters. No evidence of either species was found within or adjacent to this pond.

Photo 2. Section B – Power Station Pond – facing east.

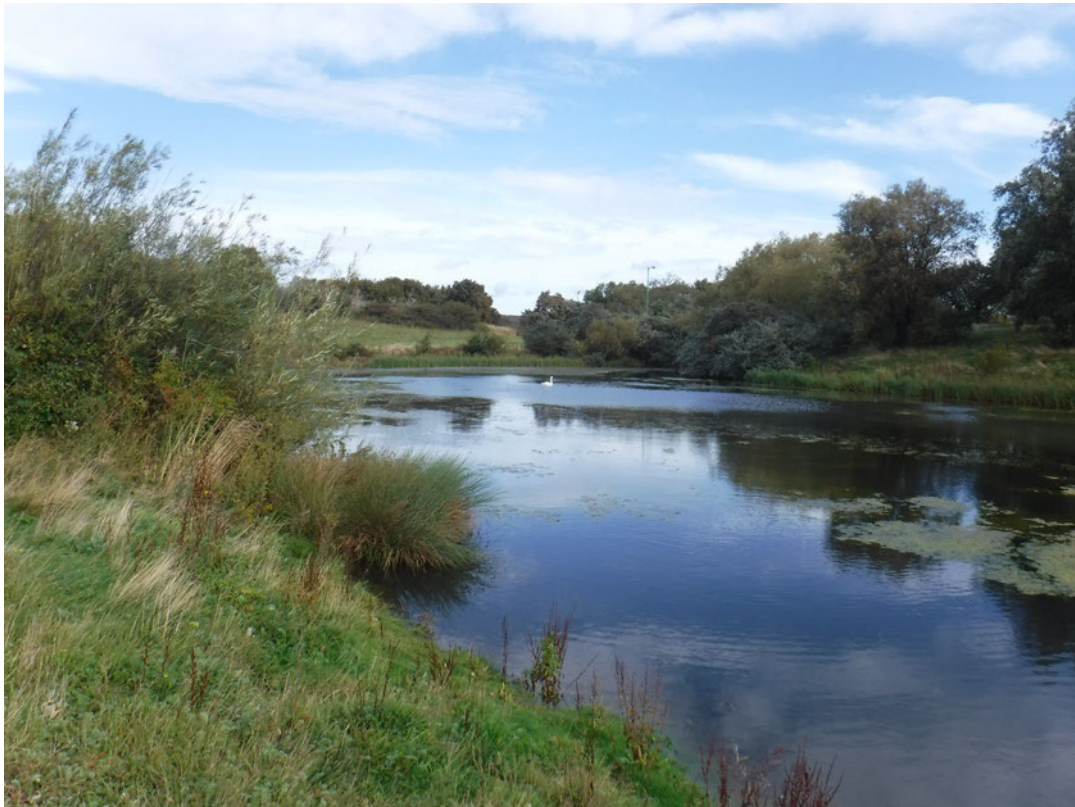
- 3.3.1.1 Steel House pond is a large waterbody with a central grid reference of NZ5757 2406. It is an irregular shaped pond approximately 150 m long and 85m wide at its southern end, curving and tapering to a much narrower profile (approximately 7 m wide) at its northern end. A small ditch runs southwards from the railway, passing beneath the road to Steel House before entering the pond at its northern end. Another small ditch runs south-east from Dormanstown, parallel with the A1085 and passing beneath a road, before entering the pond at its southern end. Neither of these sections of ditches were accessible during the survey.

- 3.3.1.2 The pond was holding water at the time of survey with no notable flow. Aquatic vegetation within the pond itself included *Potamogeton* spp. and yellow flag *Iris pseudacorus*. Other aquatic vegetation along the water's edge included willows *Salix* spp. and alder *Alnus glutinosa*.

- 3.3.1.3 There is a small island in the southern section of the pond at NZ5761 2402. The pond is surrounded by grassland and mature trees. Waterfowl were present on the pond and fish were observed to be feeding at the water's surface. Rat droppings were visible on the bridge to the south-east of the pond.

- 3.3.1.4 The Steel House Pond was considered to be of medium potential value for water voles with a greater sustained water depth (in excess of 1 m) than the other water bodies surveyed, and a steep bank profile in places. No evidence of water vole was found within or adjacent to the Steel House Pond.

- 3.3.1.5 The habitat within Steel House Pond was considered to be of medium potential value for otters due to the substantial areas of bankside vegetated cover in places, which would provide suitable habitat for resting up, and the presence of fish as a food source. No evidence of otters was found within or adjacent to the Steel House Pond.

Photo 3. Section C – Steel House Pond – facing north.

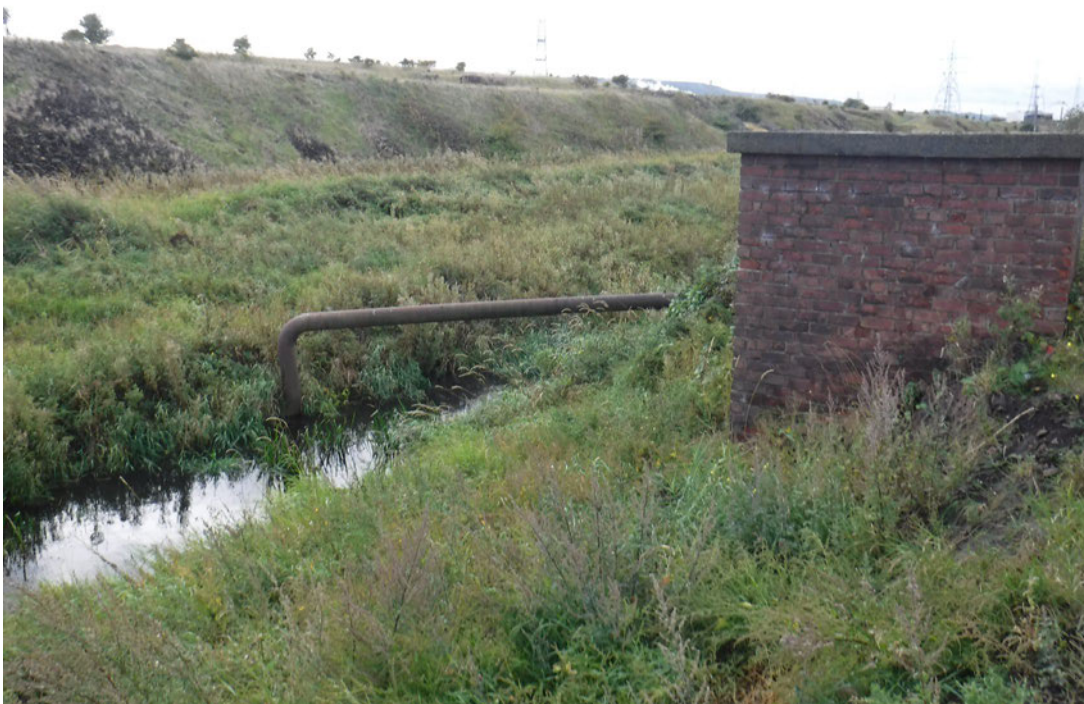
- 3.4.1.1 The Mill Race is a curvilinear ditch approximately 150 m long and 1.2 m wide with a central grid reference of NZ5703 2414. At its western end it joins with Railway Channel (Section E).

- 3.4.1.2 The ditch was holding water at the time of survey with no notable flow observed. The ditch was vegetated with aquatic vegetation dominated by marsh marigold.

- 3.4.1.3 The banking substrate is rocky and at the time of the survey was colonised by species such as rosebay, bramble and great willowherb.
- 3.4.1.4 The ditch is surrounded by grassland and scrub habitat. The presence of fish was considered likely.

- 3.4.1.5 Habitat within The Mill Race was considered to be of low potential value for water voles as the bank profile was gently sloping (5-15 degree slope) and the channel depth was less than 1m with extensive very shallow margins. This pond was also considered to be of low potential value for otters. No evidence of either species was found.

Photo 4. Section D – The Mill Race – facing north-east.

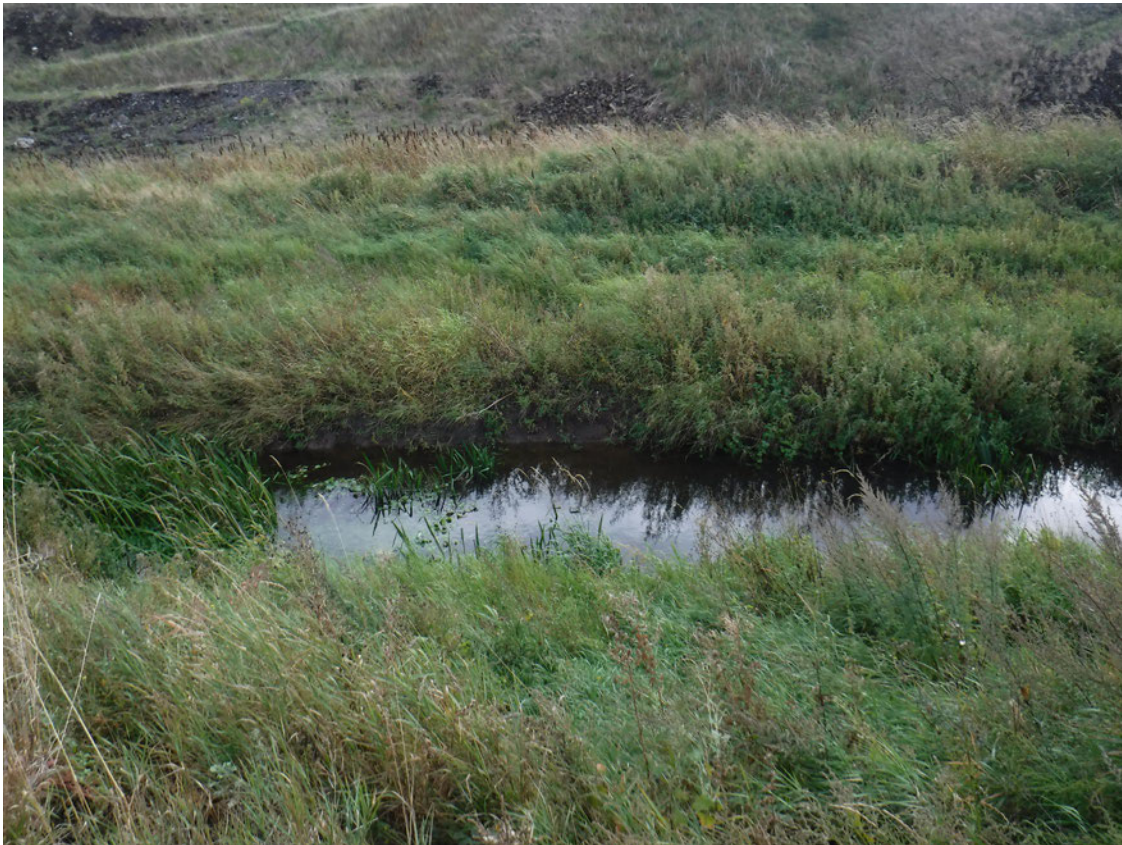
- 3.5.1.1 The Railway Channel is a straight ditch approximately 560 m in length and 1.2 m wide, with a central grid reference of NZ5696 2411. It is parallel to an old dismantled railway line and is intersected by the Mill Race half way along its length.

- 3.5.1.2 The ditch was holding water at the time of survey with a slow flow from north to south. The ditch was vegetated with aquatic vegetation dominated by marsh marigold.

- 3.5.1.3 The banking substrate is rocky and is colonised by species such as rosebay, bramble and great willowherb.
- 3.5.1.4 The ditch is surrounded by ephemeral, tall herb grassland and scrub habitat. The presence of fish was considered likely.

- 3.5.1.5 The habitat within the Railway Channel was considered to be of low potential value for water voles and otters. The substrate throughout the site is "made ground" comprising extremely hard and interlocking industrial waste, ballast and refuse hardcore, making burrow excavation difficult and presenting a high risk of burrow collapse. No evidence of either species was found.

Photo 5. Section E – The Railway Channel.
