Net Zero Teesside – Environmental Statement

Planning Inspectorate Reference: EN010103

Appendix 12D: Bat Survey Report

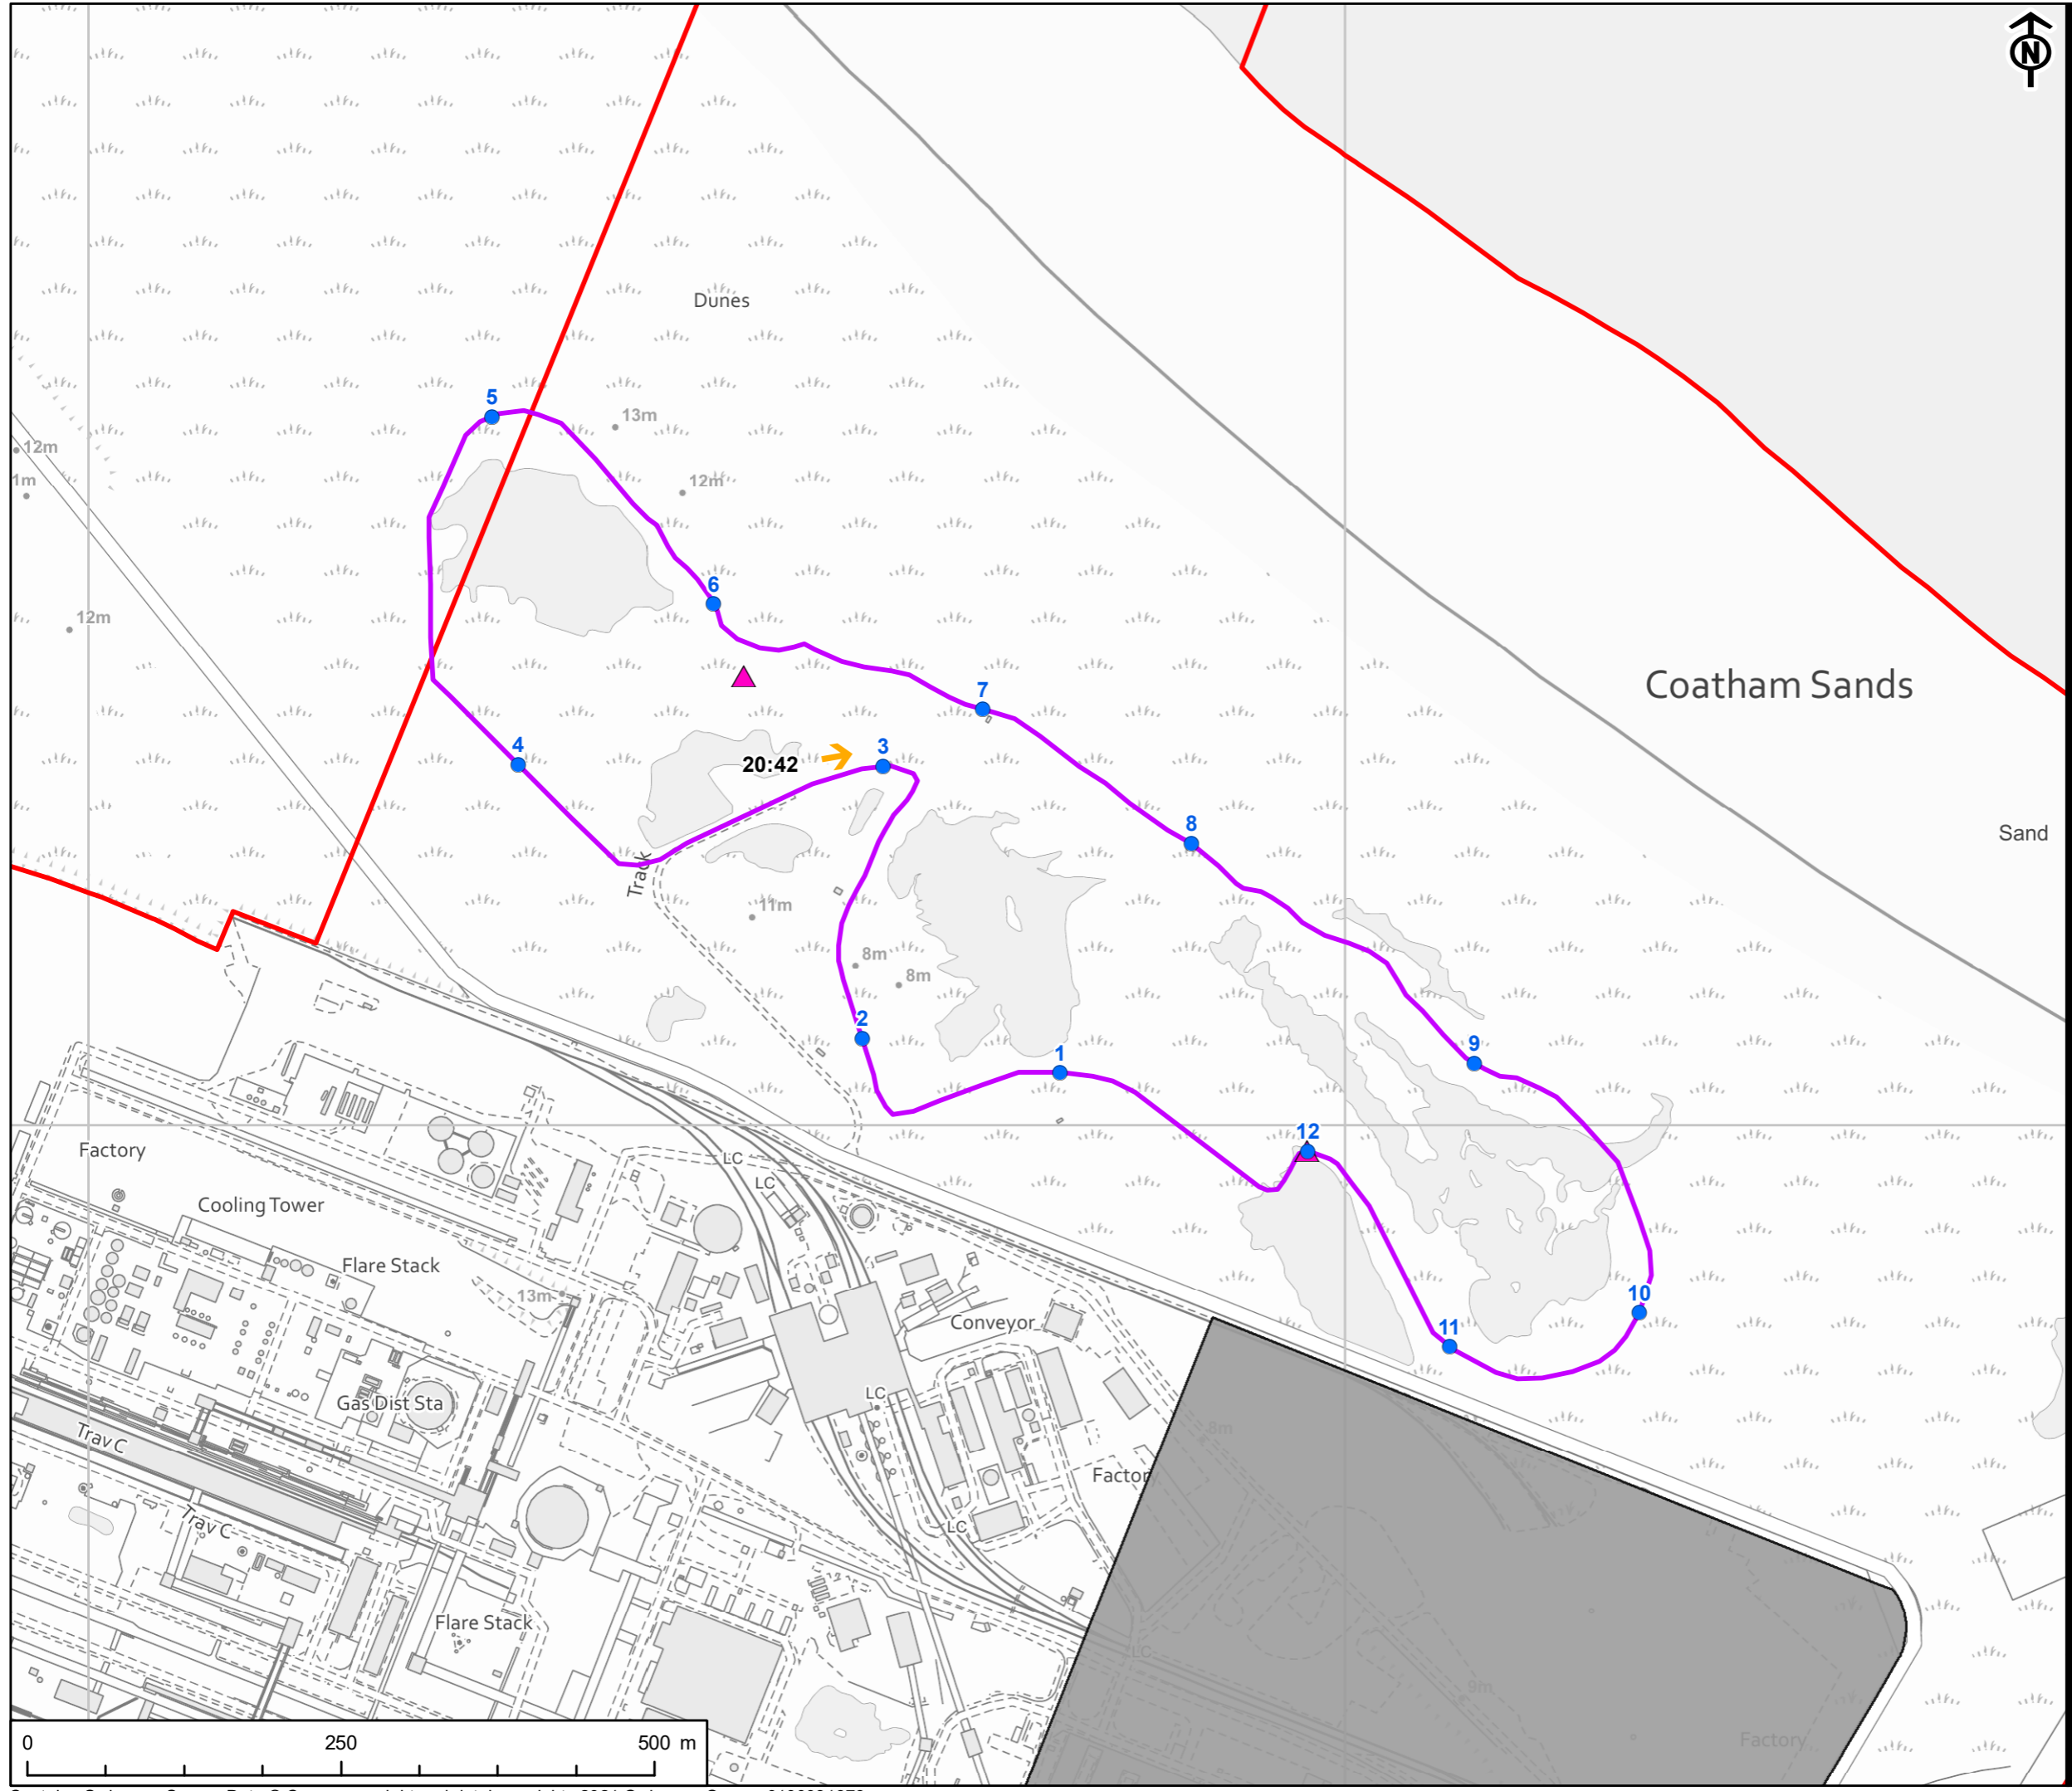
TITLE	
FIGURE 4.5 WALKED TRANSECT AND STATIC MONITORING LOCATIONS IN 2020 (COATHAM SANDS) - SEPTEMBER 2020	
REFERENCE	
NZT_210104_CSBA_4.5_v1	
SHEET NUMBER	DATE
1 of 1	04/01/2021

PROJECT	
NET ZERO TEESIDE	
CLIENT	
NZT POWER AND NZNS STORAGE	
KEY	
	Site Boundary
	Power, Capture and Compressor Site
	Song Meter SM2BAT+ Static Bat Detector
	Stationary Listening Point (SLP)
	Bat Transect Route
Bat Activity - Species	
	PIPI

- 12.3.20 The transect route is shown on Figure 12D.3. The transect route was walked once per survey.
- 12.3.21 The transect survey involved walking the transect route slowly, with stops at pre-determined Stationary Listening Points (SLPs, see Figure 12.D3), and recording all bat observations on scaled maps with notes on species and activity/behaviour. At each of the SLPs the surveyors stopped for a period of approximately 3 minutes to record all bat activity during that period. Any bat activity observed whilst walking between the SLPs was also recorded. The survey dates, timings and weather conditions are presented in Annex C.

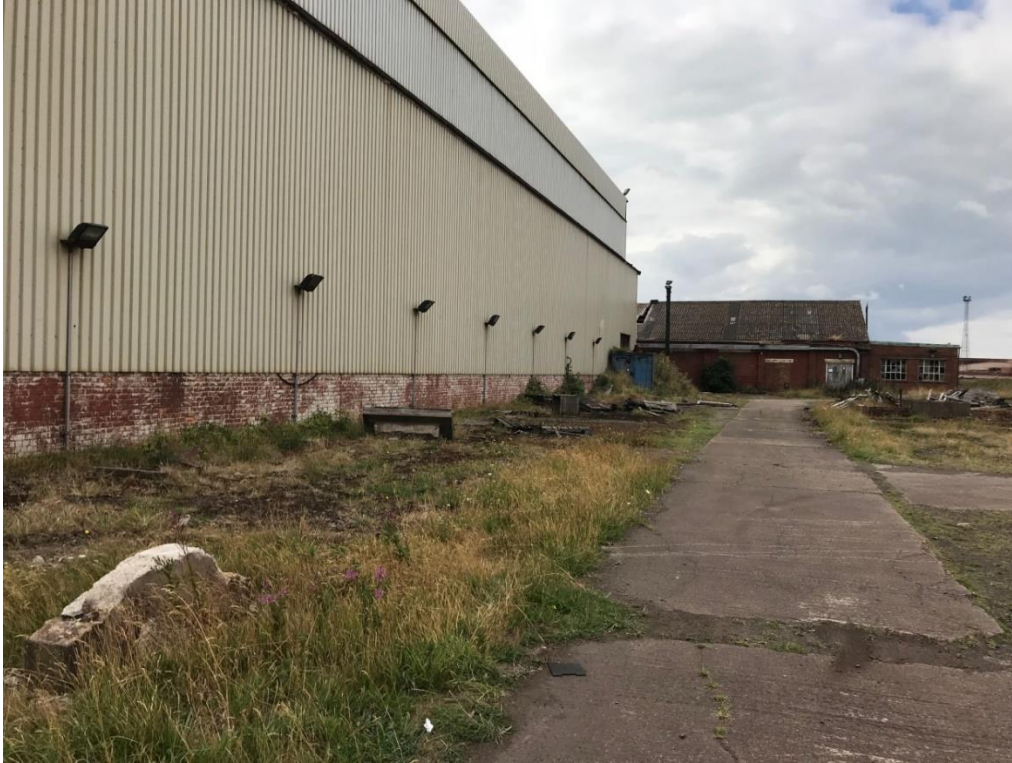
Photograph 1 – View south-west along the rear of the structure B1a

- 12.4.7 Structure B1a is a large disused warehouse covering approximately 6,000 m². It is constructed over a series of connected metal ‘A’ frames. The structure is of mixed material construction, with the lower sections of the outer external walls constructed of brick with intact mortar, and the upper external walls and roof elevations clad in corrugated metal sheeting (Photograph 1, Annex A). Much of the roof has been removed and therefore the B1a is not weatherproof. Site staff identified that the condition of the remaining roof continues to decline now that wind can get under the roof to lift the sheeting.

- 12.4.9 No evidence of bats was found within B1a. It is assessed as having negligible suitability for roosting bats due to its metal construction and poor condition. It is considered that this building can only decrease in suitability for bats over time given its existing poor state of repair and the absence of large sections of the roof resulting in the lack of a suitable roosting environment.

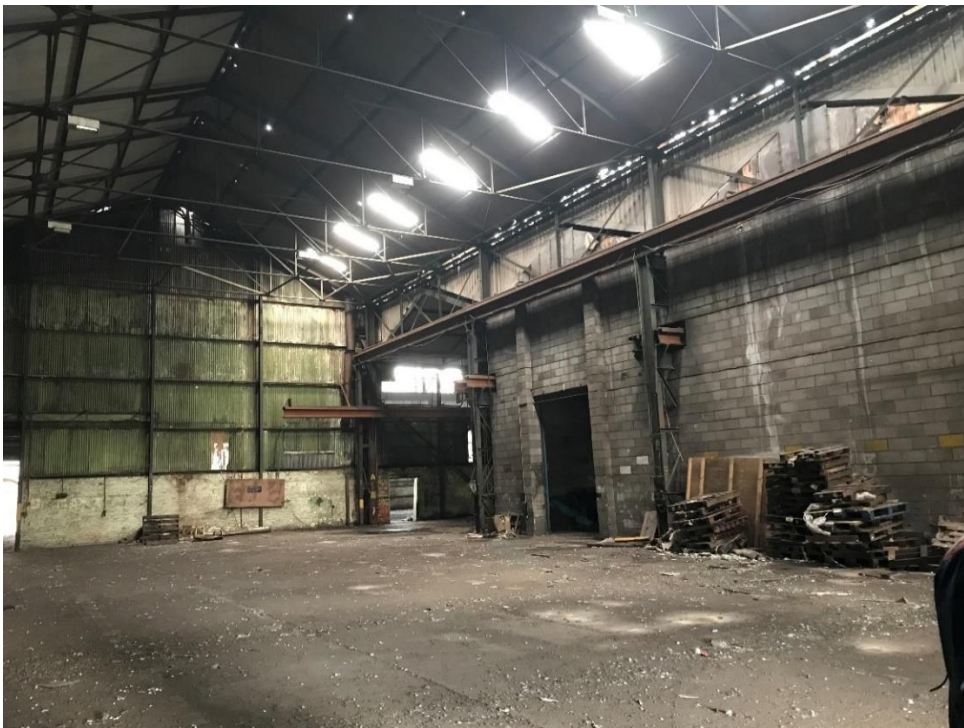
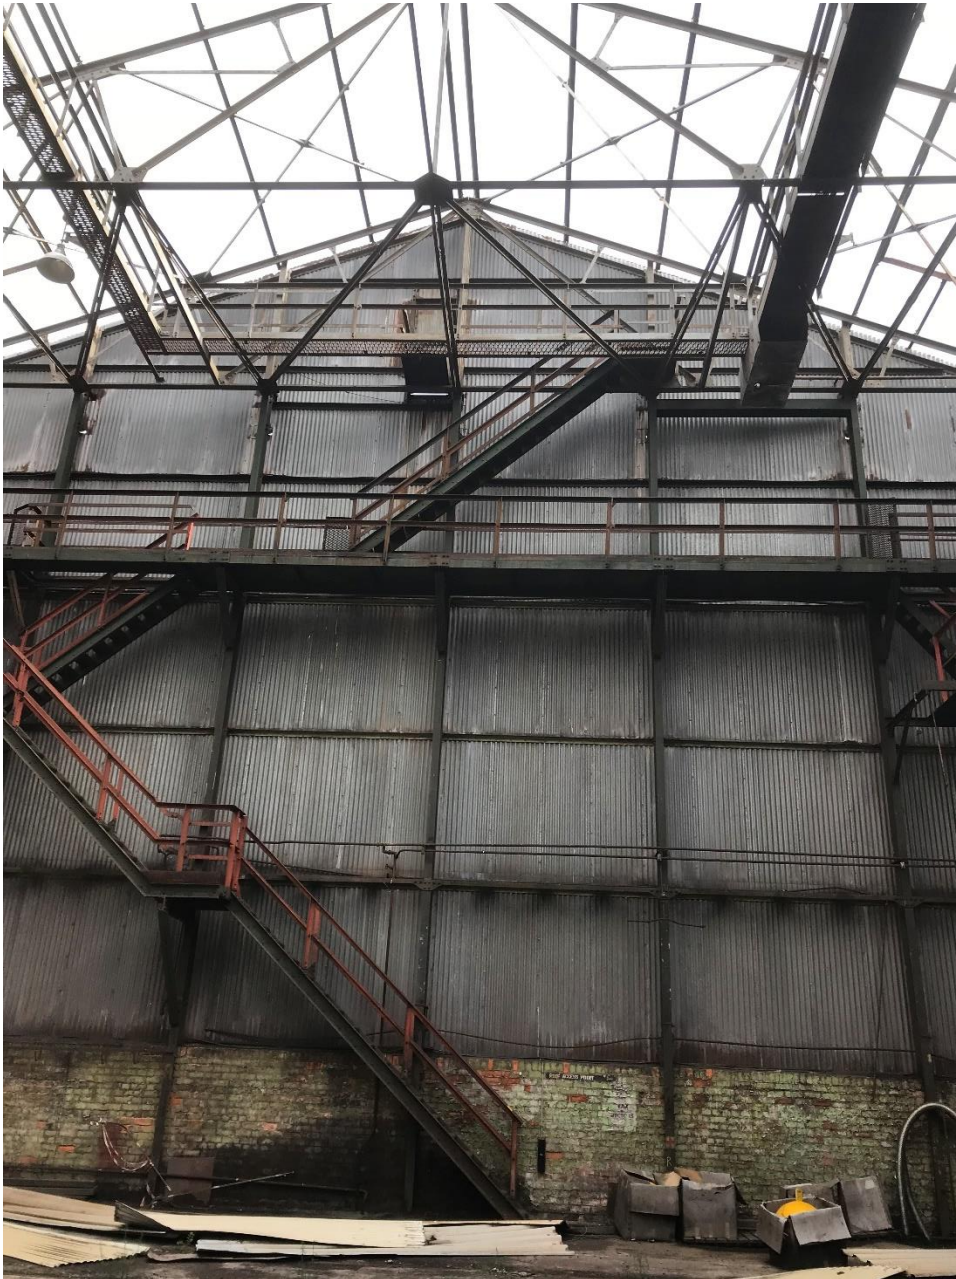
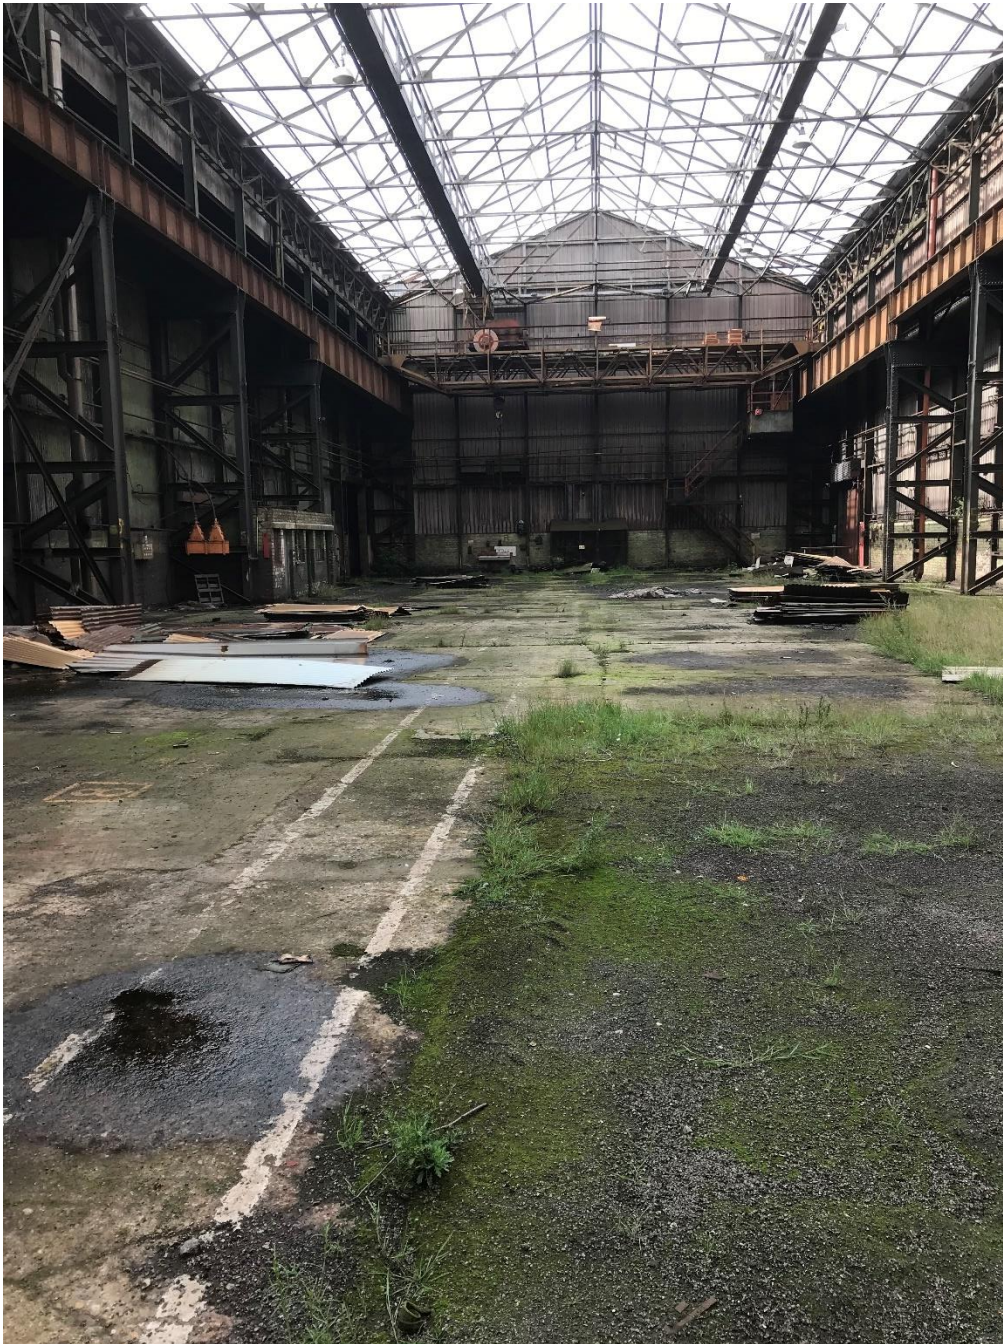
Photograph 2 – Interior of structure B1a

Photograph 3 – Interior of structure B1a

Photograph 4 – Interior of structure B1a
