YPL Harbour Facilities Site Characterisation and Generic Risk Assessment

Document title: YPL Harbour Facilities Site Characterisation and Generic Risk Assessment

Project name: York Potash Project

Client: Sirius Minerals

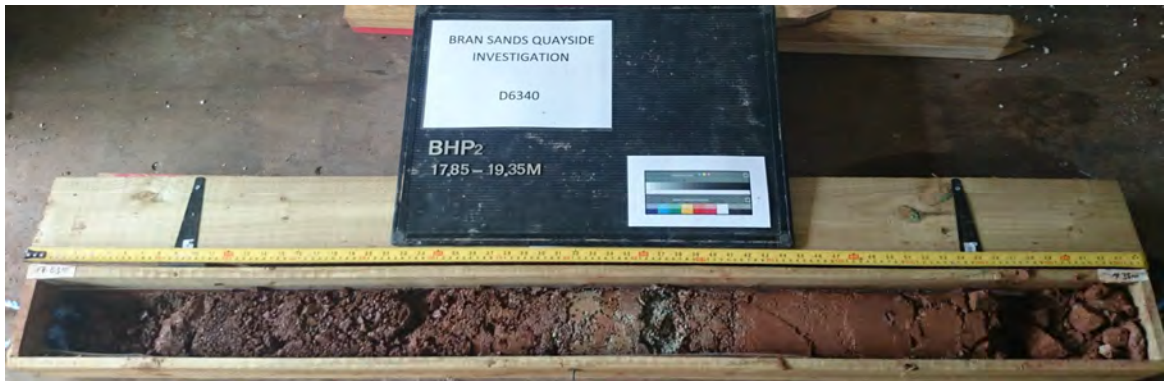
BHP2 - 17.85m - 19.35m

D	17.85-19.35	50/65mm (25,50)				NI	18	18.05m-19.20m: 3no closely spaced planar bedding fractures, undulating and smooth. Dip: 0-15°.				
			100	24	0	NI	19	18.84m-18.96m: Subvertical joint, stepped and smooth, closed and clean. Dip: 50°. Fresh weak reddish brown mudstone. Discontinuities are closely spaced, subhorizontal, planar, smooth. 19.10m-19.20m: Subvertical joint, stepped and rough. 2-4mm clay infill. Dip: 80°.				
						NI	20	Continued next sheet

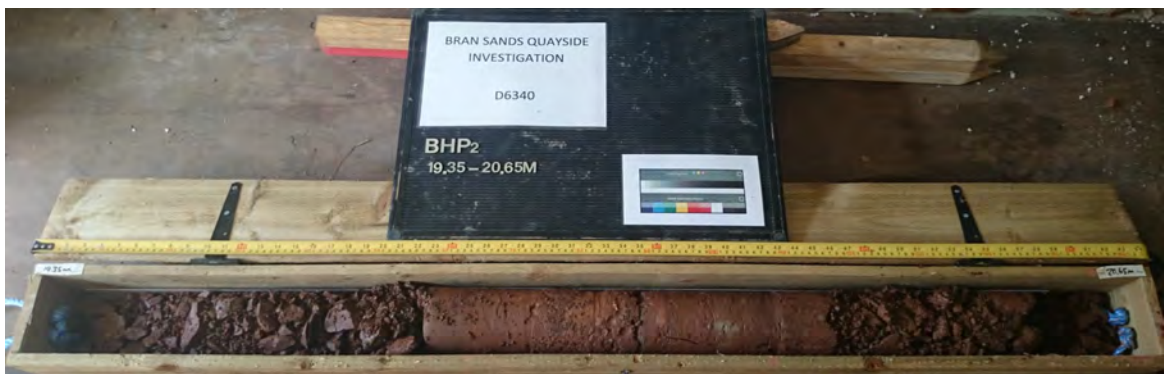
BHP2 - 19.35m-20.65m

Type	Depth From - To(m)	N (cu)	TCR (%)	SCR (%)	RQD (%)	FI	(Casing) Groundwater	Description	Depth (m)	Level (m AOD)	Legend	Well Backfill	
	19.35-20.65		100	42	0	NI		Extremely weak to weak locally to wholly decomposed reddish brown and locally grey MUDSTONE. Interlocking fractures throughout core causing it to be recovered as non intact. 20.15m-20.45m: 3no undulating to smooth planar bedding fractures, 0-10mm, clear to clay infill. Dip: 0-5°.					
						15							
						NI							
						AZCU	21
