The Lower Tees and its Coast – The Risks that Industry, Dredging and Development Pose to Crabs and Seals

Dr Simon Gibbon

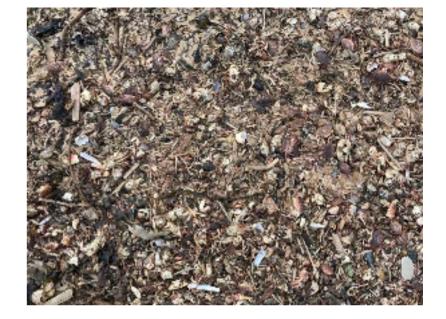
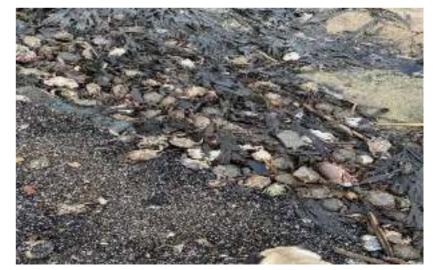
Map of 2021 Die-off

Fig 1: Location map for the coastline from which unusual crab wash ups were reported between October and November 2021, adapted from the Environment Agency's incident investigation summary. Locations with washups shown in Figures 2 to 5. Key industrial facilities considered as possible point source pollution are marked with black dots, and the extent of dredging in the Tees and dredging disposal site are outlined in black.

- Localised to inshore waters
- Not all species impacted
- Crabs are born north as far as Lindisfarne
- No large crabs but few small crabs
- Migratory lobsters largely unaffected

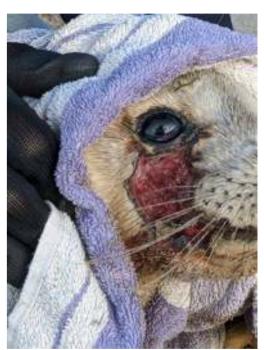
23 Stranded Pups

- 16 had mouth rot
- All underweight many below birth
- Different bacteria so not common source
- Mainly weaned / some unweaned
- All had high levels of the industrial chemicals (PCBs) in their tissues

- Pups dying mainly in the immediate postweaning period.
- Pups dying because of:
 - their low body weight and hence physical weakness
 - and their mouth-rot bacterial infection.
- Both of these principal factors are likely to be caused by:
 - the relatively high PCB contamination of their body tissues,
 - indicated by the blubber analyses for PCBs.

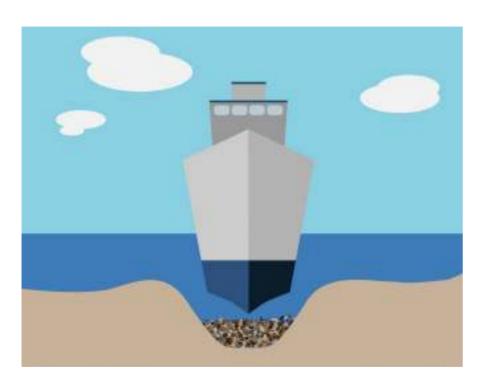
- Sand washes up
- Silt washes down

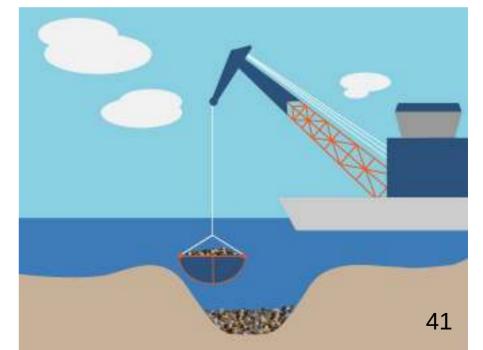
River Tees Maintenance Dredging

- River Tees has been dredged for over 100 years
- 10 year maintenance dredging disposal licence – annual amounts:
 - River Tees <2.5million tonnes wet
 - Hartlepool <0.5million tonnes wet
 - Total volume less than 2million cubic metres (2 hectare cubes) 9 x 30 storey buildings
- Dispose at Tees Bay A (inner) 3 miles from shore
- Granted based on 25 riverbed surface samples
- Selective extra sampling every 3 years

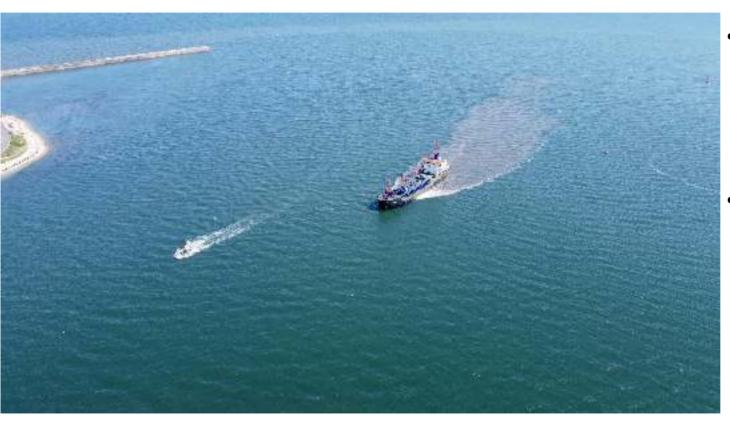
Dredging Material Destination

- Local (>10%)
 - Resuspension
 - Turbidity
 - Release of contaminants
- Disposal site (<90%)
 - Resuspension
 - Turbidity
 - Release of contaminants
 - Seabed loss

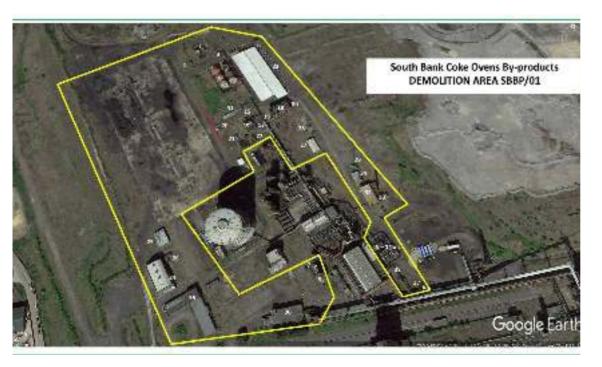
Contemporary Source of Coal Tar

2021

200t Coal tar 400t Tar/naptha/ammoniacal liquid 500t Coal tar residue

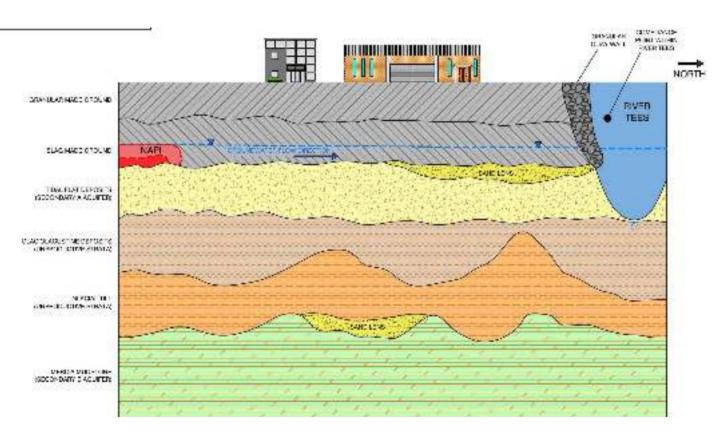
Site Conceptual Map

- Simplified
- End state
- Not construction
- Incorrect isolation of NAPLs

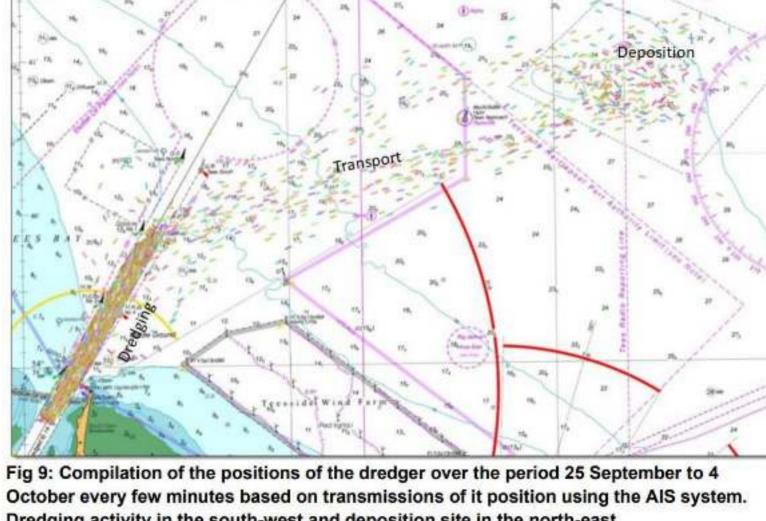
Dredging activity in the south-west and deposition site in the north-east.

- Tees dredgers Cleveland County & Heortnesse low availably autumn 2021
- UK Dredging Ltd's THSD Orca commissioned to dredge outer Tees estuary channel 25/9 to 4/10
- Potential differences:
 - 24 / 7 operation
 - what was being dredged

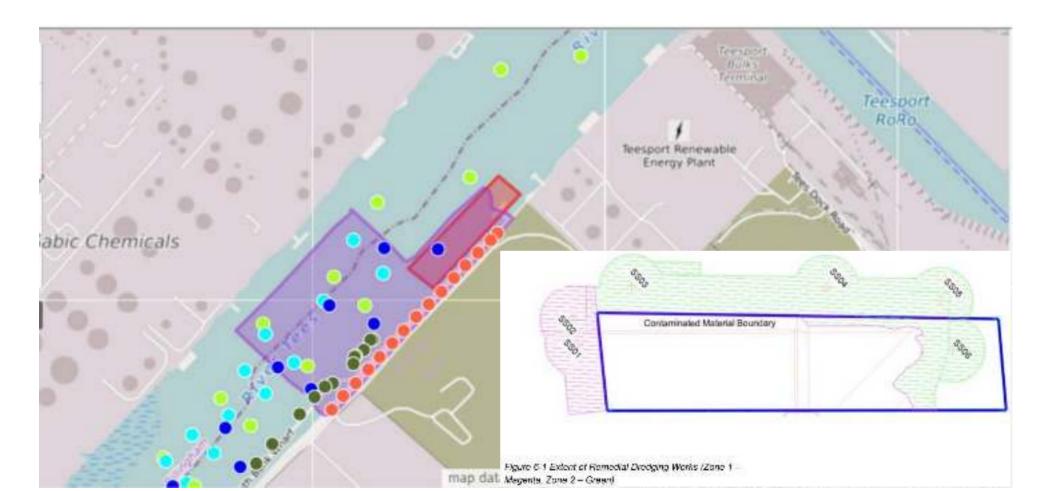
Exclusion Zone

- South Bank Quay required dredging of highly contaminated area (Borehole 34)
- Excluded from disposal at sea
- Material had to be taken to land
- Dredge had to avoid any spillage into the river
- Marine Management Organisation (MMO) license required before and after sediment sampling

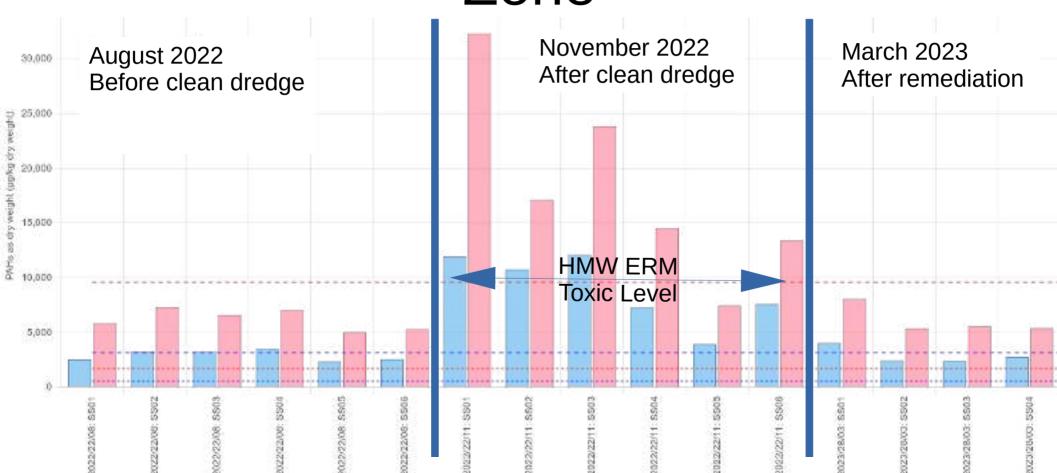
Surface Sampling Around Exclusion Zone

- This contamination was only discovered because the license required sediment sampling immediately after the completion of the dredging
- The River Tees is dredging over 250days a year for 10 hours a day by 2 dredgers plus any capital dredging occurring
- Around 40 samples are taken once every 3 years
- So unless sampling occurs before an area is redredged then that event will be unknown / undocumented / unrecorded
- More than 1500 dredger days occur between each sampling
