# South Industrial Zone

# **Appendix H1: Former Steelworks Land, South Tees Outline Remedial Strategy Flood Risk Assessment**

## Former Steelworks Land, South Tees

Outline Remediation Strategy

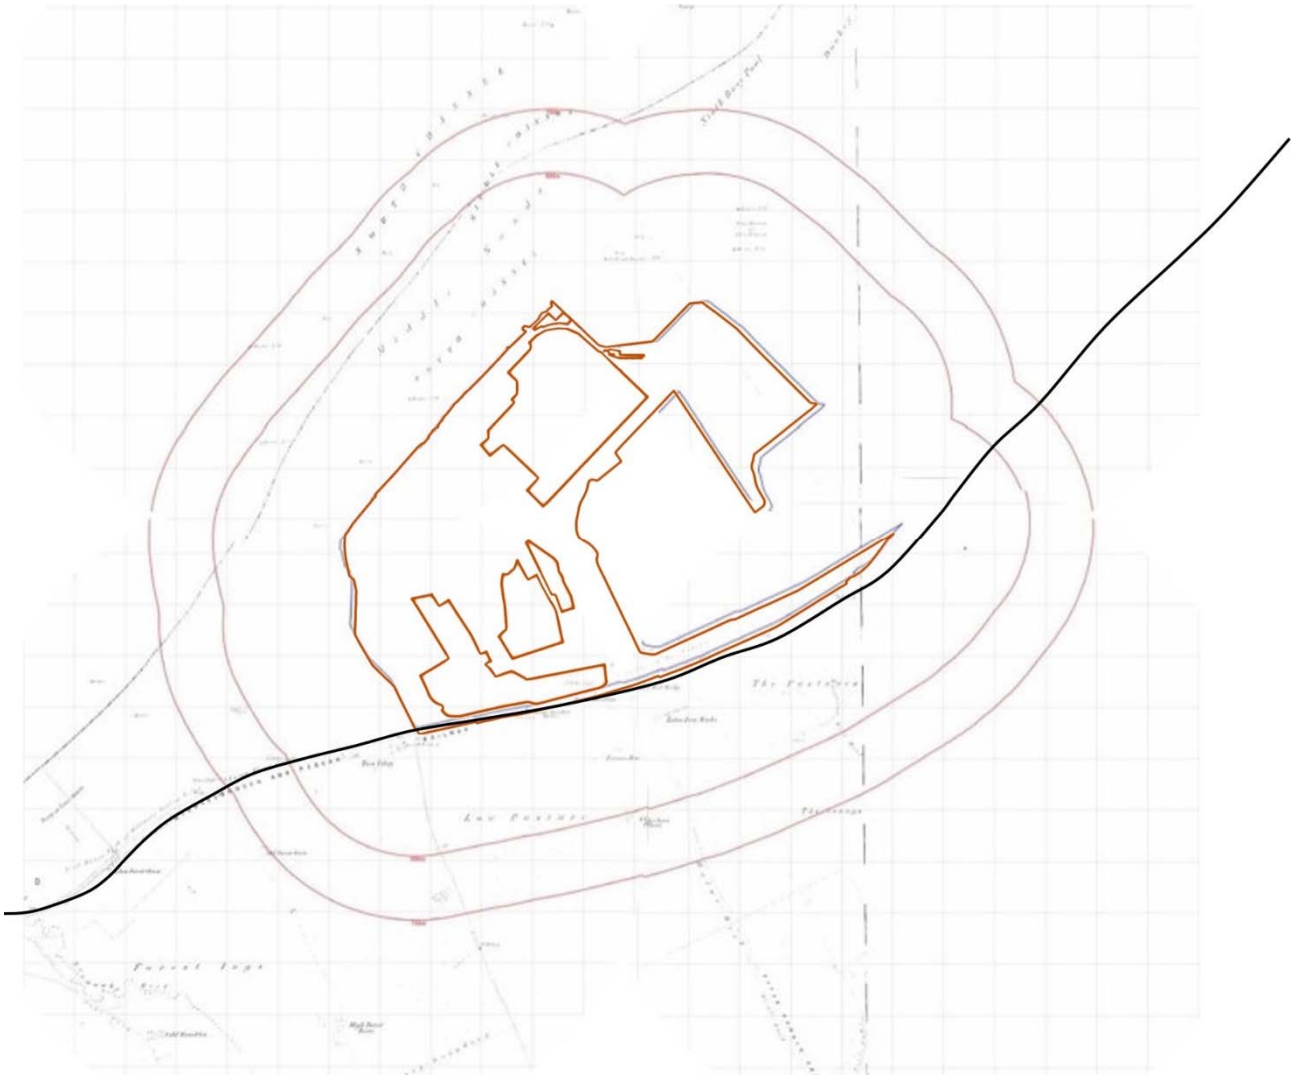
Large scale historic maps are available between 1856 and to 2014. Since 1856 the area has undergone significant development following land reclamation between 1897 and 1913.

**On-Site:** Earliest historic maps available demonstrate minimal development within the area and surrounding areas. Land was principally constituted of low lying scrub land. In closer proximity to the River Tees to the north of the area large areas of land were constituted of mud, sand and marshes.

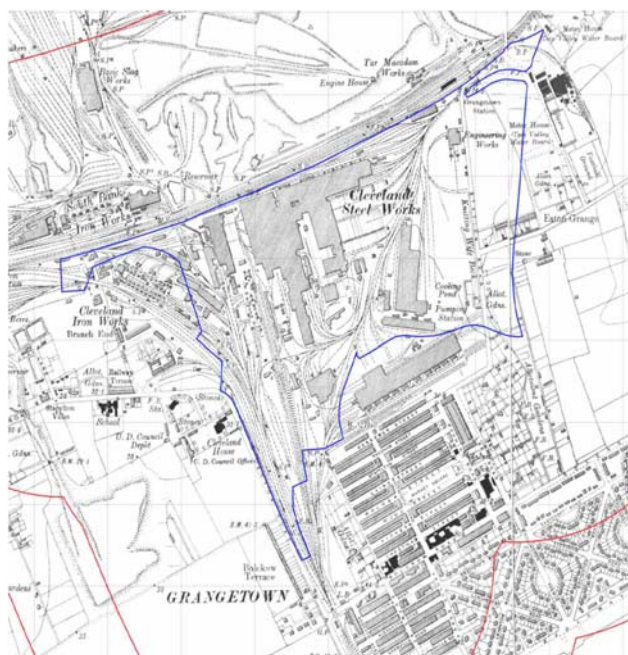
**On-Site:** The Cleveland Steel Works continued to dominate at this time, with expansion of the main works buildings towards the south. An engineering works is now shown in the north east of the area off Station Road. A cooling pond and pumping station are shown in the south east corner of the area.

**Off-Site:** The slag heaps continued to be present to the north of the area, along with the basic slag works. The South Bank Iron Works was now shown to the north of the area. A tarmacadam works is shown approximately 50 north of the area. The athletics track has been replaced by a large building adjacent to the south of the area.

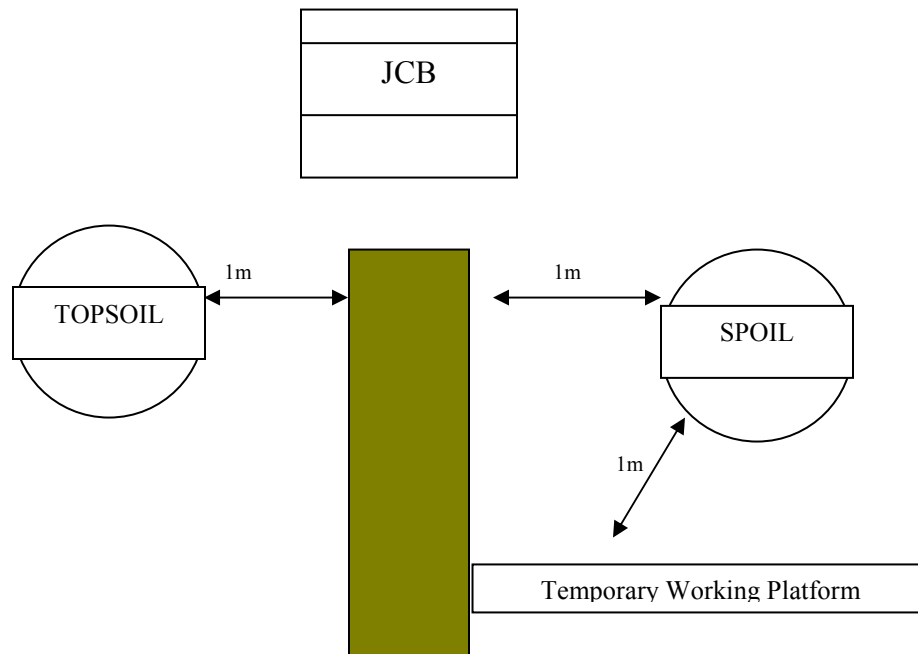
**Figure 1: Schematic Diagram identifying the Safe Working Zone during Trial Pitting**  
(Adapted; Mowlem Environmental Sciences Group)
