REDCAR EFW FACILITY: OUTFALL PIPE

Phase 1 Habitat Survey Briefing Note

SEC8563
Redcar
Briefing Note
Final
29 October 2020

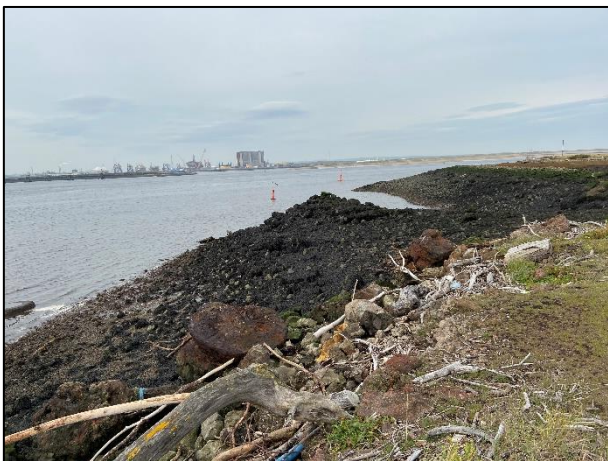
Photo 1: Location of the terminal end of the potential outfall pipe.

The pipeline route has been proposed through the area of lowest sensitivity, between two internal access roads, adjacent to a fence line until it terminates at the shoreline of Tees Bay where there is an existing outfall pipe located (Photo 1). The outfall area comprises pebbles at the lower shoreline with boulders and debris located at the top of the bank. Further west of this the area becomes intertidal with areas of standing water. The majority of the Survey Area is comprised of spoil and bare ground. A strip of semi-improved grassland (Photo 2) with occasional low-growing scrub including dog rose and Japanese rose is present within the centre of the Survey Area. The quality of grassland habitat declines eastward across the survey area. An extended species list for these areas is provided in Appendix B. There are a few buildings and built structures/features within the survey area (Photo 3). A small area of swamp or shallow wetland is located at the northern extremity of the buffer, approximately 41m from the pipe route (Photo 4).

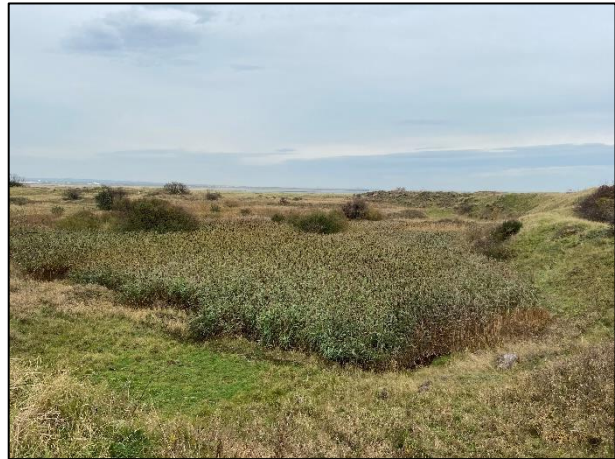
Photo 4: Area of wetland 41m to the north of the pipeline route

Description	Grid reference	Photo Reference
<p>An area of wetland supporting species including <i>Typha psp.</i>, <i>Phragmites australis</i>, <i>Carex sp.</i>, <i>Mentha aquatica</i> and <i>Juncus spp.</i> It is a pond at the end stage of succession. No waterfowl were recorded at the time of survey and due to the dense vegetation of the swamp it is considered that fish are unlikely. Vegetation cover was 80% whilst there was less than 10% visible water. There is 100% shade on the water from the emerging vegetation. Although the water quality appeared good the water may well be saline due to the coastal setting. It is isolated from other water bodies by the Tees Estuary and Tees Mouth as well the bare ground and spoil expanses which dominate the industrial setting. There is limited terrestrial habitat connectivity along the narrow grassland strip running eastwards to the next closest waterbody 950m east. It is separated from the pipeline route by semi-improved grassland and a strip of bare ground.</p>	NZ 55094 26023

Whilst the swamp was determined to provide Average suitability for GCN based on the HSI scoring matrix, given that it is highly isolated due to the barriers to GCN movement caused by the coastal setting, surrounding industrialised land use and habitat types and considering the lack of historical records, the likelihood of GCN presence is considered to be very low.

The swamp is in the latter stages of succession, being dominated by dense common reed and bulrush, though a small patch of open water does exist within the centre of the swamp. Without management, the habitat suitability for GCN is likely to deteriorate in the coming years as the density of vegetation increases and open water, an important resource for displaying male newts during the breeding season, diminishes.

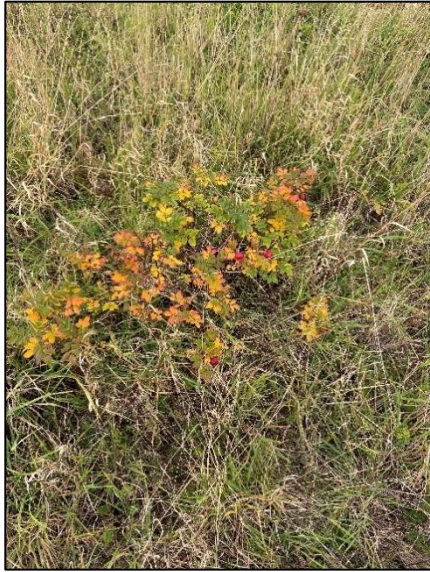
Photo 5: Japanese rose present within the site.

Invasive species including Japanese rose (Photo 5) and wall cotoneaster (Photo 6) were recorded towards the west of the site where the outfall pipe will be located. An additional stand of Japanese rose was located further east toward the centre of the site. A record of montbretia was also recorded just north of the 50m buffer.

Care should be taken during the construction of the pipe and outfall to avoid spreading the identified invasive species.

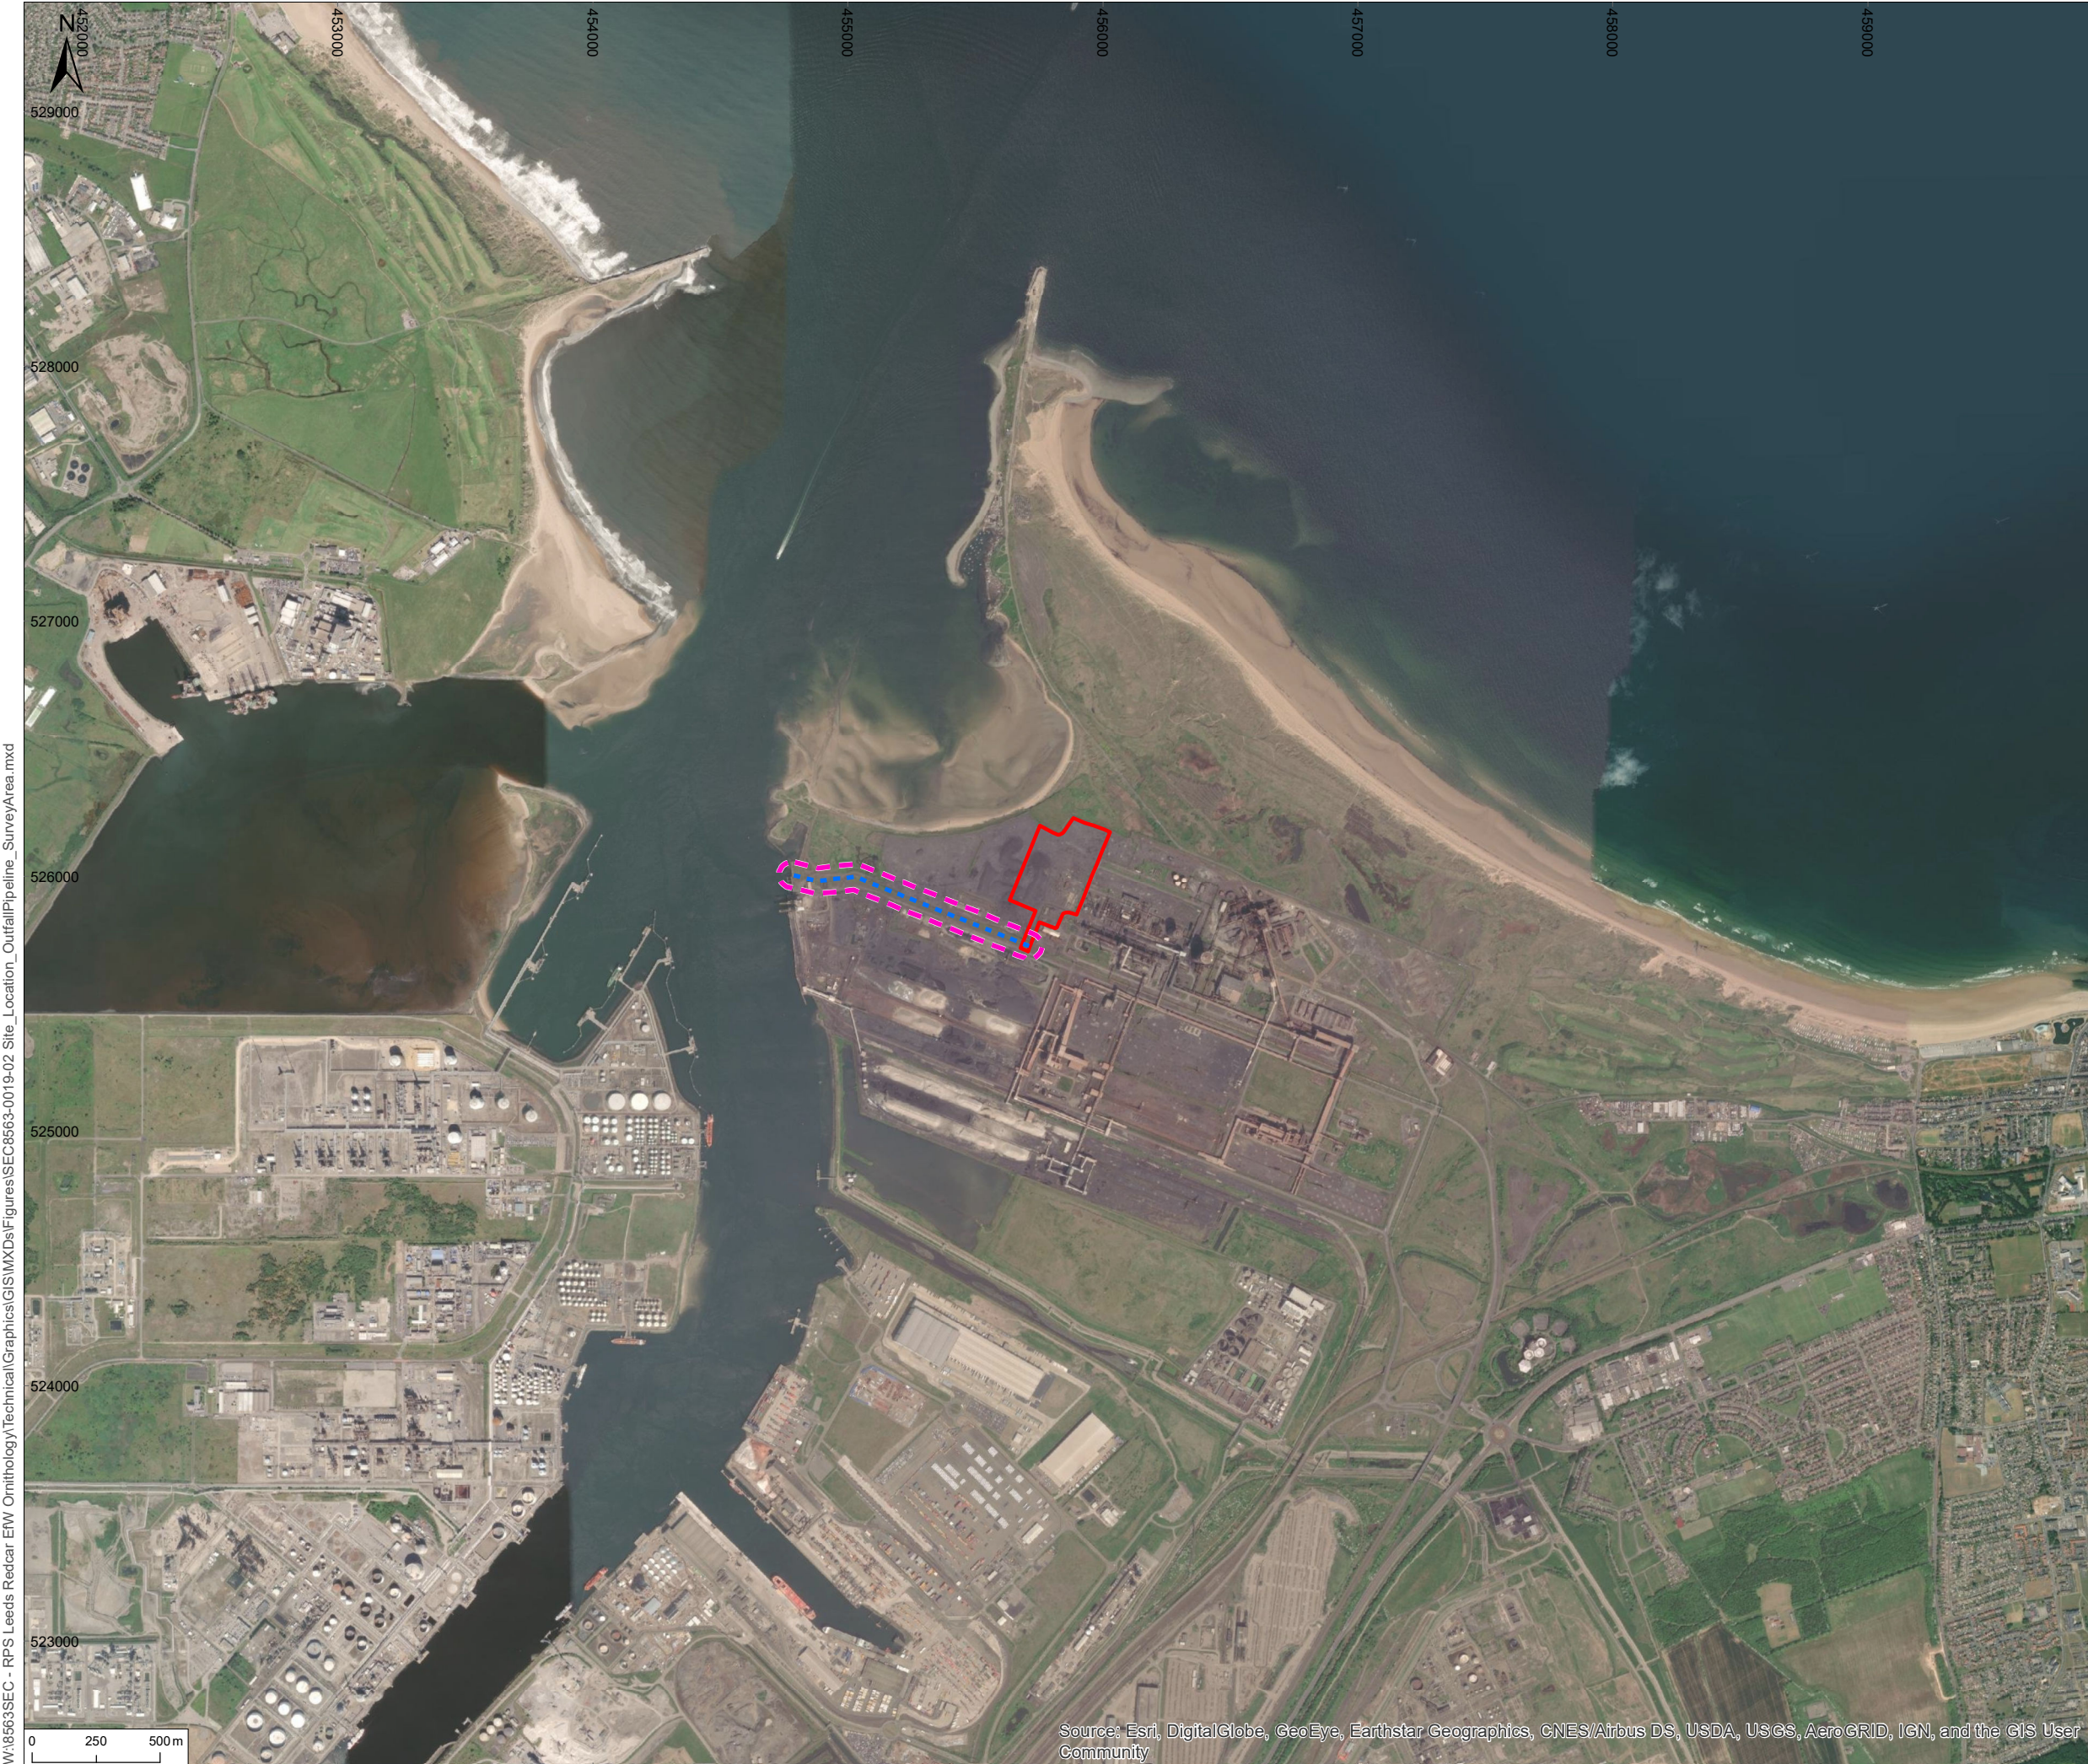
Title Site Location and Survey Area

- Legend**
- Site boundary
 - Indicative outfall pipeline route
 - Extended phase 1 habitat survey area (50m buffer)

The proposed works involve the construction of an outfall pipe, discharging to the Tees Mouth. The excavation for the pipeline would be approximately 0.9m – 1.5m wide along the route (Figure 1). The works are temporary, entirely reversible, do not affect potential GCN hibernation habitat and can be undertaken in such a way as to avoid any impact on GCN.
