# METALS PROCESSING AREA, FORMER STEELWORKS, REDCAR

Phase II Environmental Site Assessment (Shallow Soils)

South Tees Development Corporation

REPORT NO. 10035117-AUK-XX-XX-RP-ZZ-0125-01-MRA\_Shallow\_Soils

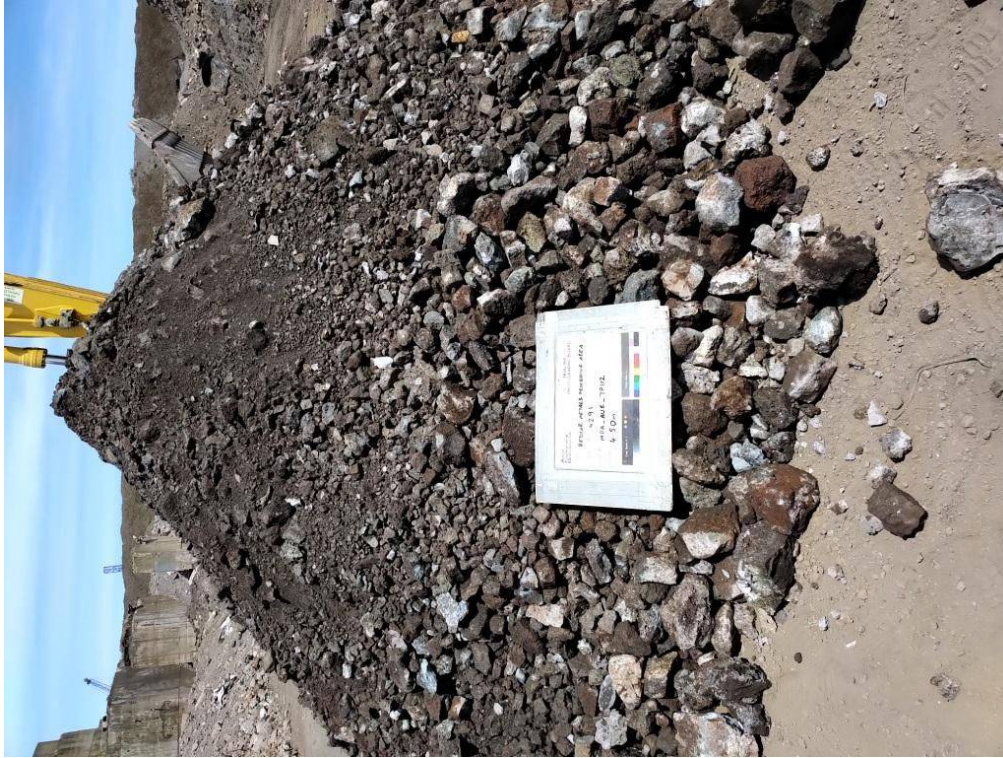
Figure MPA\_AUK\_TP112.3  
MPA\_AUK\_TP112

0.90	ES3					at c.1.20m BGL ... fine to medium sand (relic bedding for a cable).
1.60	J4					
1.80	B5					
2.30	LB6				(4.10)	between c.2.40-4.50m BGL ... lenses of red brown slightly clayey sandy gravel. Sand is fine to coarse and includes ash and clinker. Gravel is fine to coarse subangular and includes ash, clinker and burnt mudstone.

**GROUNDWATER**  
 No groundwater inflow observed. At c.3.50-4.50m BGL - slag is damp.

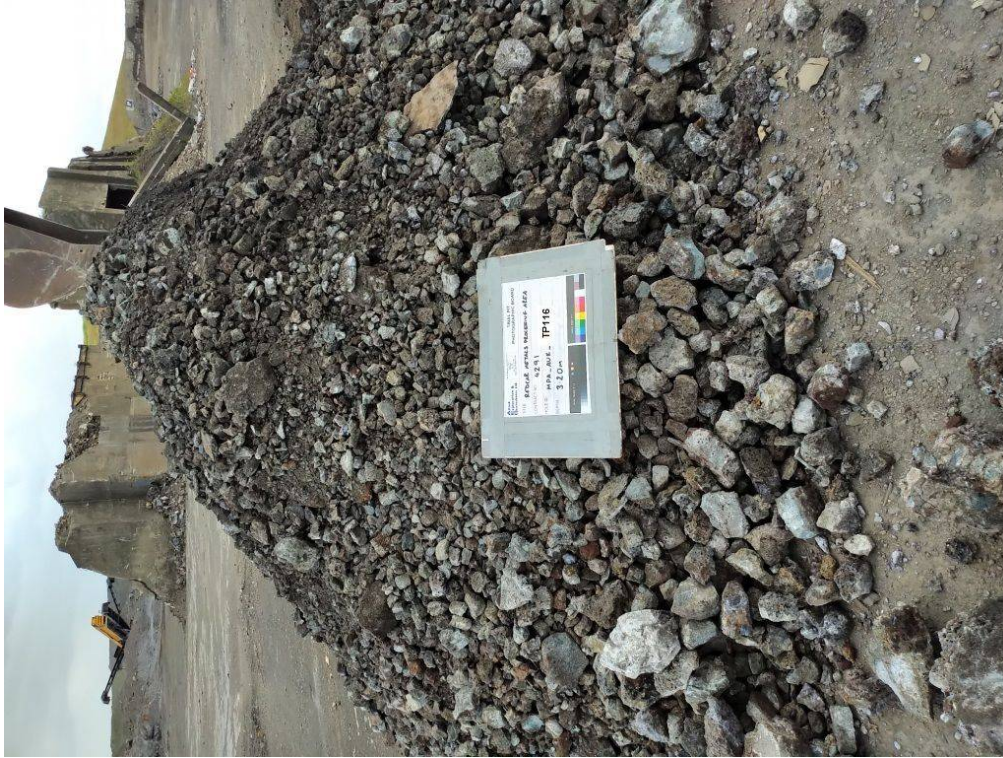
Figure MPA\_AUK\_TP116.3  
MPA\_AUK\_TP116

0.60	ES3							
1.30	J4							
1.50	B5							
2.00	LB6							
2.30	J7						(4.30)	
2.50	B8							
3.30	J9							
3.50	B10							between c.2.80-4.50m BGL ... lenses of red brown sandy gravel. Sand is fine to coarse and mainly includes ash. Gravel is fine to medium subangular and includes ash, clinker and burnt mudstone.

**GROUNDWATER**  
 No groundwater inflow observed. At c.3.50-4.00m BGL - Slag is damp.

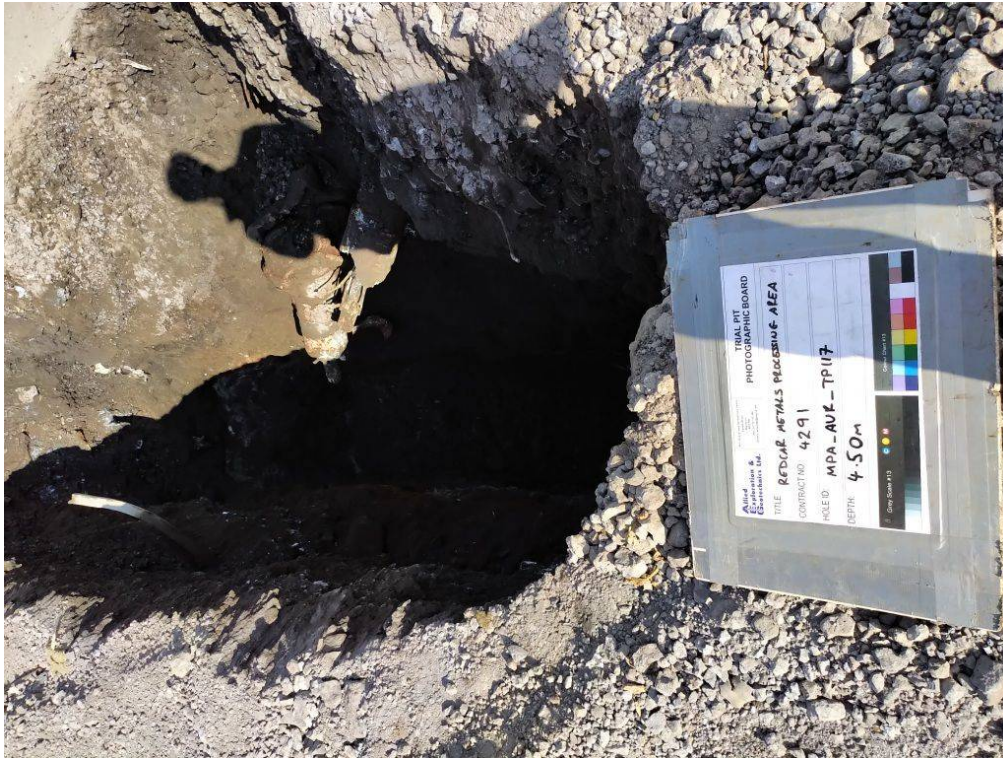
Figure MPA\_AUK\_TP117.1  
MPA\_AUK\_TP117

A potential ACM (cement pipe) was noted in situ in MPA\_AUK\_TP117.

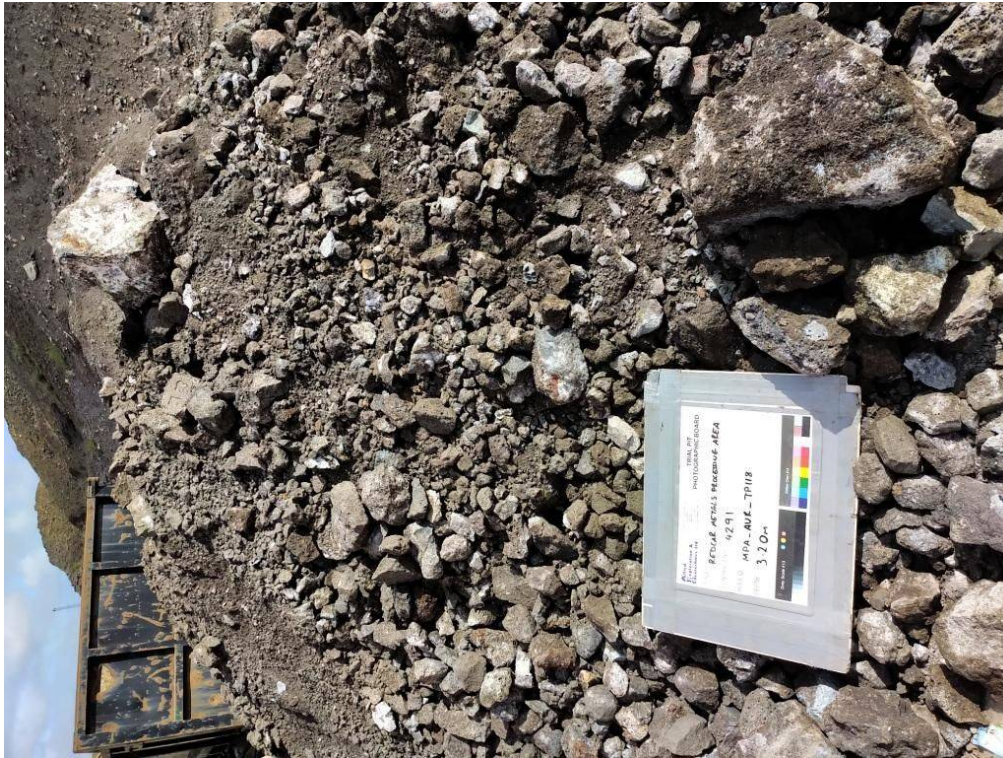
Figure MPA\_AUK\_TP118.3  
MPA\_AUK\_TP118 Spoil

2.00	B6						
2.70	J7						
3.00	LB8						(3.00)
3.70	J9						at c.3.60m BGL ... a pocket of yellow bricks noted.
4.00	B10						4.50
						Complete at 4.50m BGL.

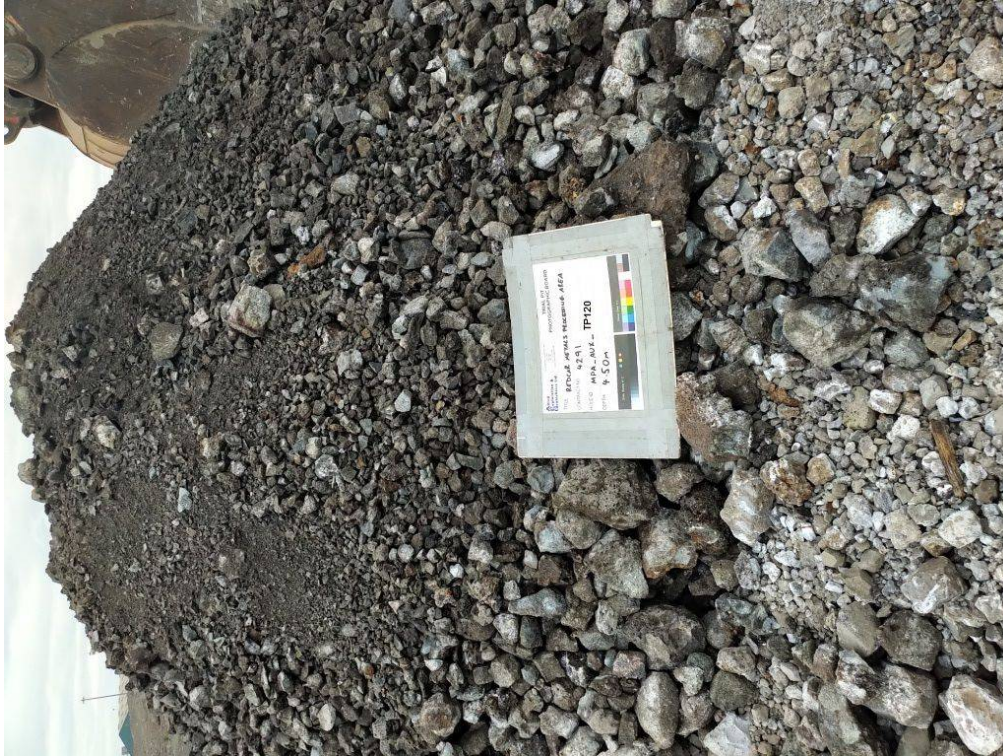
Figure MPA\_AUK\_TP120.3  
MPA\_AUK\_TP120

3.20	B8					between c.2.90-4.50m BGL ... lenses of orange brown clayey GRAVEL. Gravel is fine to coarse angular and includes burnt mudstone.
4.00	J9

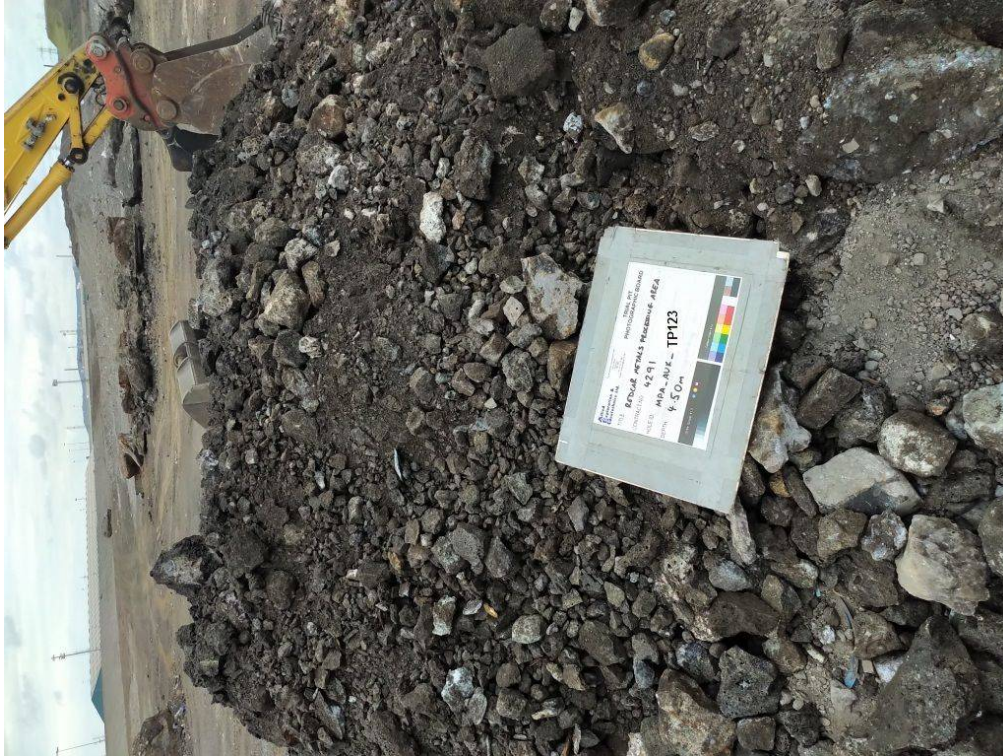
Figure MPA\_AUK\_TP123.3  
MPA\_AUK\_TP123

0.80	ES3						between c.1.00-4.50m BGL ... random lenses and bands of orange burnt clayey shale (recovered as fine to coarse angular gravel).
1.50	J4
