# METALS PROCESSING AREA, FORMER STEELWORKS, REDCAR

Phase II Environmental Site Assessment (Shallow Soils)

South Tees Development Corporation

REPORT NO. 10035117-AUK-XX-XX-RP-ZZ-0125-02-MRA\_Shallow\_Soils

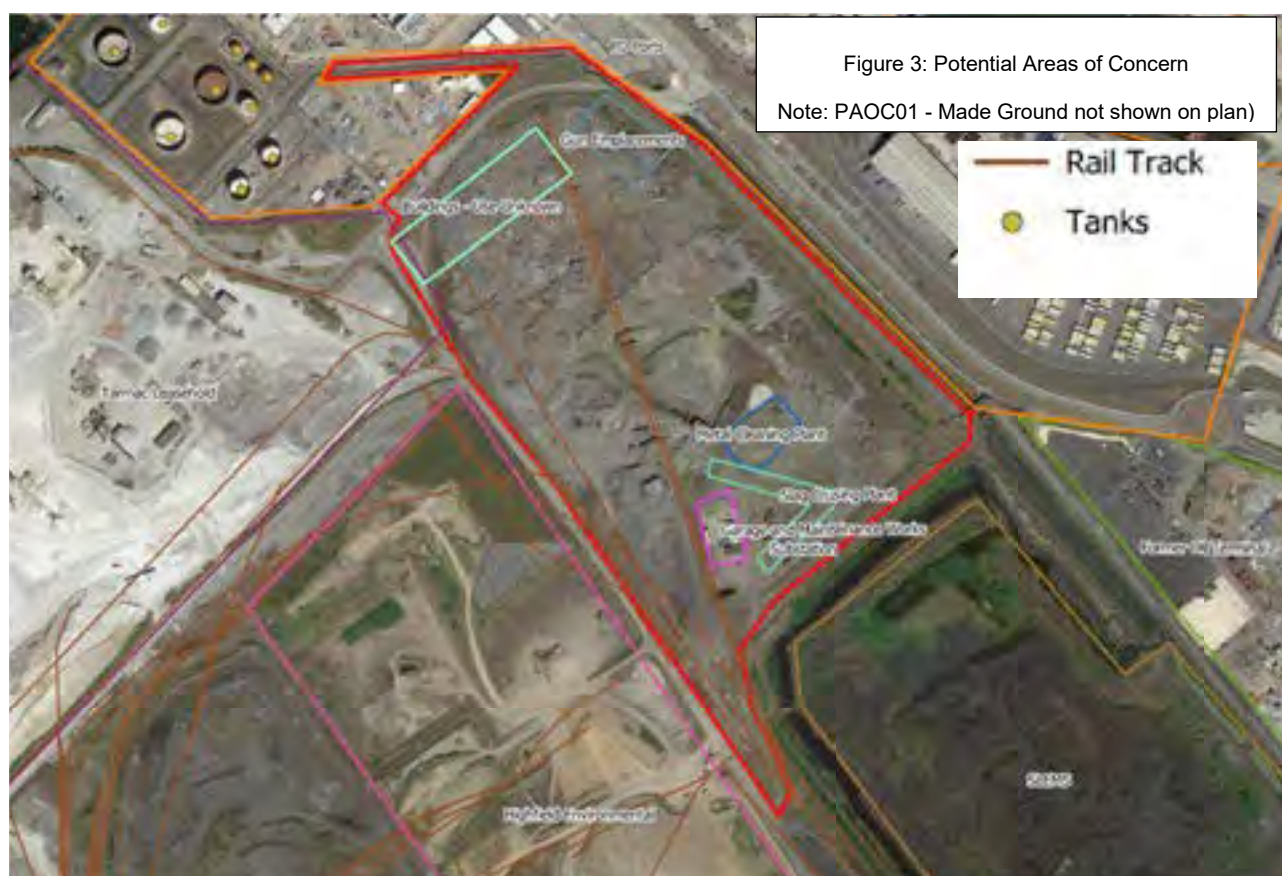
Based on a review of the documents listed in Section 2.1 above and the DEFRA Magic Website <https://magic.defra.gov.uk/MagicMap.aspx> accessed 3rd August 2020 the following potential areas of concern (Environmental PAOC) have been identified for the site and are summarised on Figure 3 below and in Appendix A.

The significance of these potential sources is considered further in Section 3.2.
