METALS PROCESSING AREA, FORMER STEELWORKS, REDCAR

Phase II Environmental Site Assessment Deep Soils and
Controlled Waters

South Tees Development Corporation

REPORT NO. 10035117-AUK-XX-XX-RP-ZZ-0233-01-MRA_Deep_Soils

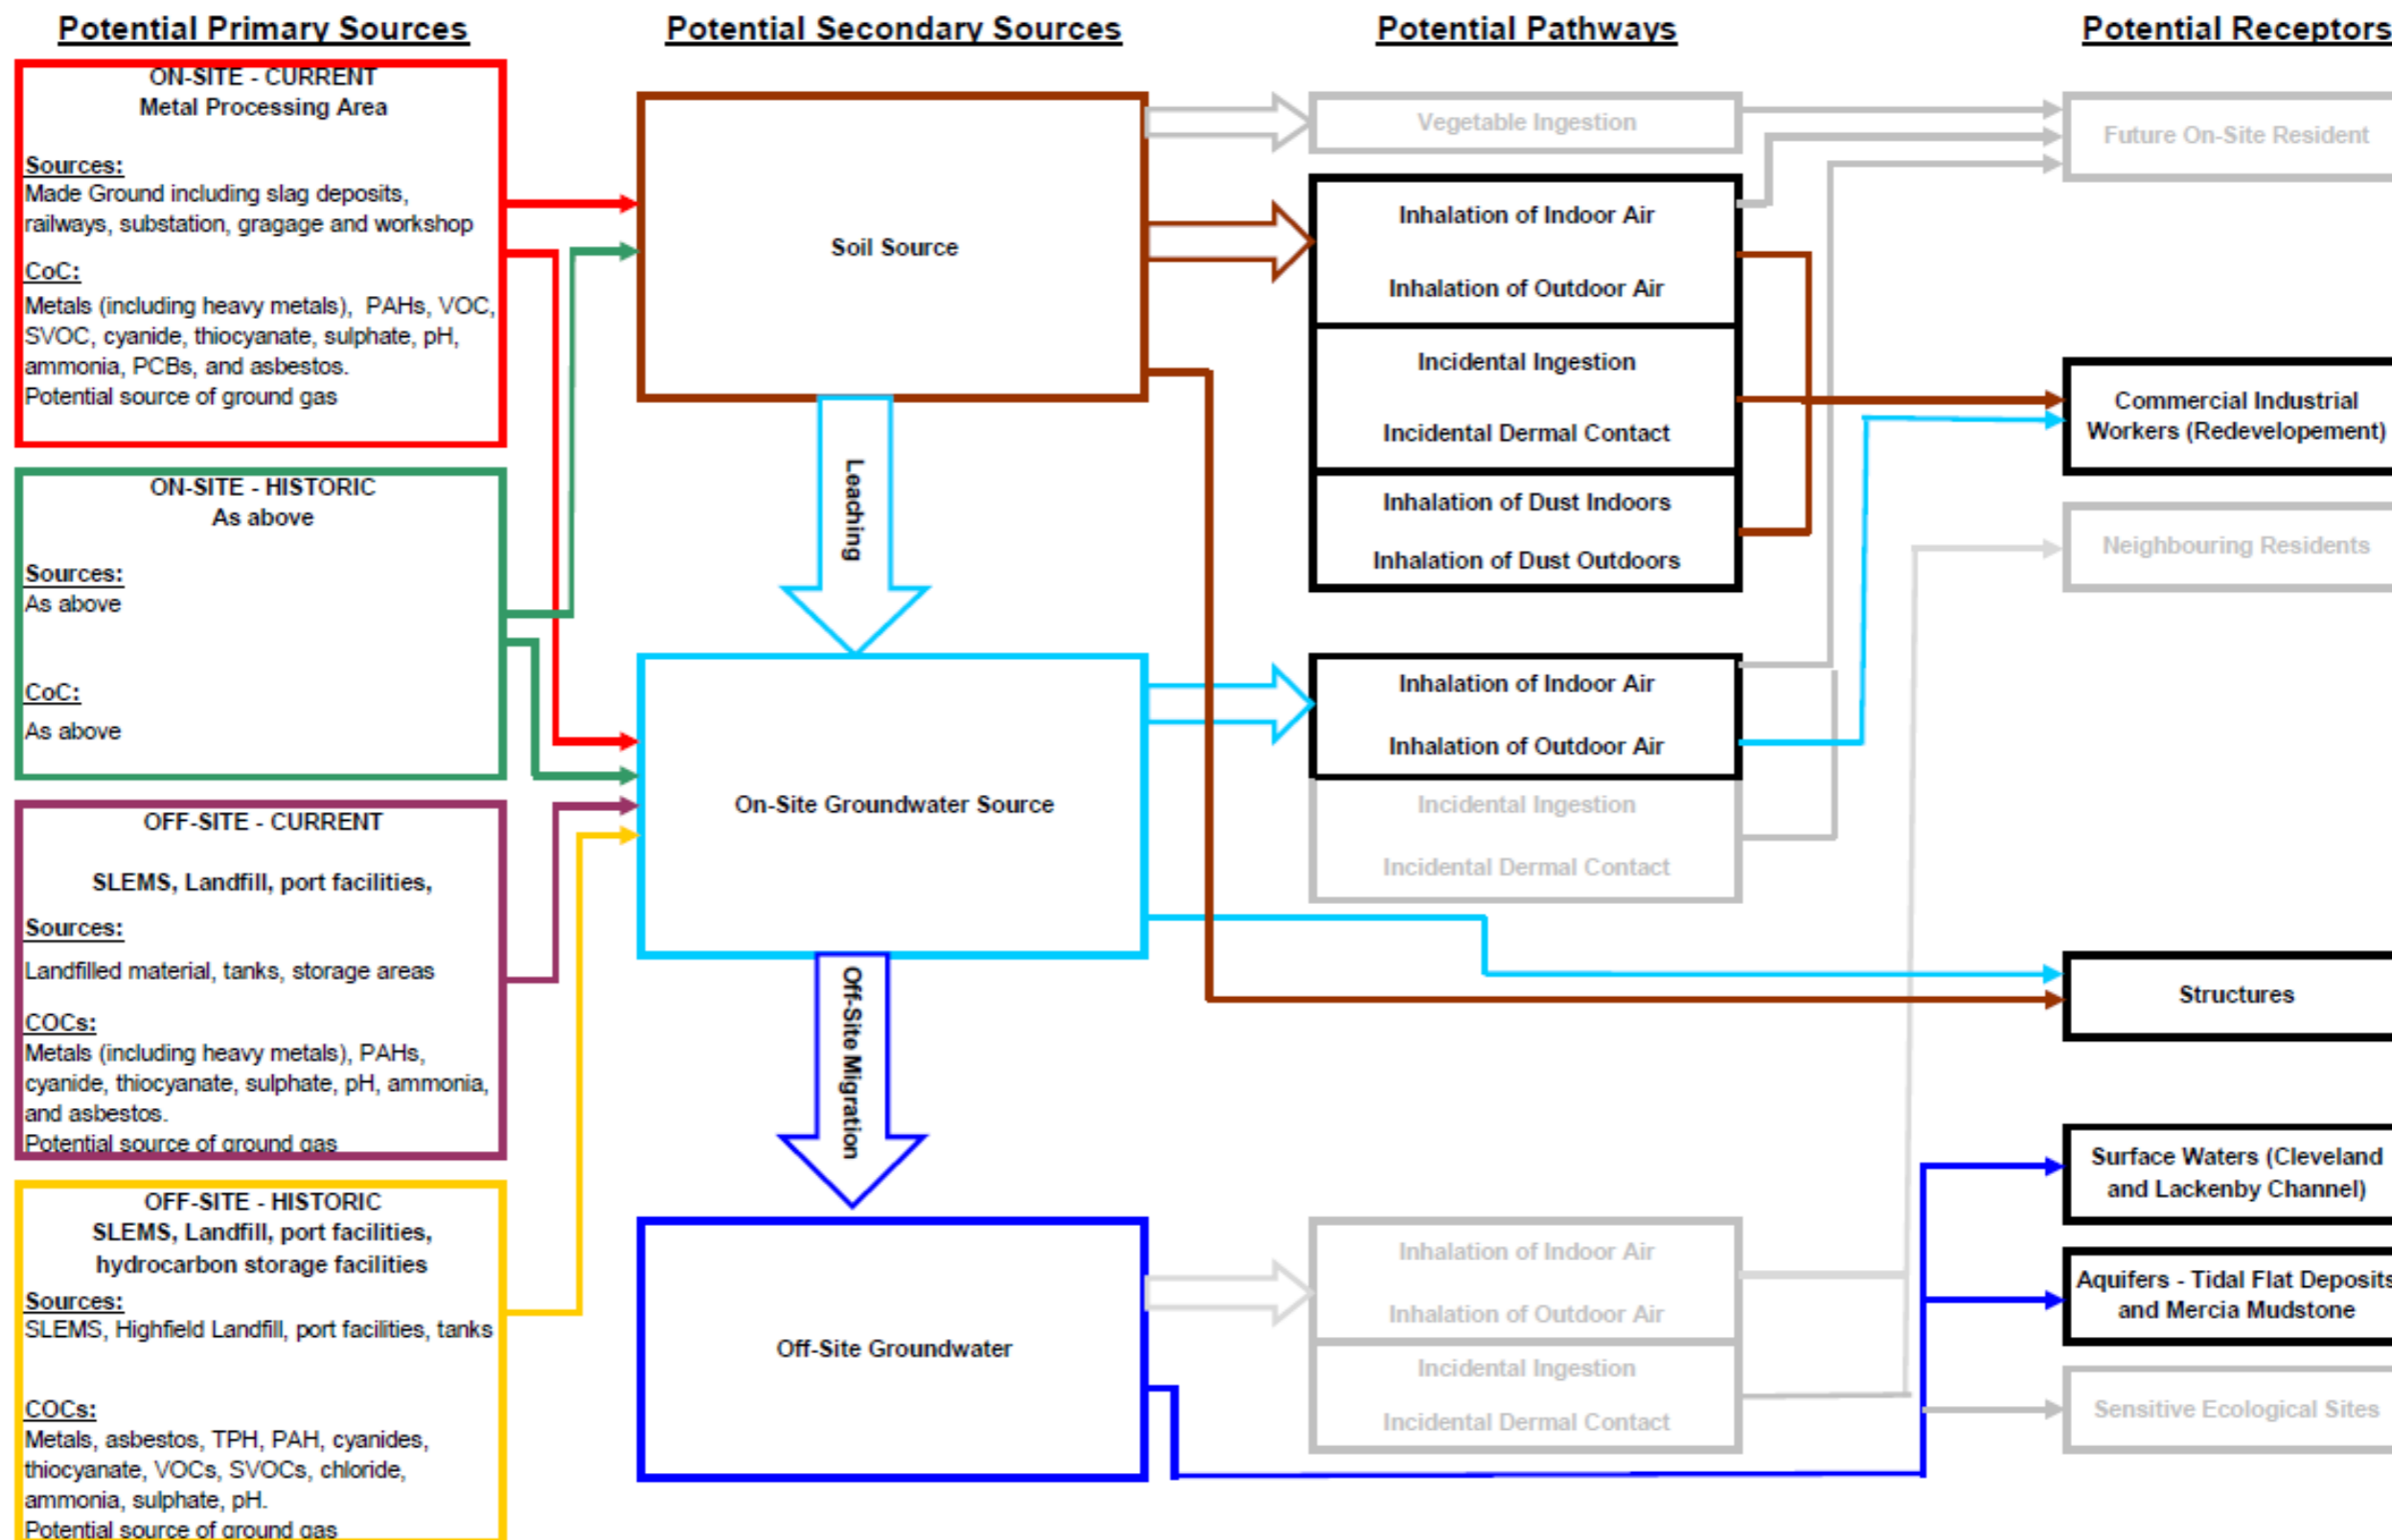
Figure 6
Outline Conceptual Site Model - Commercial Industrial End Use

The above data has been used to produce an initial CSM (based on chronic exposure pathways) for the site, this is presented below as Figure 6. The assessment of risk to on site commercial works is considered sufficiently conservative to protect off site commercial workers.

Key: — Pollutant linkage not considered to present a significant level of risk

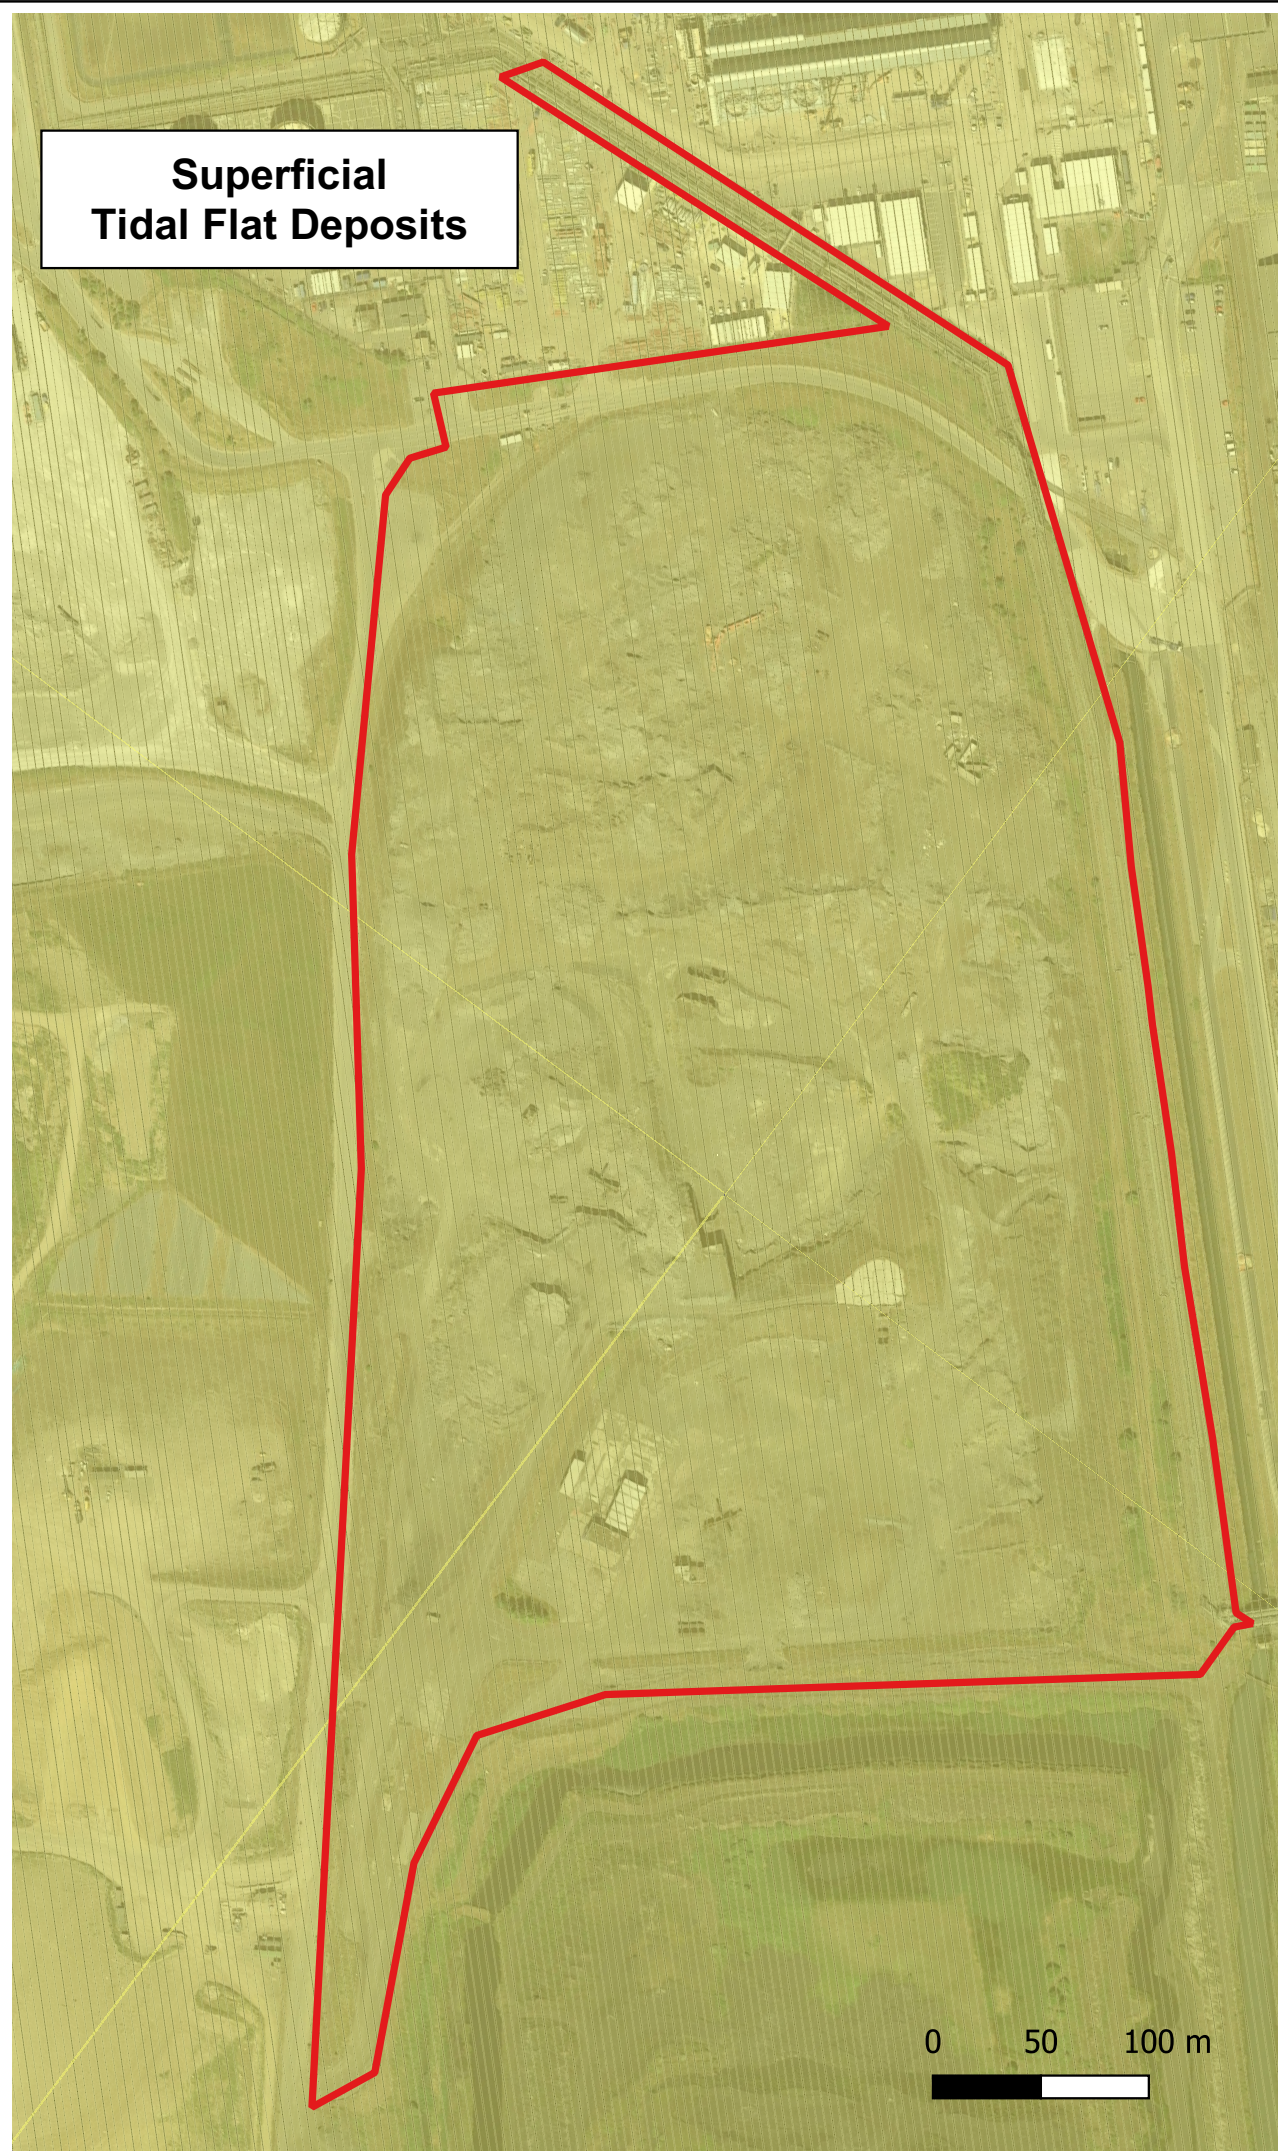
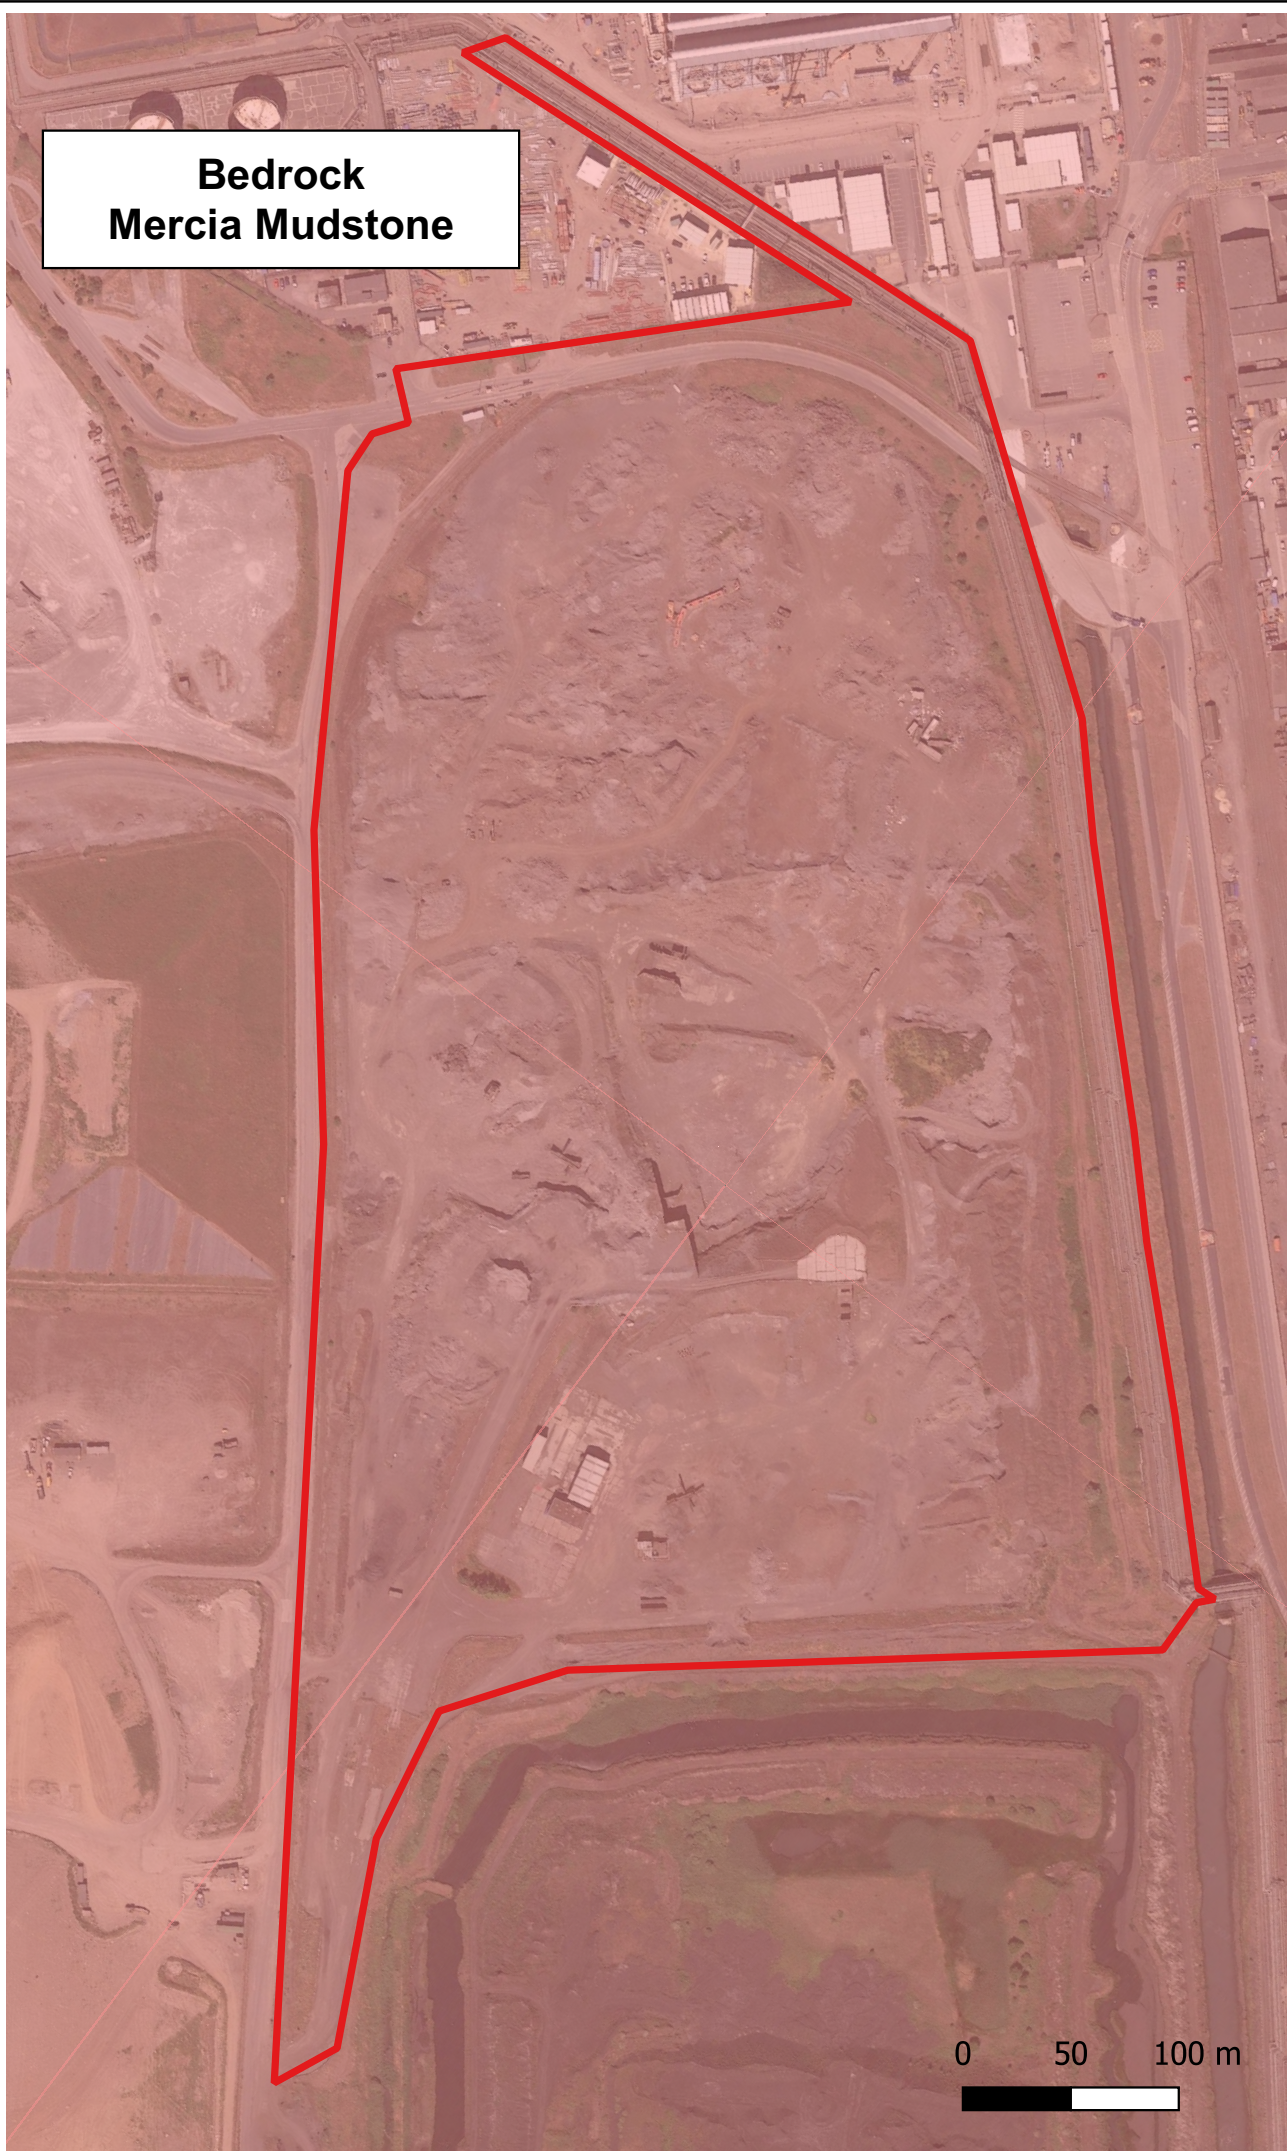
**Superficial
Tidal Flat Deposits**

**Bedrock
Mercia Mudstone**

Review of the British Geological Survey (BGS) data suggests that the majority of the site is underlain by Tidal Flat Deposits predominantly comprising sand and clay. This is anticipated to be underlain by Glaciolacustrine Deposits and Glacial Till based on data from historic boreholes in the vicinity of the MPA.

Bedrock beneath the site is anticipated to comprise Mercia Mudstone. Excerpts from the BGS mapping data are presented as Figure 2 below and in Appendix A.

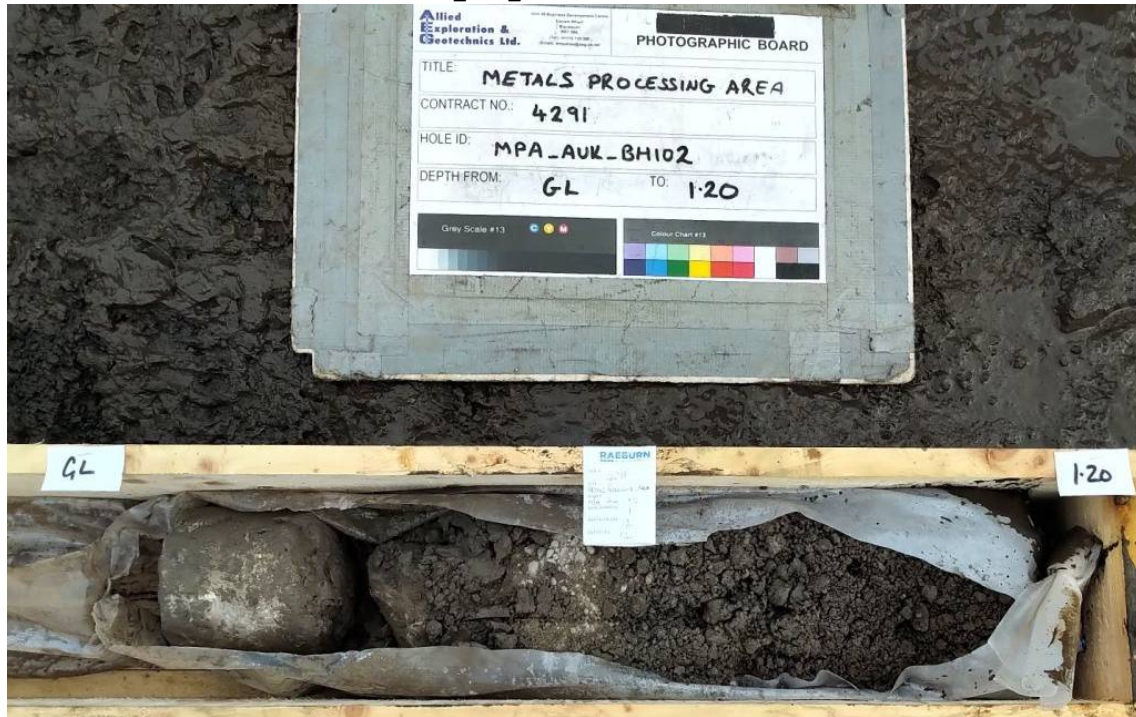
Figure MPA_AUK_BH102.1
MPA_AUK_BH102 0.00-1.20m BGL

- **Slag-dominant material:** Generally ranging from gravel to boulder size fragments of slag. The slag material generally ranged from light grey to dark grey/black in colour, but a wide range of other colours were also noted including blue, brown, green, and purple. Discolouration of the slag surface was also noted with white crystallisation/discolouration often noted on the outer surface along with occasional iron rich areas. Slag is estimated to comprise 75 - 100% of the soil matrix, weighted towards the latter.
