# ESTON ROAD INTRUSIVE WORKS

Final Factual Report  
(Rev.00)

**Allied  
Exploration &  
Geotechnics Ltd.**

The site works were commissioned in order to determine the ground conditions on site prior to the construction of the proposed roundabout and spur road connected to Eston Road in Lackenby, Middlesbrough.

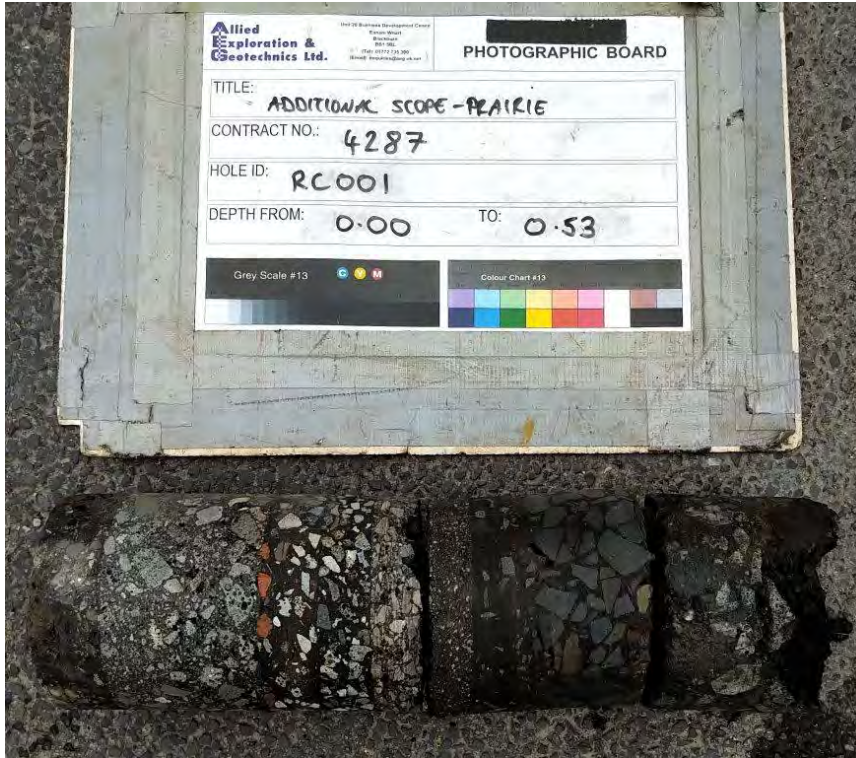
Figure RC001.1  
RC001 - Core

RUN DETAILS		STRATA			
Depth & (Core Ø)	Recovery %	Reduced Level	Legend	Depth (Thickness)	Description
(155mm)	100	9.32		0.045	5mm Hot Rolled Tarmacadam Surface Course (Binder = Bitumen, Aggregate = 30-40%, Aggregate = Dolerite, Estimated Voids = <1%), Layer Condition = Slightly Deteriorated).

(0.095)	20mm Hot Rolled Asphalt Base Course (Binder = Tar, Aggregate = 60-70%, Aggregate = Slag and Basalt, Estimated Voids = <1%), Layer Condition = Fresh).

9.22		0.140	10mm Stone Mastic Asphalt Base Course (Binder = Unknown, Aggregate = 60-70%, Aggregate = Basalt and possibly brick, Estimated Voids = <1%), Layer Condition = Fresh).

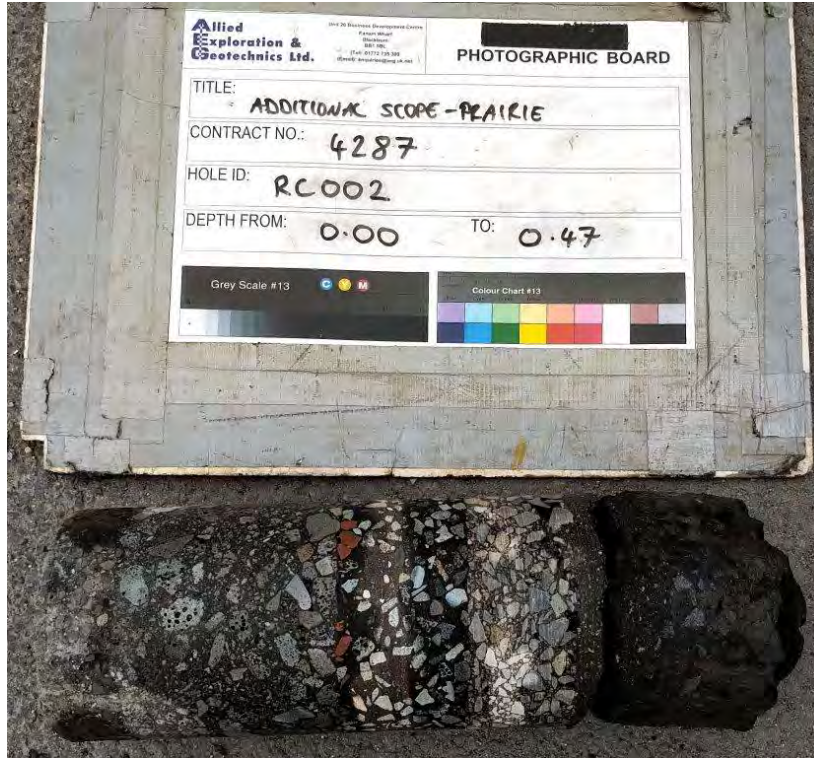
Figure RC002.1  
RC002 - Core

RUN DETAILS		STRATA			
Depth & (Core Ø)	Recovery %	Reduced Level	Legend	Depth (Thickness)	Description
(155mm)	100	9.55		(0.050) 0.050	5mm Hot Rolled Tarmacadam Surface Course (Binder = Bitumen, Aggregate = 30-40%, Aggregate = Dolerite, Estimated Voids = <1%), Layer Condition = Slightly Deteriorated).

9.42		(0.135) 0.185	28mm Hot Rolled Asphalt Base Course (Binder = Tar, Aggregate = 60-70%, Aggregate = Slag and Basalt, Estimated Voids = <1% (Max. Void Size = 2mm)), Layer Condition = Fresh).

9.37		0.230	20mm Stone Mastic Asphalt Base Course (Binder = Unknown, Aggregate = 50-60%, Aggregate = Basalt and possibly brick, Estimated Voids = <1%), Layer Condition = Fresh).

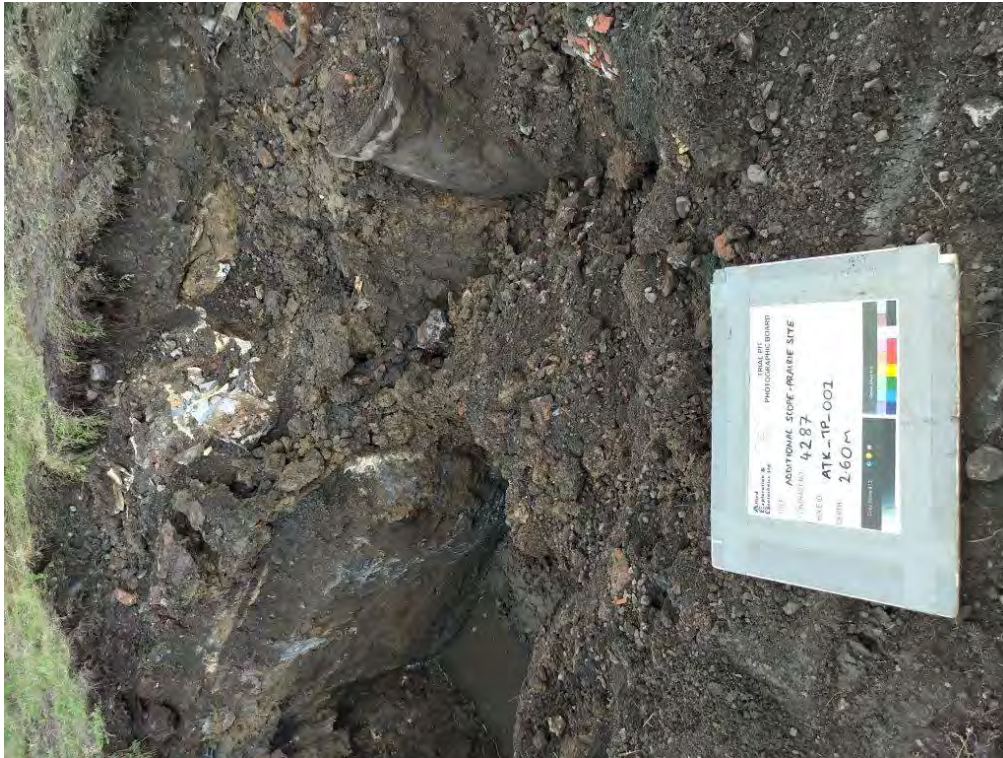
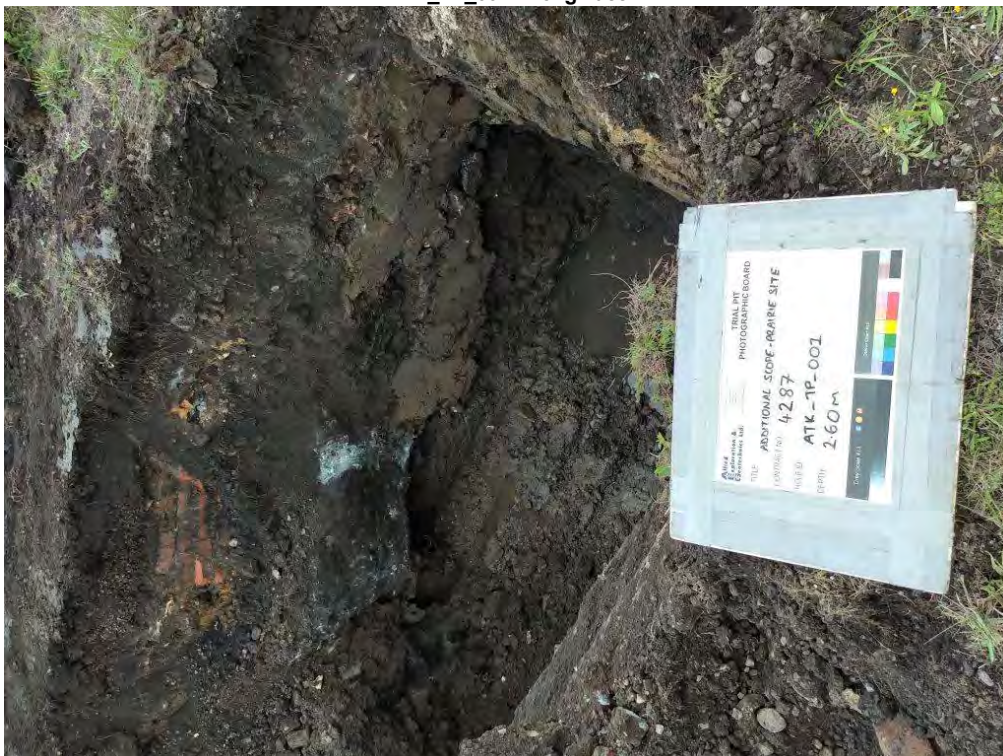
Figure ATK\_TP\_001.1  
ATK\_TP\_001 - Long Face

2.60	B7					5.76	2.60	at c.2.60m BGL ... concrete slab/base. <i>Terminated at 2.60m BGL - due to encountering a concrete slab.</i>

**GROUNDWATER**  
 Groundwater seepage at 2.10m BGL (Slow inflow).

**STABILITY**  
 Pit sides and base stable throughout excavation.

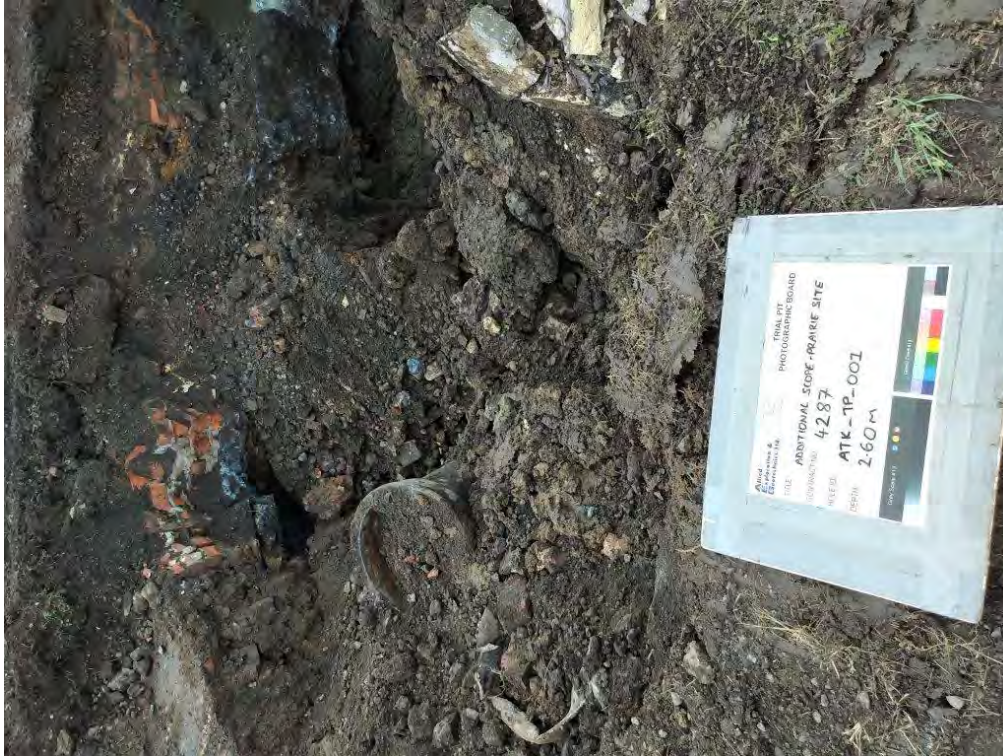
Figure ATK\_TP\_001.5  
ATK\_TP\_001 - Structures

Exploratory Hole Number	Type of Service	Orientation & Depth (size where indicated)	Status (Damaged/Undamaged)	Additional Remarks
ATK_TP_001	Cast iron pipe	c.045° at 0.60m BGL (610mm diameter)	Undamaged	Sketch provided, please refer to Trial Pit Record
ATK_TP_002	Railway track line	0.80m BGL	Damaged/Removed	3.50m of track noted
ATK_TP_003	Cable	000° at 0.90m BGL (76mm diameter)	Damaged	None
ATK_TP_005	Cast iron pipe	090° at 0.40m BGL (152mm diameter)	Undamaged	None
	Cable	090° at 0.90m BGL (76mm diameter).	Damaged	None
ATK_TP_007	1 No. electric cable inside clay pipe conduit	135° at 0.80m BGL. (Cable - 25mm diameter Clay pipe - 152mm diameter)	Damaged	None
	2 No. electric cables	000° at 0.80m BGL (76mm diameter)	Damaged	None
	1 No. electric cable	090° at 0.80m BGL (76mm diameter)	Damaged	None

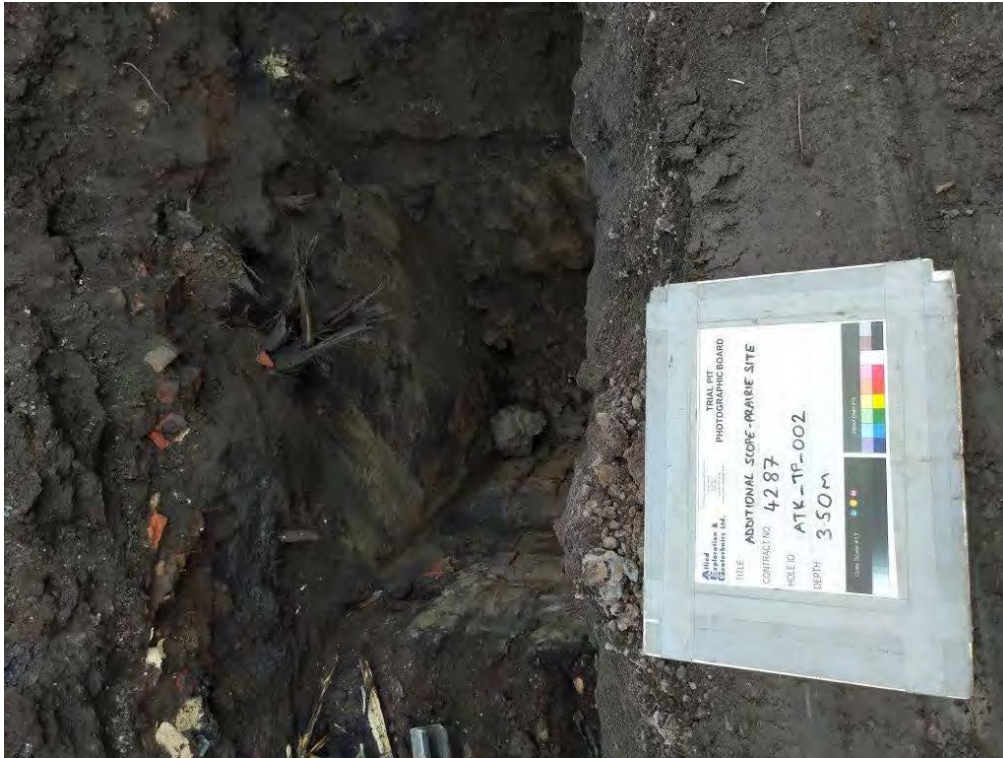
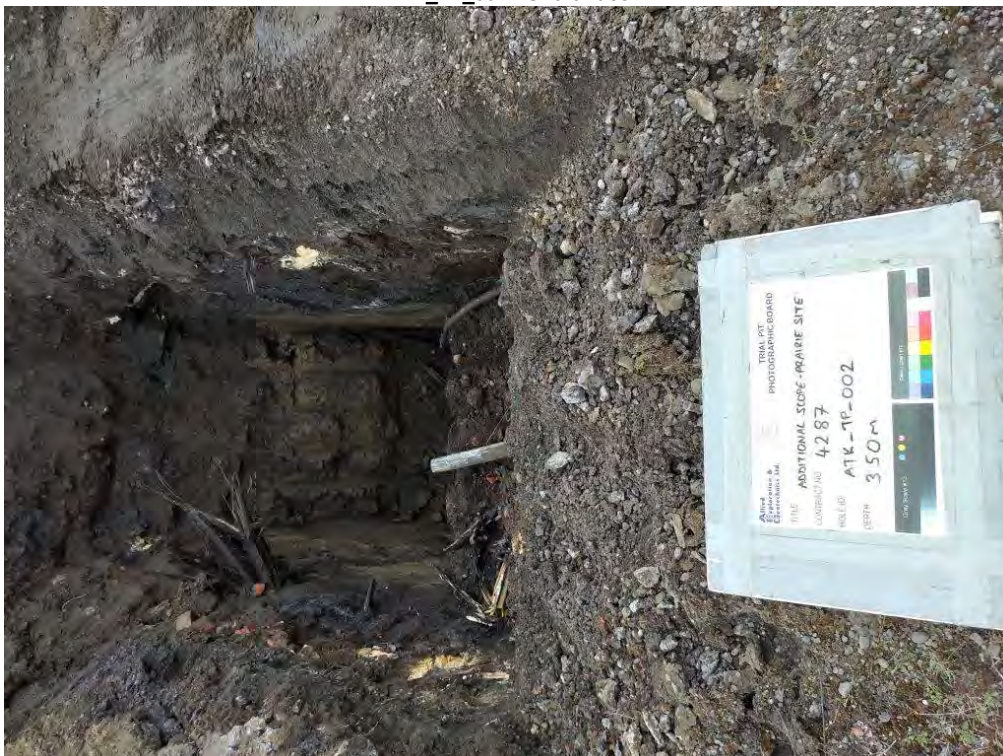
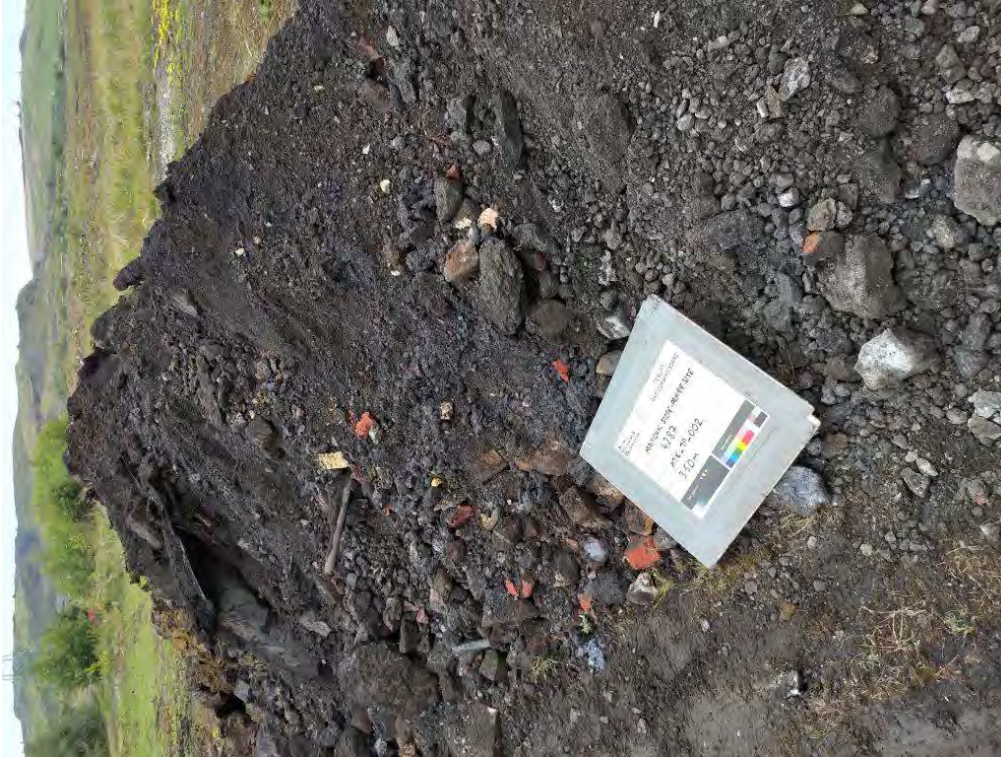
Figure ATK\_TP\_002.1  
ATK\_TP\_002 - Long Face

1.80 2.00	J6 B7				(2.80)		
2.90 3.00 3.20	J8 ES9 B10				(0.70)	3.50	Firm and friable laminated grey brown CLAY with silty lenses. at c.2.90m BGL ... clay is of intermediate plasticity.
							Complete at 3.50m BGL.

**GROUNDWATER**  
 No groundwater inflow observed.

**STABILITY**  
 Pit sides and base stable throughout excavation.

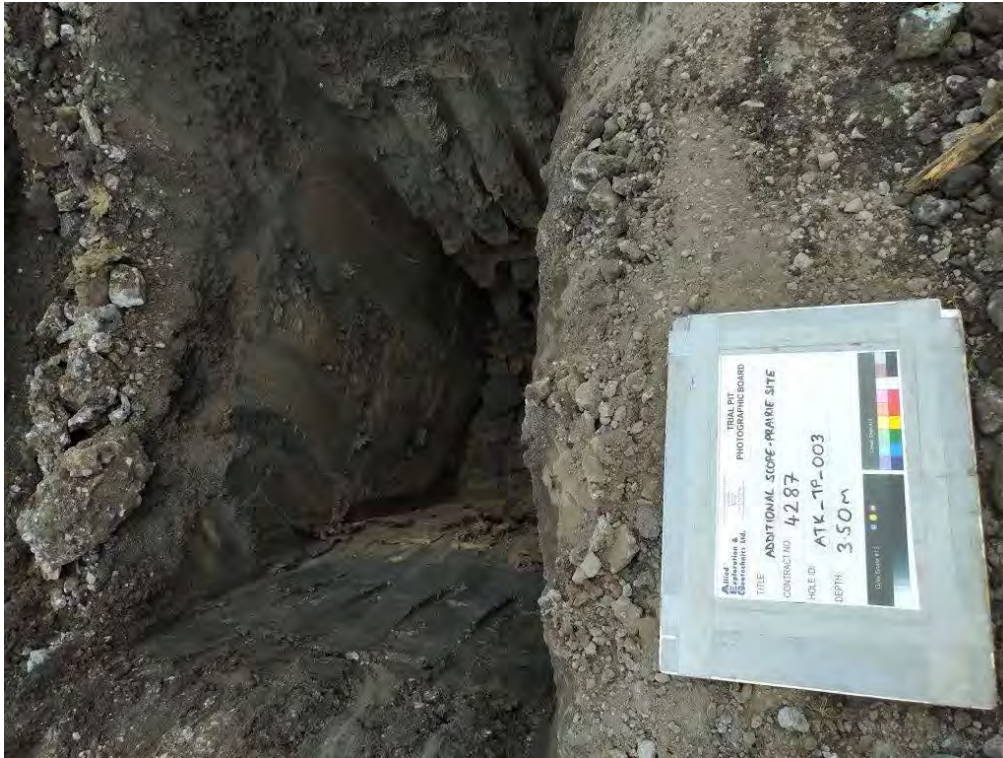
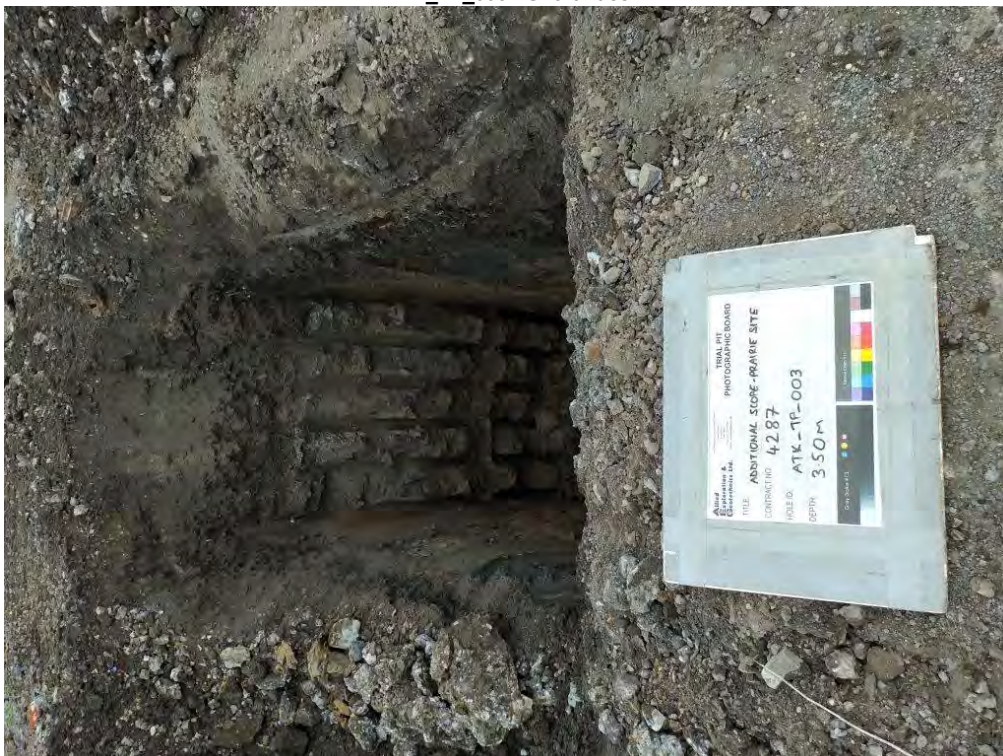
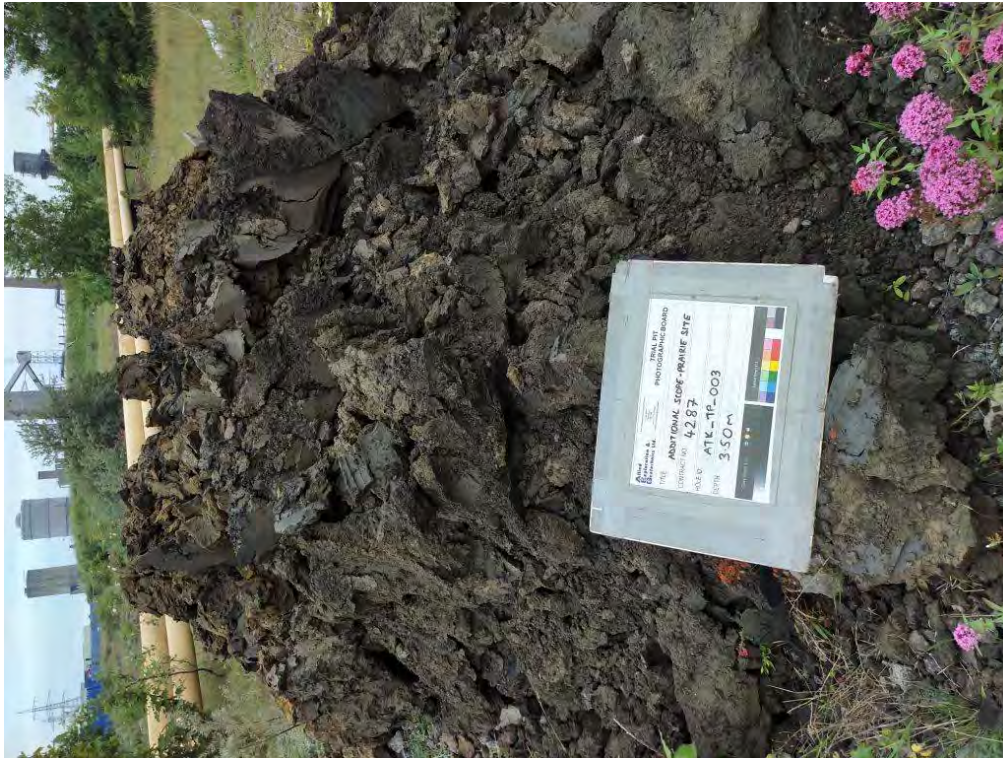
Figure ATK\_TP\_003.1  
ATK\_TP\_003 - Long Face

3.10	J9			4.99	3.50	
3.30	B10					Complete at 3.50m BGL.

**GROUNDWATER**  
 No groundwater inflow observed.

**STABILITY**  
 Pit sides and base stable throughout excavation.

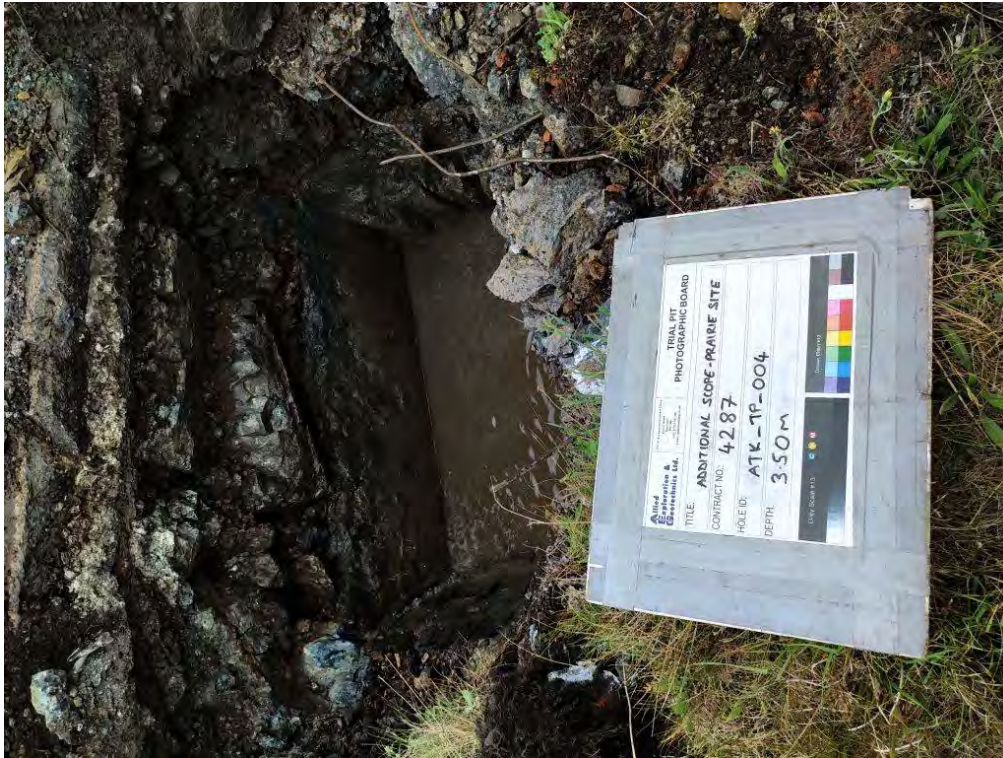
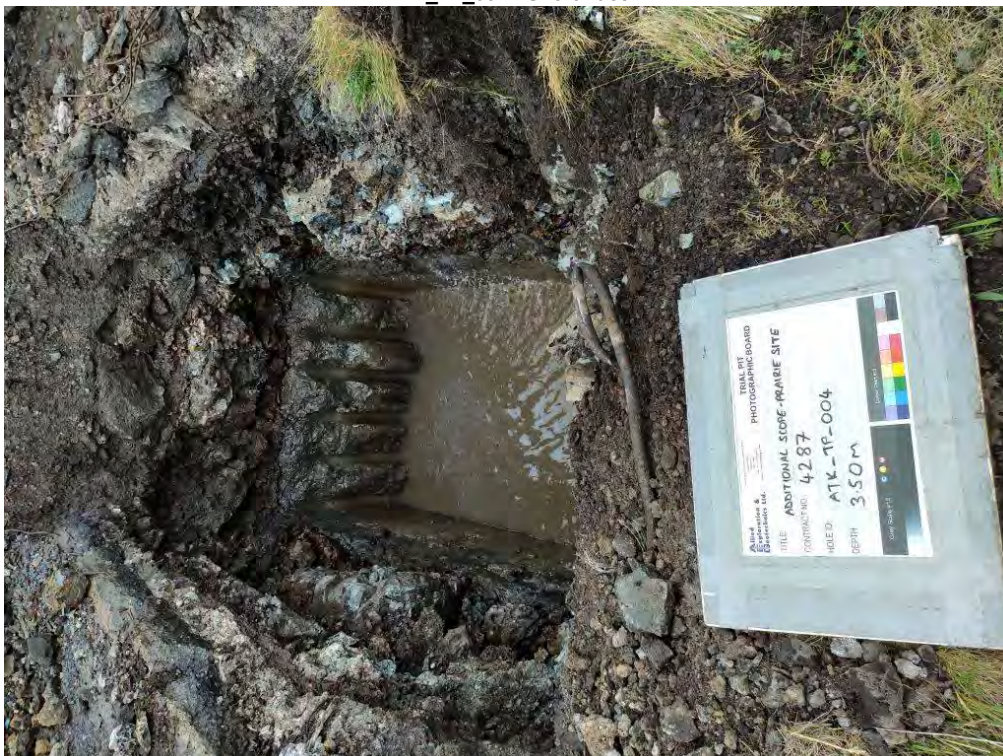
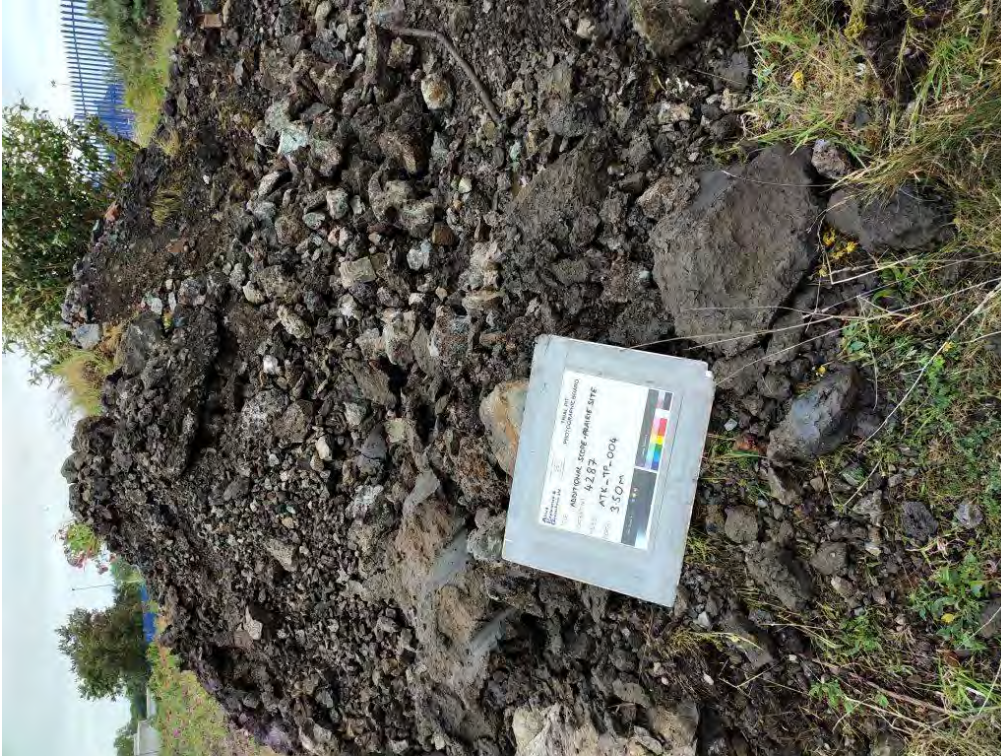
Figure ATK\_TP\_004.1  
ATK\_TP\_004 - Long Face

2.10	B5			6.61		2.20	Firm brown grey slightly organic slightly sandy silty CLAY with root fibers. Sand is fine to medium.			
2.40	J6									
2.60	B9

**GROUNDWATER**  
 Saturated strata at 1.60m BGL (Heavy inflow).

**STABILITY**  
 Pit sides and base stable throughout excavation.

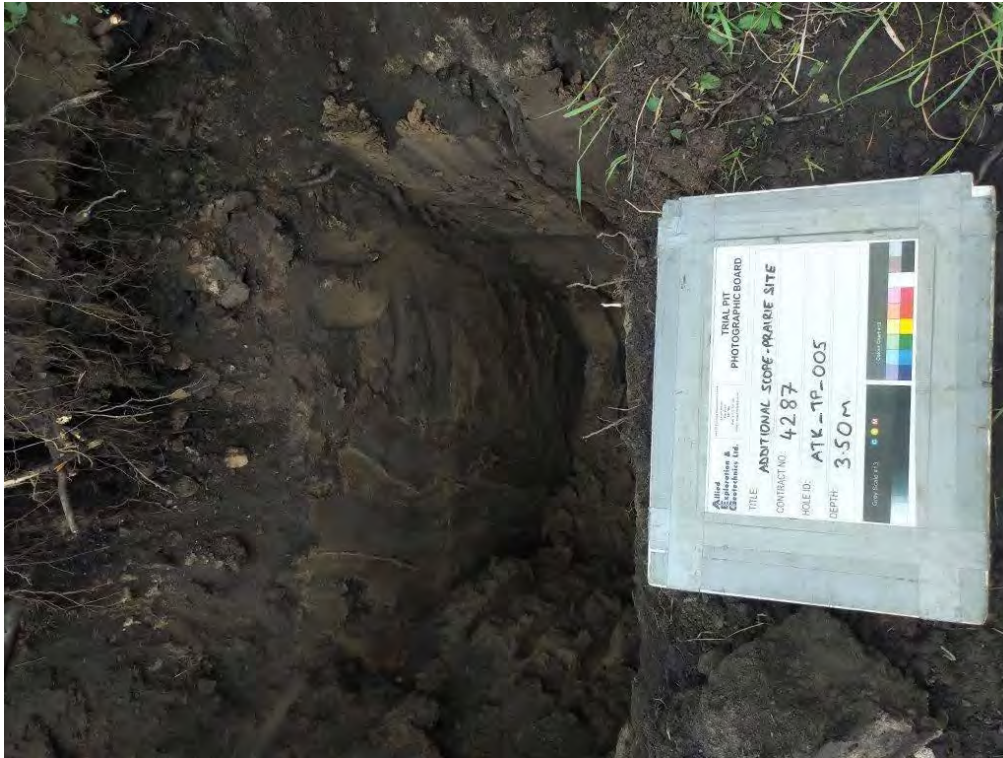
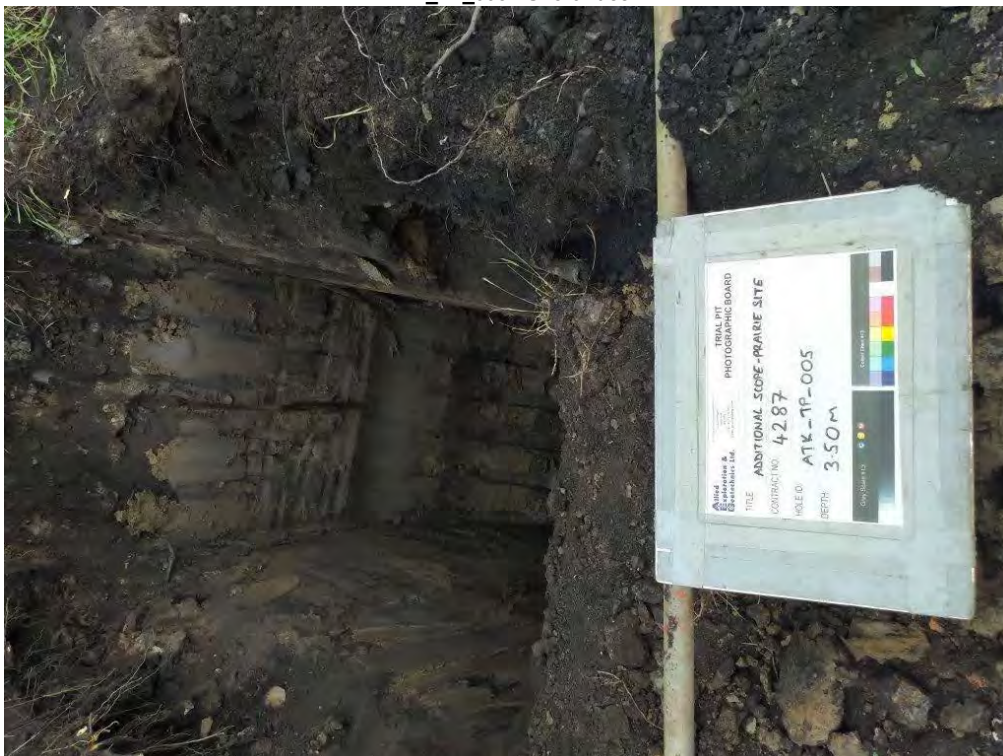
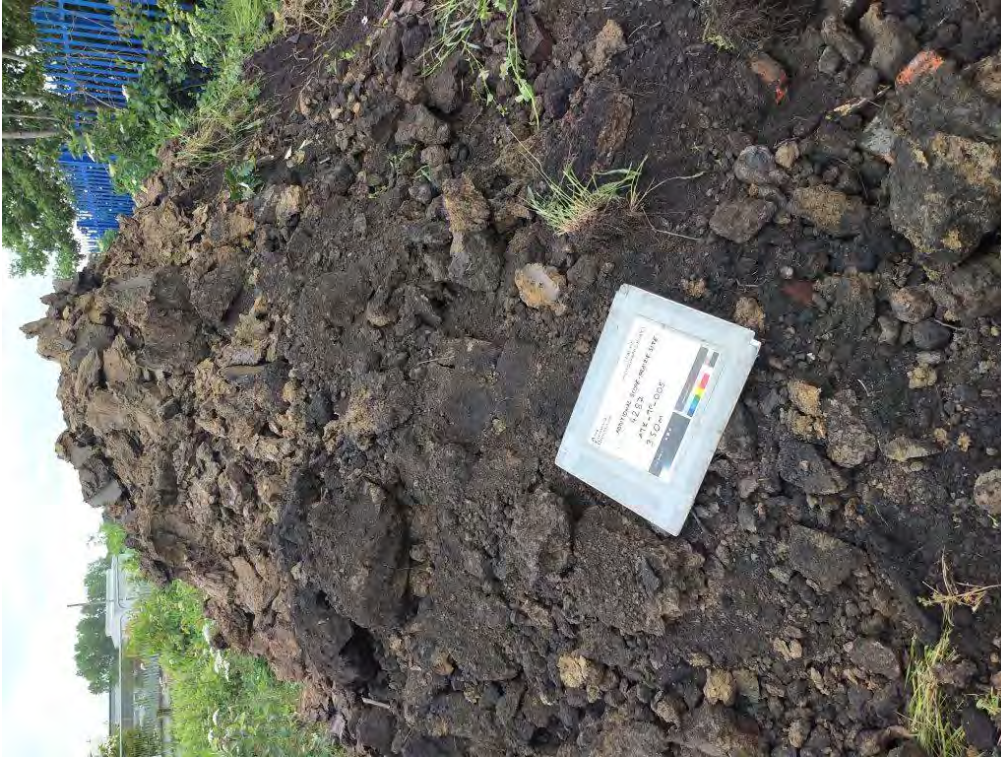
Figure ATK\_TP\_005.1  
ATK\_TP\_005 - Long Face

2.80	B7					at c.1.60m BGL ... clay is of intermediate plasticity.
2.90	ES8					
3.20	J9			5.98		Complete at 3.50m BGL.

**GROUNDWATER**  
No groundwater inflow observed.

**STABILITY**  
Pit sides and base stable throughout excavation.

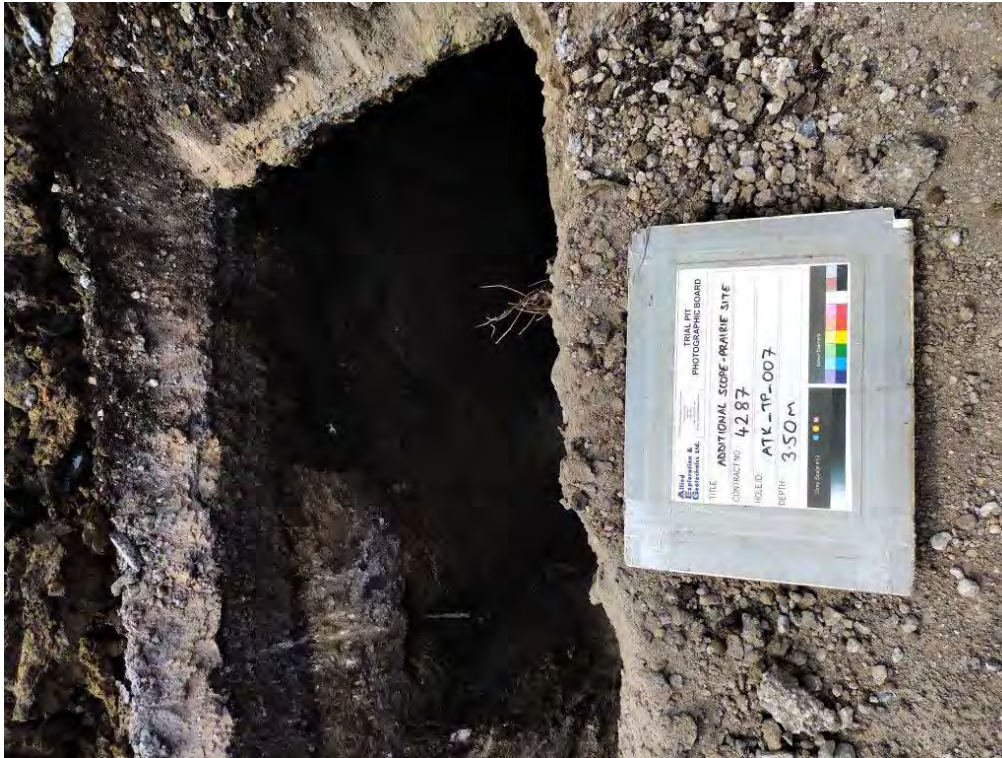
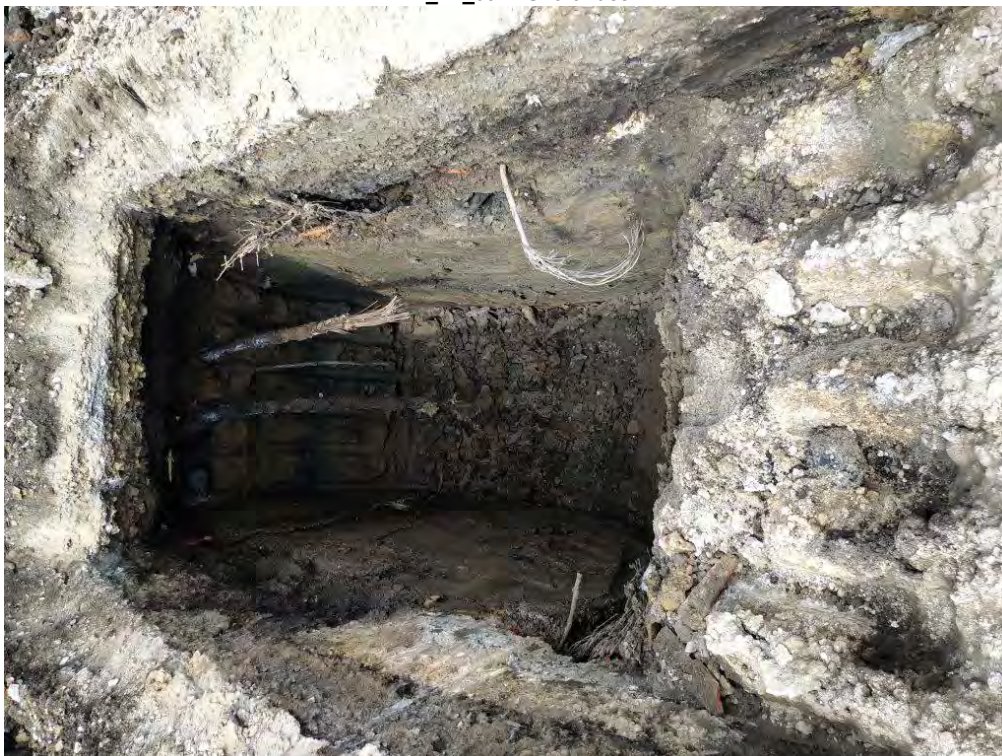
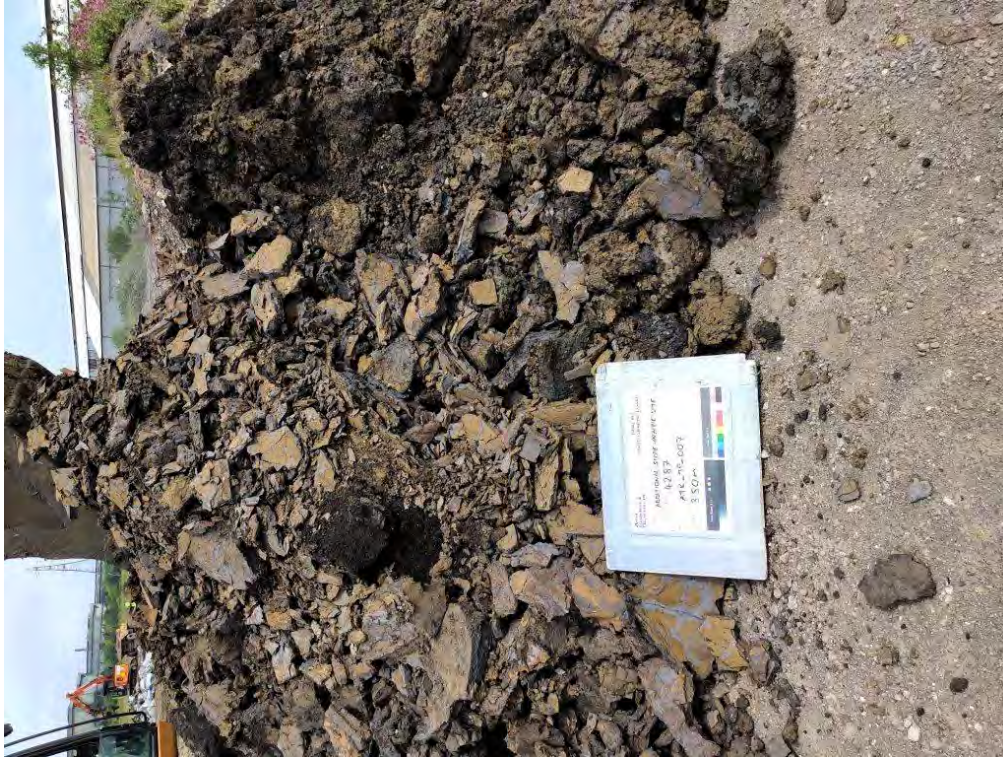
Figure ATK\_TP\_007.1  
ATK\_TP\_007 - Long Face

**GROUNDWATER**  
Water ingress from 152mm diameter cable conduit. (Slight ingress).

**STABILITY**  
Pit sides and base stable throughout excavation.

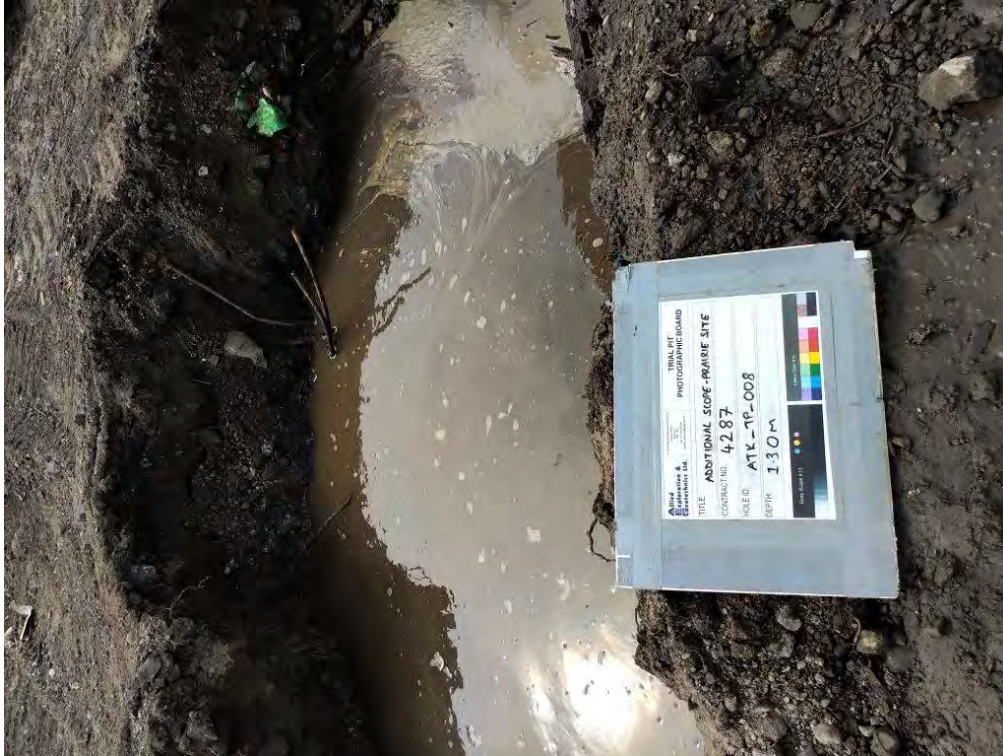
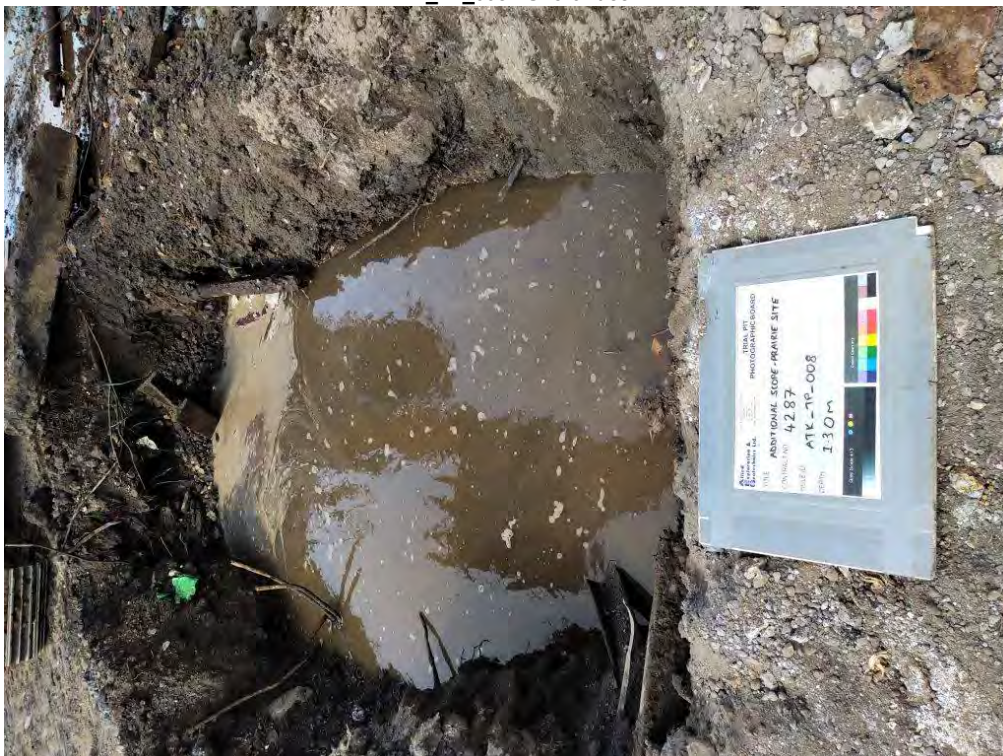
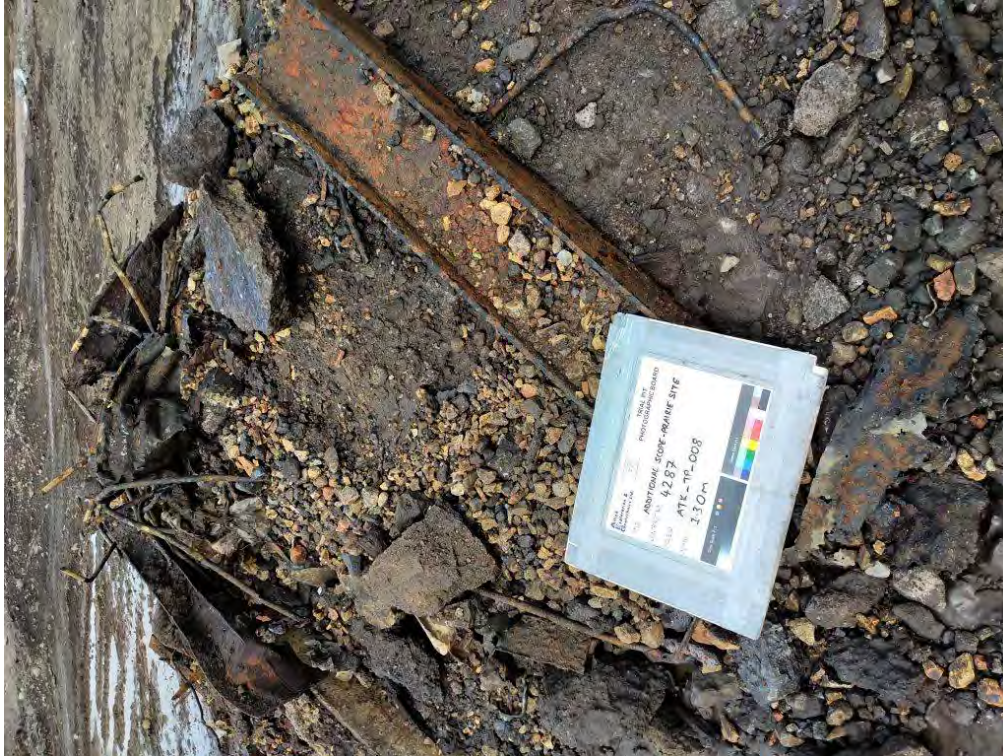
Figure ATK\_TP\_008.1  
ATK\_TP\_008 - Long Face

**GROUNDWATER**  
 Saturated strata at 0.90m BGL (Heavy inflow).

**STABILITY**  
 Pit sides and base stable throughout excavation.

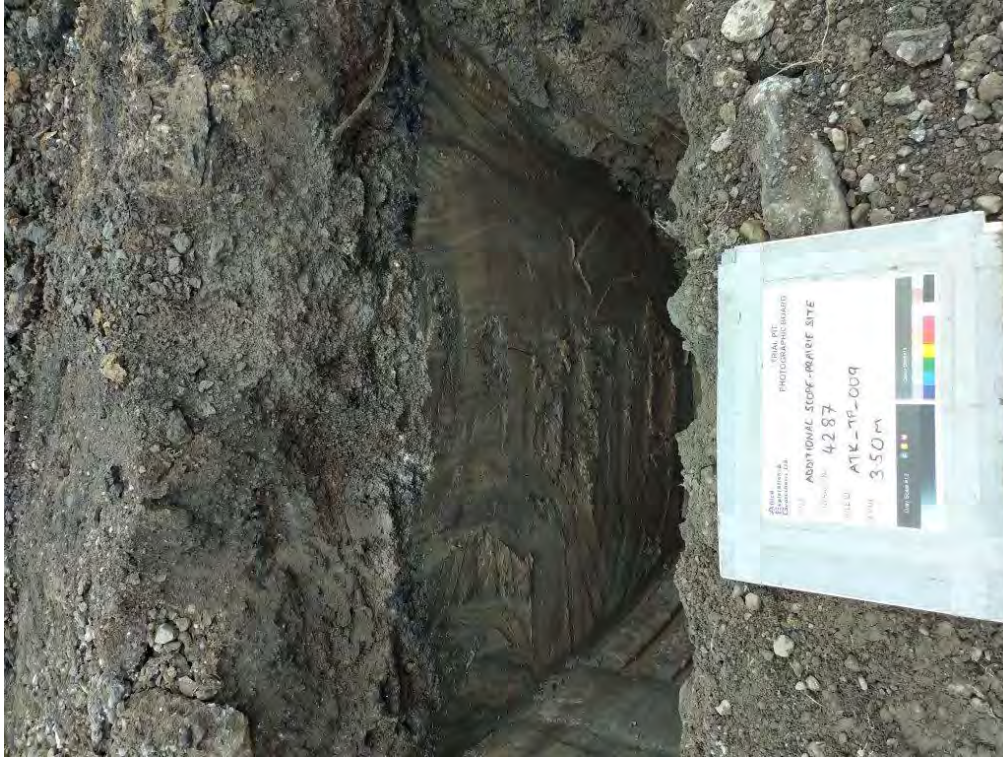
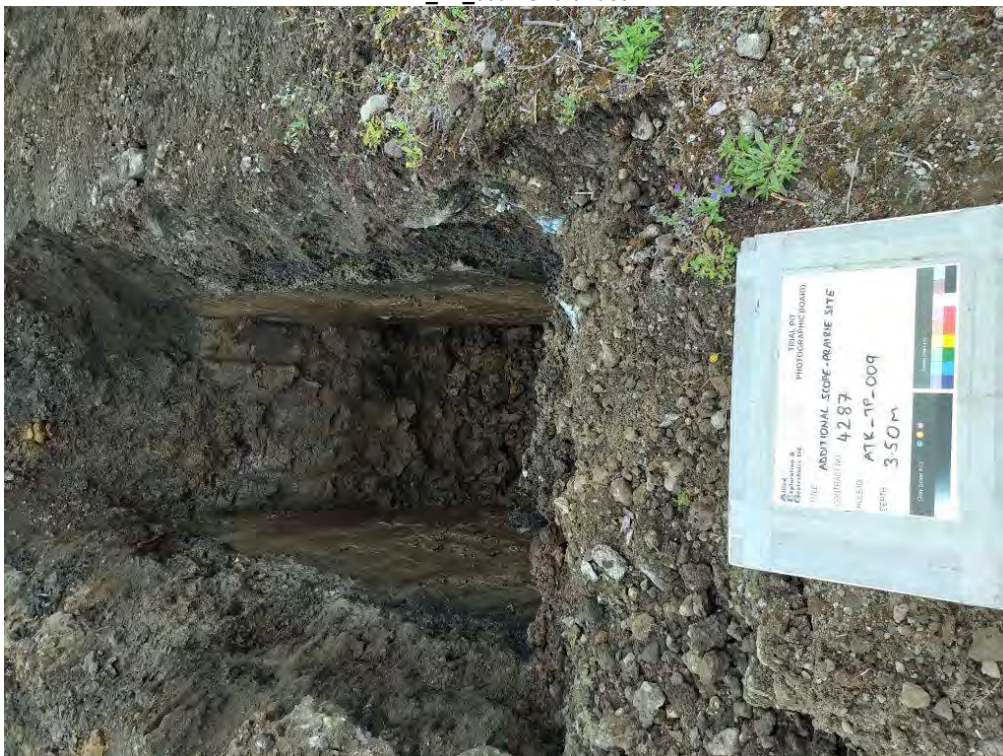
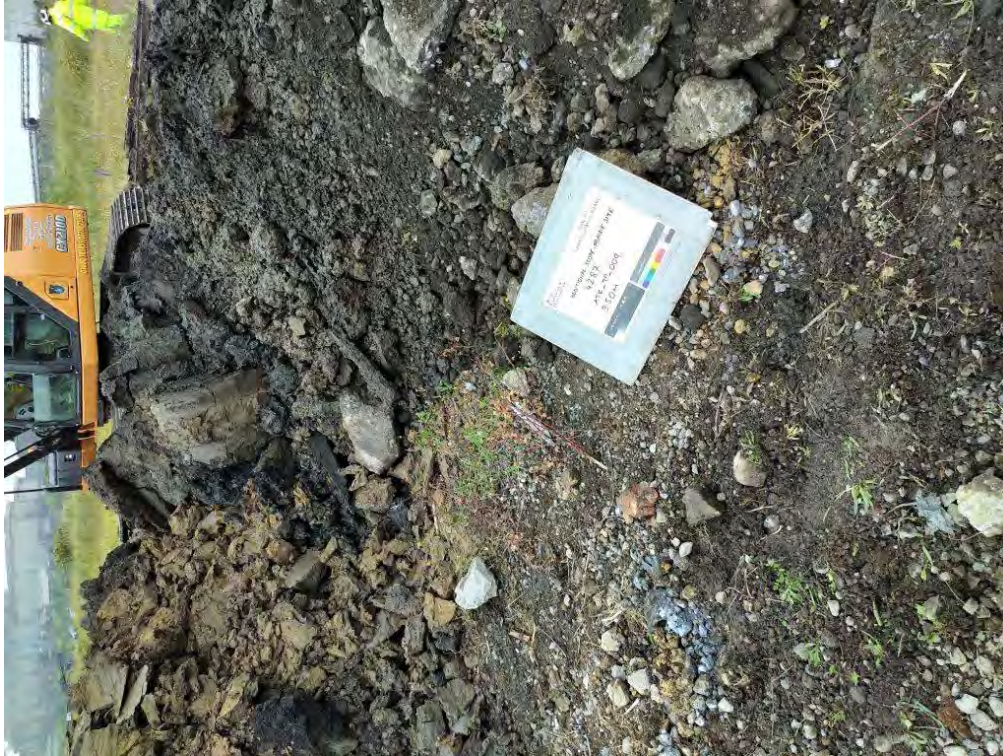
Figure ATK\_TP\_009.1  
ATK\_TP\_009 - Long Face

2.10	J7						
2.30	B8						
3.10	J9						
3.30	B10			5.50		3.50	at c.3.30m BGL ... clay is of intermediate plasticity. <i>Complete at 3.50m BGL.</i>

**GROUNDWATER**  
 Saturated strata at 0.60m BGL (Slight inflow).

**STABILITY**  
 Pit sides and base stable throughout excavation.

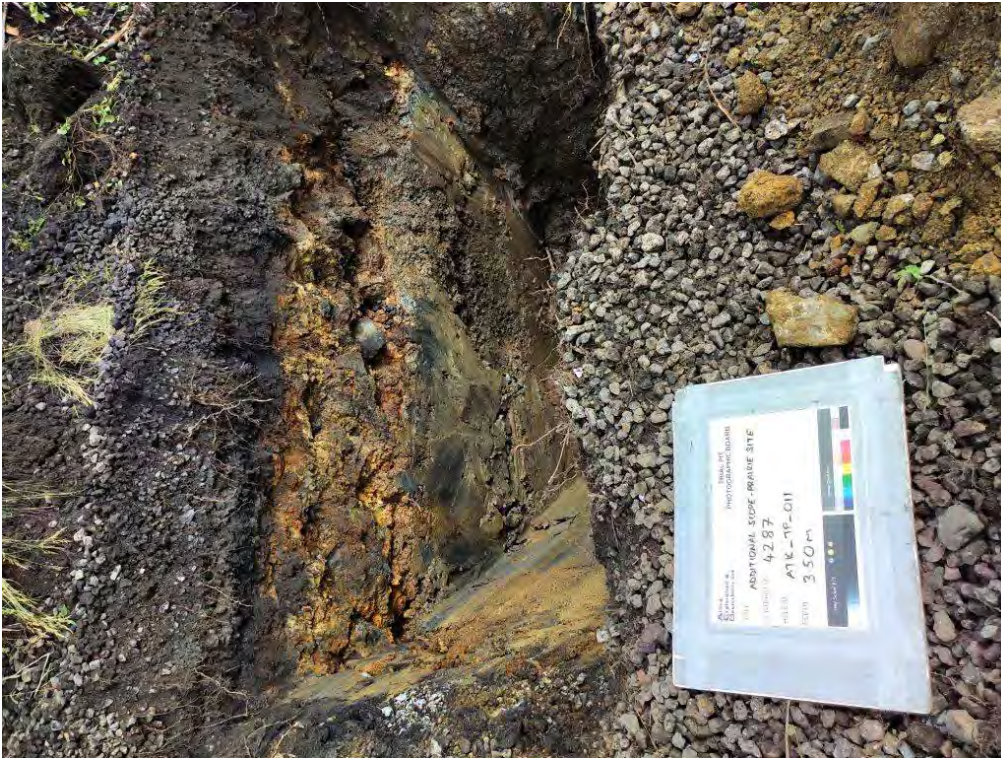
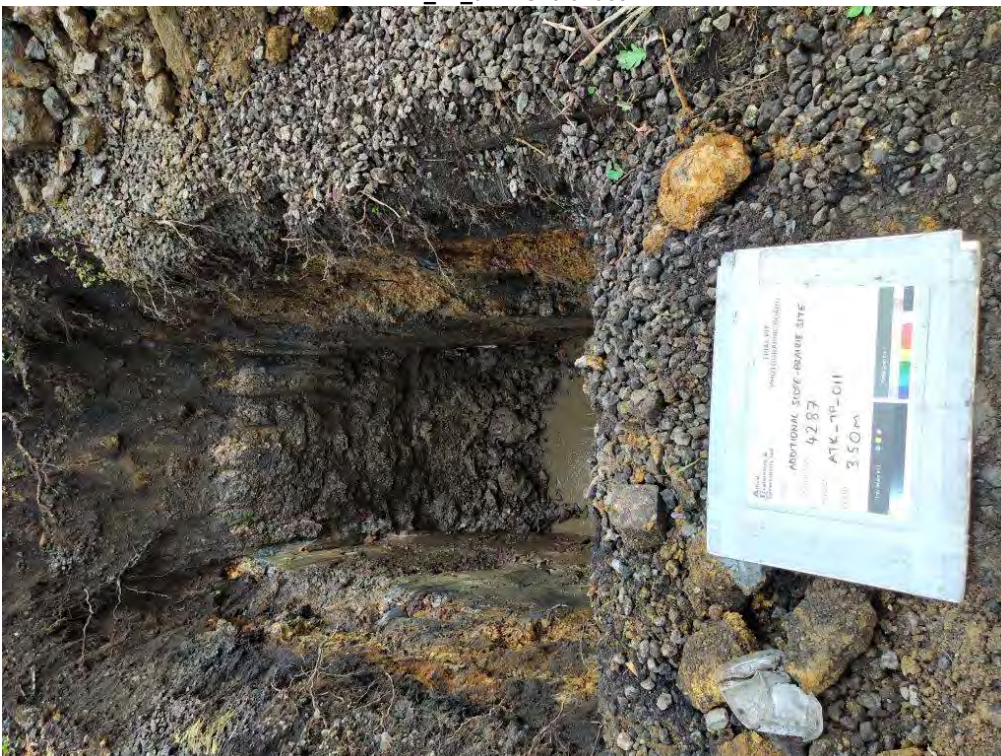
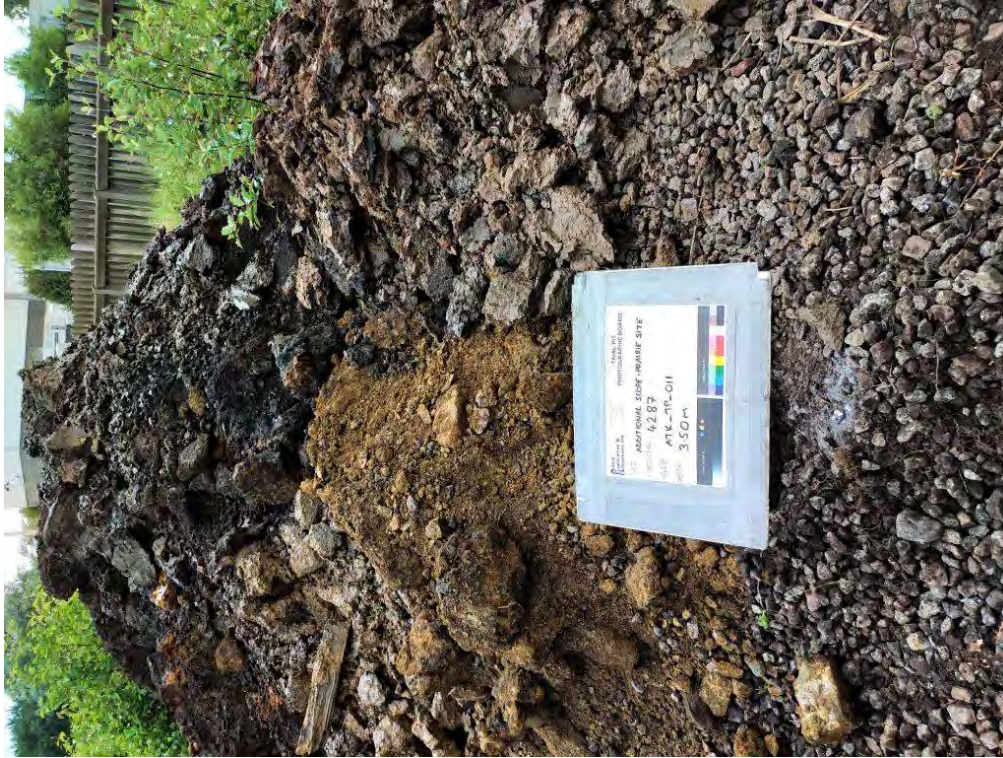
Figure ATK\_TP\_011.1  
ATK\_TP\_011 - Long Face

2.70 2.80	J6 B7			7.21	(2.00)	Soft to firm brown grey mottled black slightly sandy silty CLAY grading to firm and friable becoming stiff grey red brown sandy CLAY with occasional silty laminae. Sand is fine to medium. (Engineer notes wooden piles driven into upper section of clay (soft zone to approximately 2.20m BGL)). at c.1.70m BGL ... clay is of intermediate plasticity.
						at c.2.80m BGL ... slightly sandy slightly gravelly silty clay.
Complete at 3.50m BGL.

**GROUNDWATER**  
 Saturated strata at 0.90m BGL (Heavy inflow).

**STABILITY**  
 Pit sides and base stable throughout excavation.
