# ESTON ROAD INTRUSIVE WORKS

Final Factual Report  
(Rev.00)

**Allied  
Exploration &  
Geotechnics Ltd.**

The site works were commissioned in order to determine the ground conditions on site prior to the construction of the proposed roundabout and spur road connected to Eston Road in Lackenby, Middlesbrough.

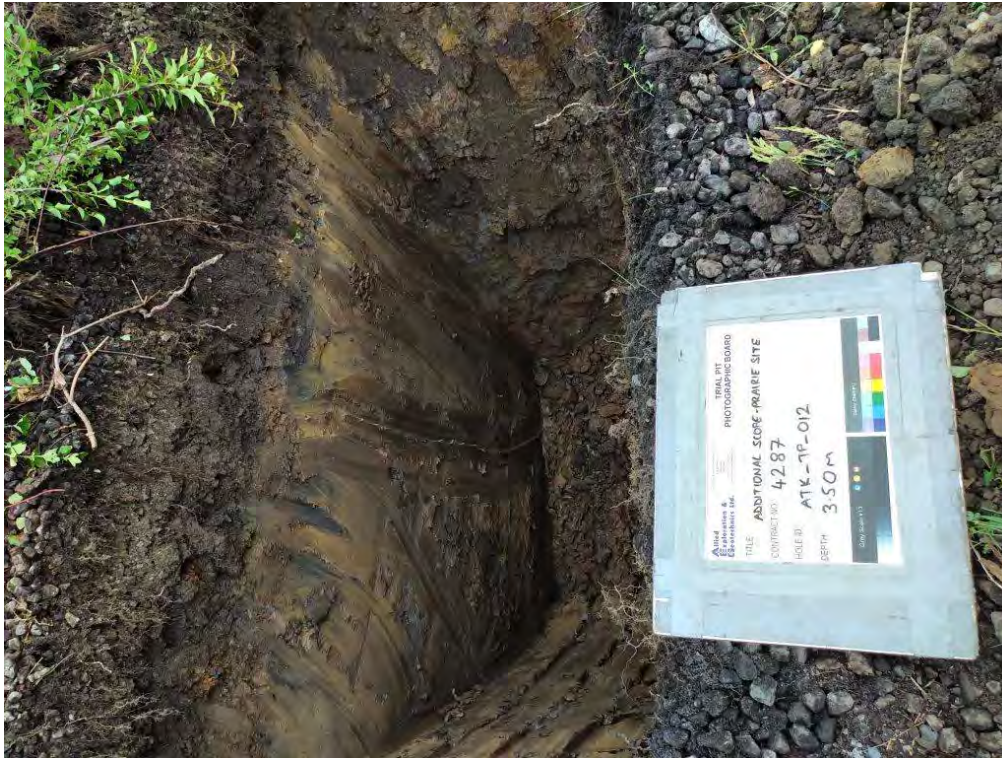
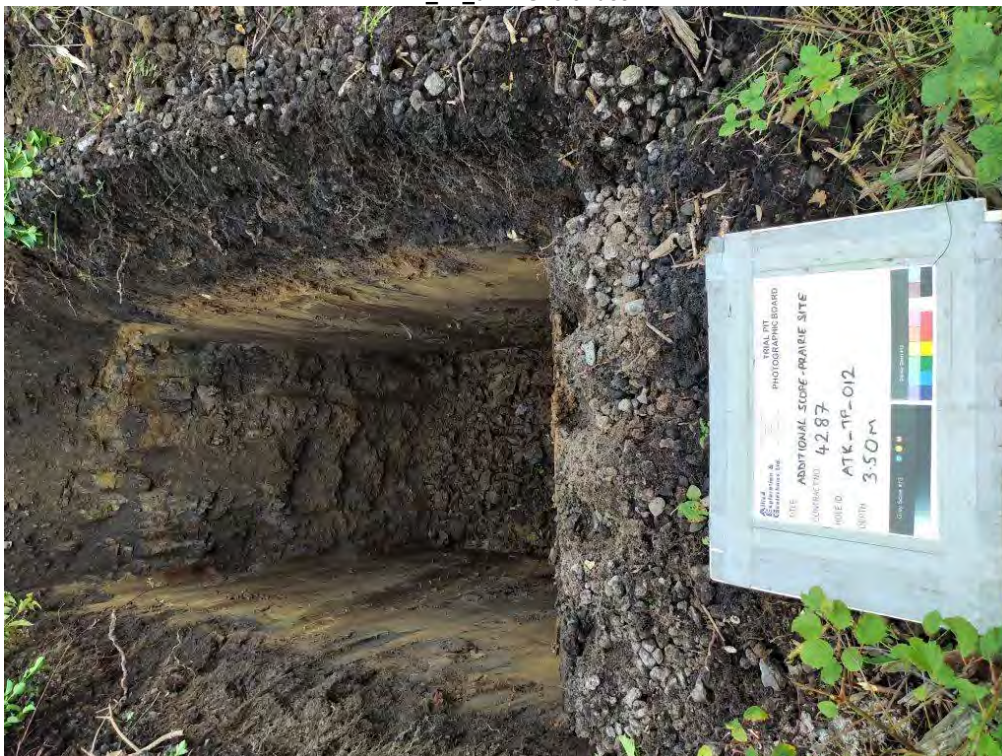
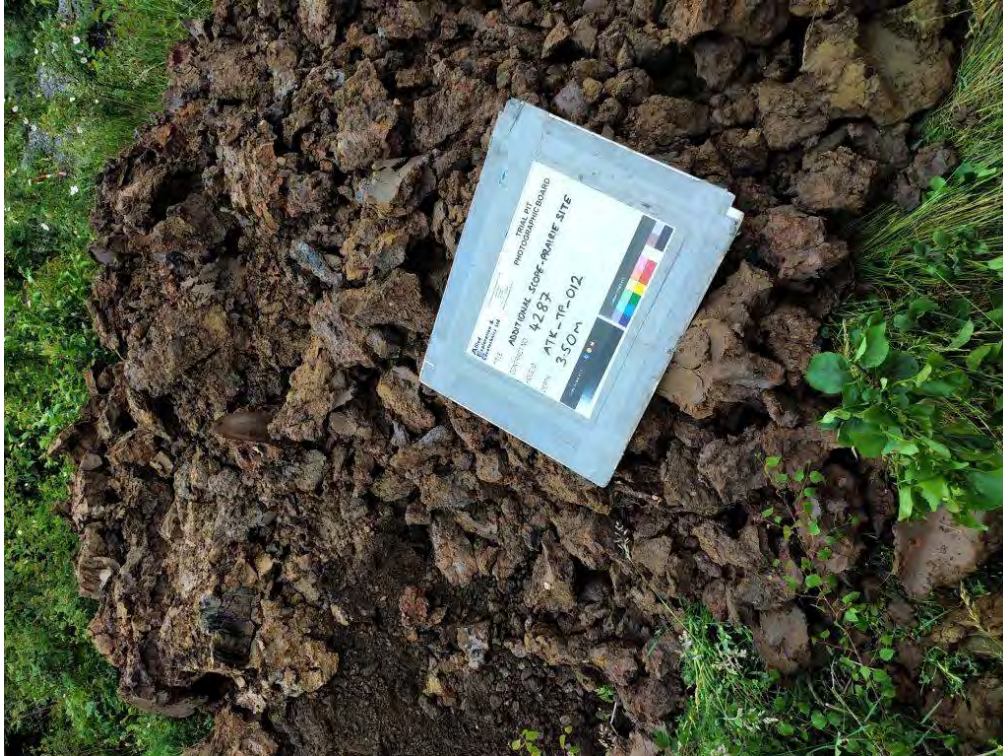
Figure ATK\_TP\_012.1  
ATK\_TP\_012 - Long Face

**GROUNDWATER**  
 No groundwater inflow observed.

**STABILITY**  
 Pit sides and base stable throughout excavation.

Hand shear vane testing using calibrated Edeco Pilcon Hand Vane equipment was carried out in one trial pit (ATK\_TP\_012) in accordance to the ground conditions encountered. The results are presented in detail
