South Bank WFD Compliance Assessment

Final Report

October 2021

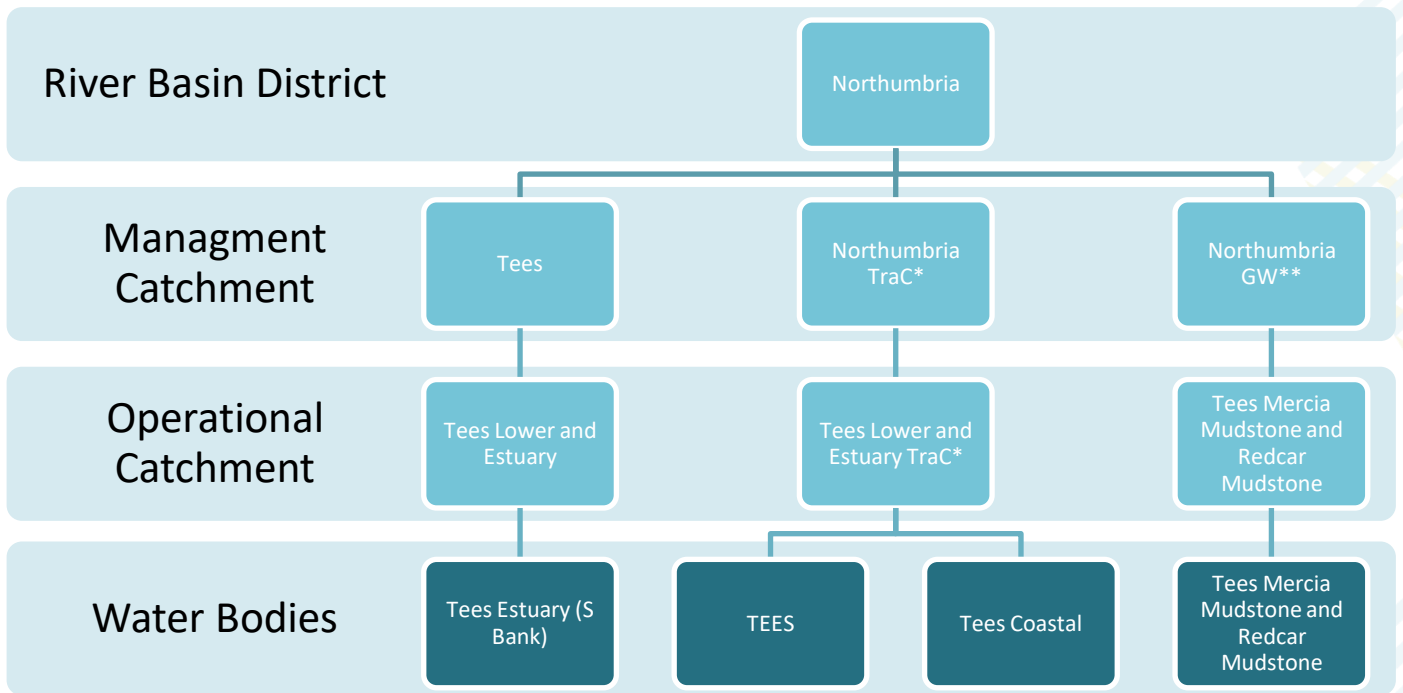
Figure 1-1: WFD water bodies relevant to this study

as well as the area of the site which, although doesn't fall within a WFD water body, is within the RBMP district:

*Transitional water body (Coastal) ** Groundwater

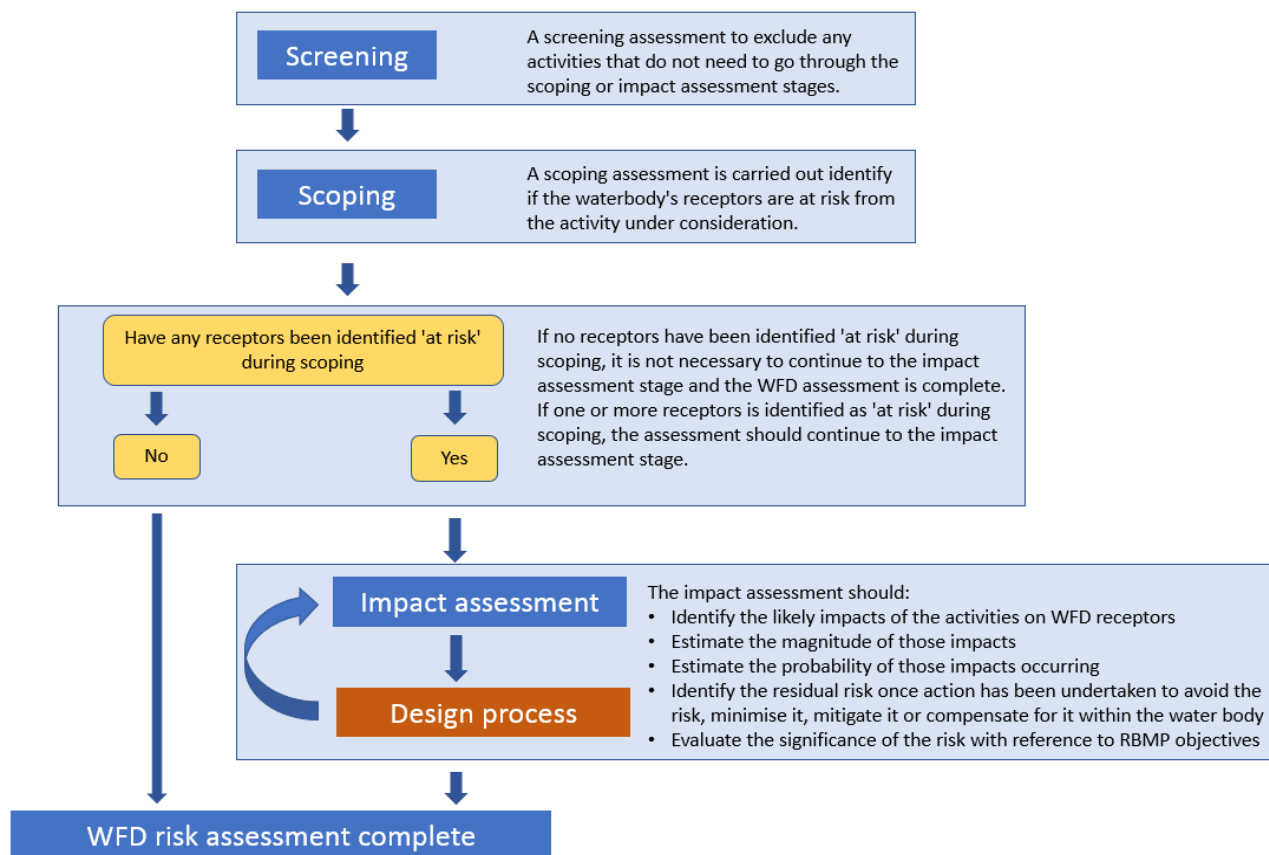
Figure 2-1: WFD assessment process flow chart

The following flow chart summarises the WFD Assessment process.

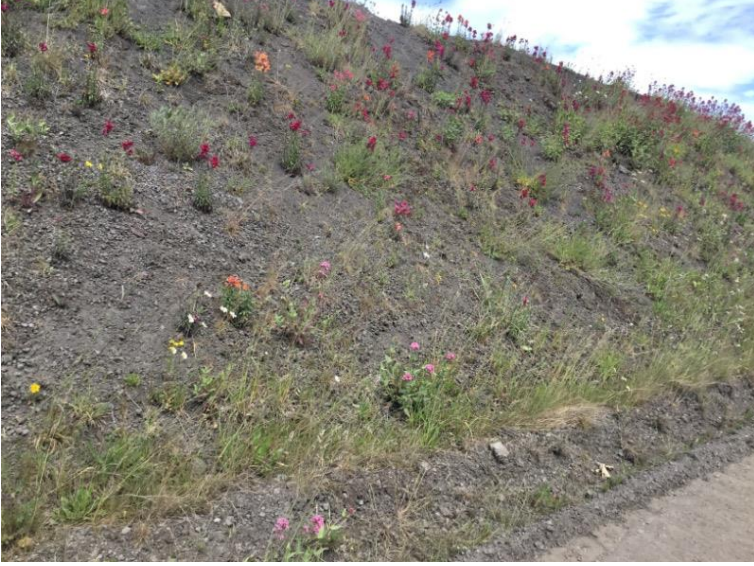
Target Note Number	Description	Photograph
1	Bank of Snapdragon on earthworks, evidence of soil importation.

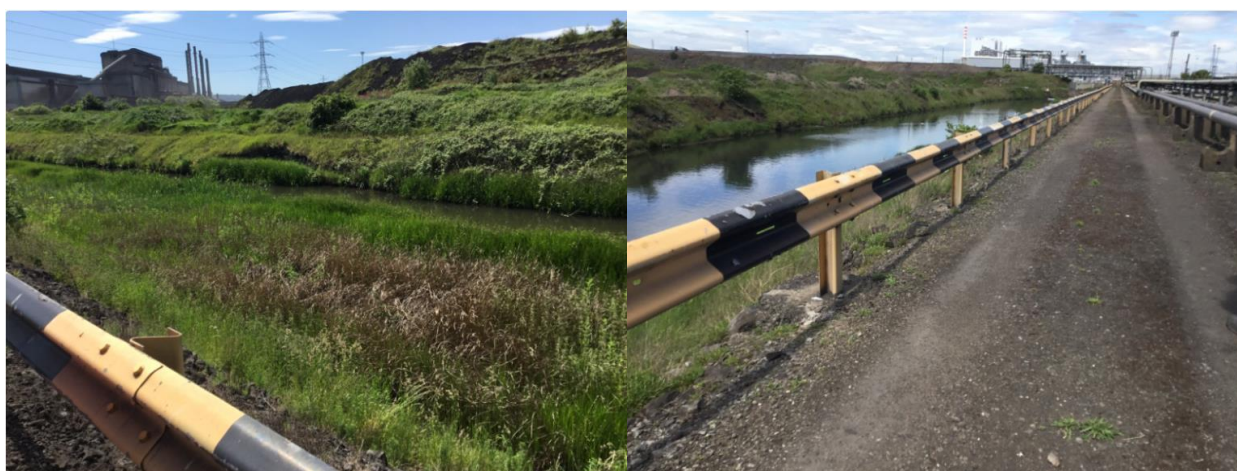
Figure B-3: The Lackenby Channel (Left) looking upstream along the Lackenby Channel, (Right) further downstream both taken from the right bank.

In the Lackenby Channel downstream of the confluence with the Cleveland channel there is an in-channel structure assumed to act as a tidal weir located at NZ 54929 22656.

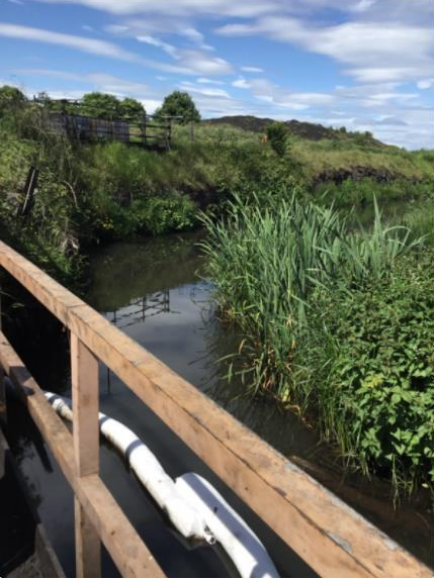
Geomorphology feature	Photograph
<p>1 At this upstream location on the Lackenby channel, looking upstream.</p> <p>The banks are well vegetated with riparian habitat and the channel profile is largely trapezoidal with a straightened planform.</p> <p>Slumping of the banks can be seen along the right bank and reedbed developing on the left bank.</p> <p>There was no indication of high flows or floods, this could have been hidden by vegetation as it had not rained for at least two weeks. No indications of dredging but the site is continually being developed and earth works are moved around the site frequently.</p>

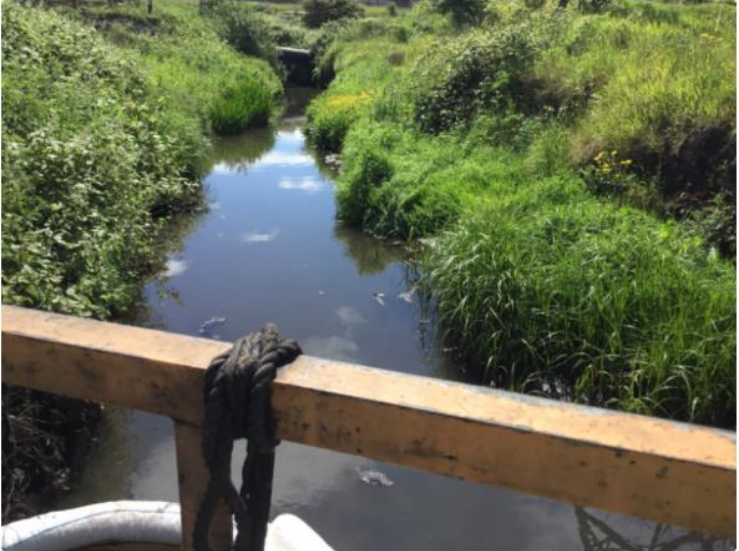
<p>1 Same location as above but looking downstream.</p> <p>The banks are terraced with some slumping features and are well vegetated.</p> <p>Although terraced on the banks, the channel profile is largely trapezoidal with a straightened planform. The slumping banks showed signs of geomorphological recovery as the channel pulls in the banks to readjust the profile, if left to recover it is likely to narrow the channel, increase sinuosity, flow diversity and raise the bed.</p>

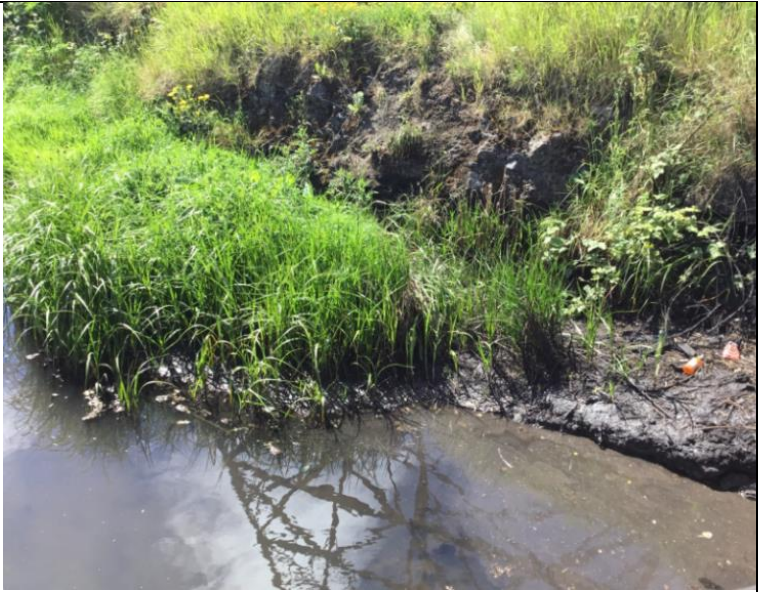
1 Photograph taken looking upstream.
Evidence of banks slumping and depositional areas of mud in the downstream slack areas.

Appears to be developing a reedbed.

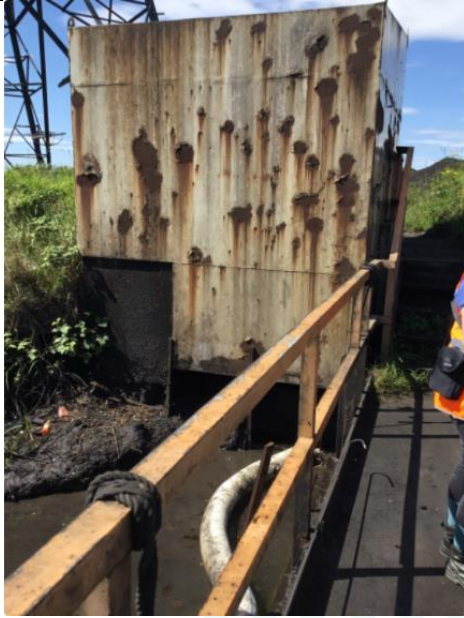
1 Structure is to be removed. Unsure about whether the foot bridge will be removed too.

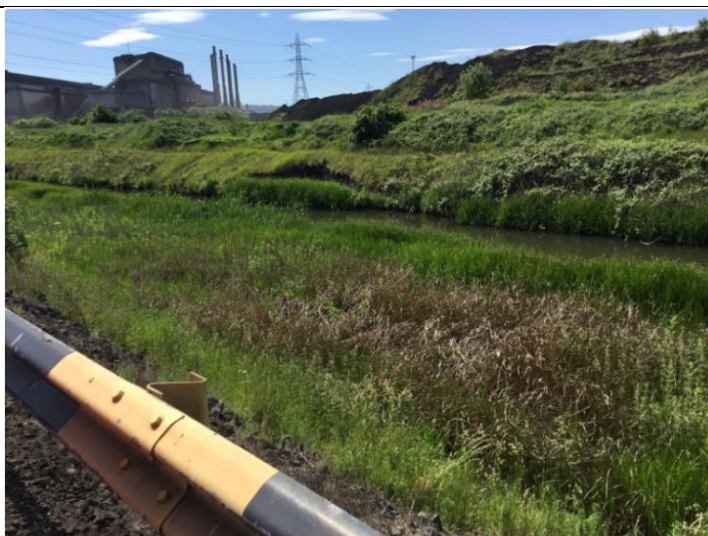
2 Looking upstream.

At 100m downstream of (1) the valley is widened with extensive reedbed and riparian vegetation. The channel is confined within its immediate channel. Could be opportunity to increase sinuosity within this valley. Large woody debris (LWD) could achieve this without the need for interventions with diggers.

Banks are slumping and should be encouraged to recover naturally with these geomorphological processes. LWD in strategic locations can maximise the natural recovery in this reach.

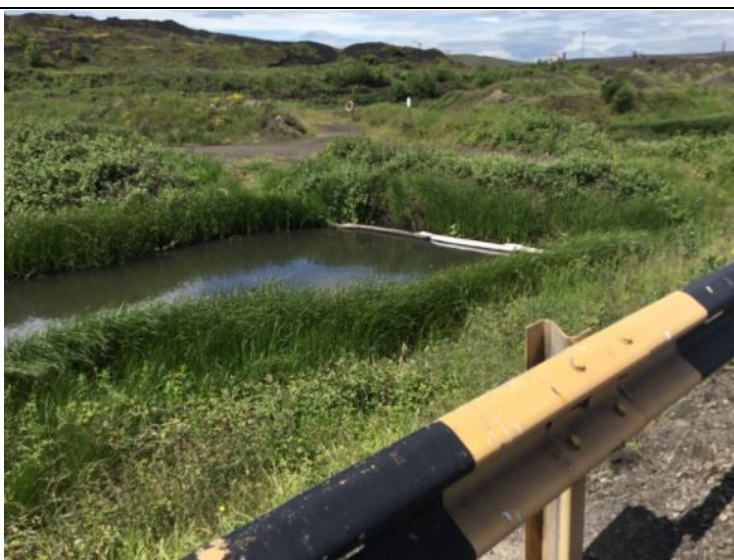
2 Looking downstream.

A vehicular bridge spans this section. If required to maintain access, would recommend over-spanning the bridge to allow natural recovery and avoid expensive hard engineering and maintenance to protect this feature.

The water is not clear and is a muddy brown colour. There is evidence of invertebrates and birds in the water.

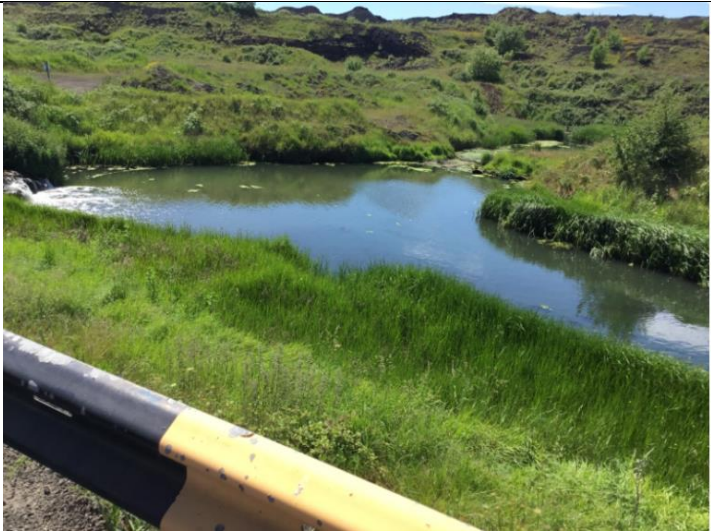
3 Looking upstream from right bank at confluence with Cleveland channel.
 There is an algal bloom present with a blue/green tinge to the water and algal scum on the surface.

Reedbeds are developing on the right bank.

There is a weir or raised structure on the Lackenby channel. Opportunity to remove or build fish passage.

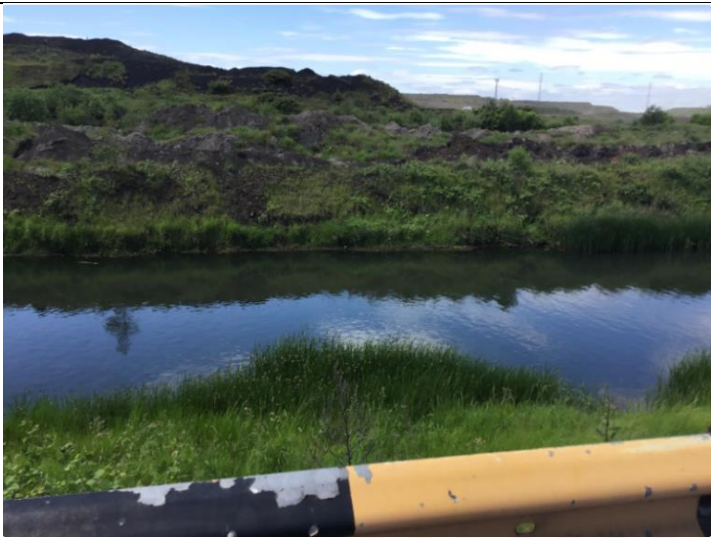
4 Looking across Lackenby from right bank.
 Vegetation is sparse in this reach, potentially evidence of recent earth works or contamination preventing growth?

Reedbed developing on right bank.

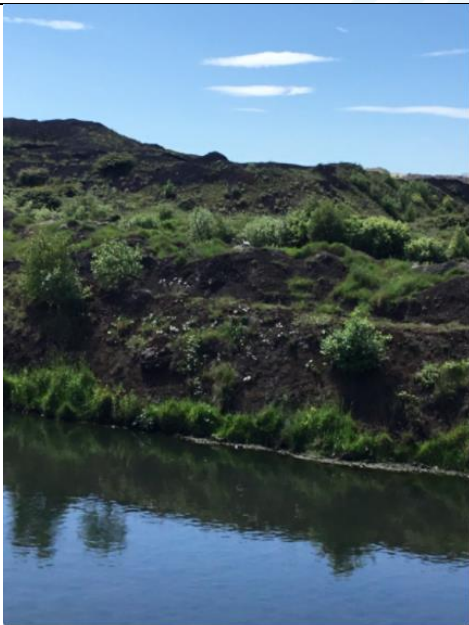
5 Looking across Lackenby from right bank.
 Vegetation is sparse in this reach, potentially evidence of recent earth works or contamination preventing growth?

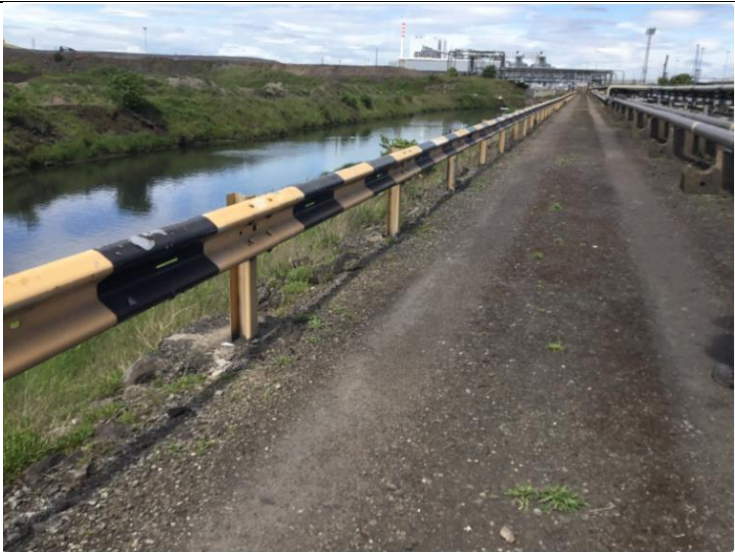
5 Looking downstream on Lackenby from right bank.

This reach has lost the developing recovery seen upstream and is straighter, over wide and trapezoidal, much like a canal.

Opportunities to improve this reach by narrowing the channel, encouraging reedbed growth, installing LWD for flow diversity and to encourage geomorphological processes.

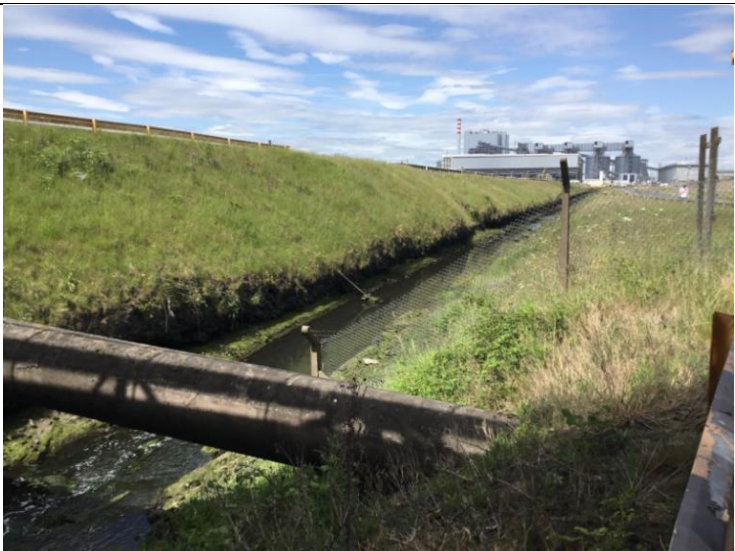
6 Looking downstream on Lackenby from right bank. This reach is outside red boundary towards Tees Port.

This reach is heavily modified with built up protective grassed banks. Banks are becoming undermined and undercut.

Asset to be aware of, pipe crossing the Lackenby channel.

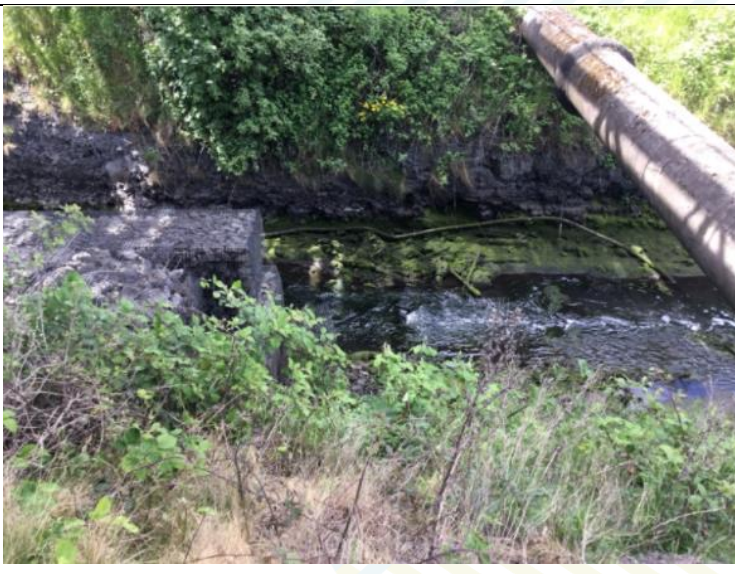
6 Looking across Lackenby from right bank. This reach is outside red boundary towards Tees Port.

Gabion baskets have been installed for increased protection, probably reactionary as the area is becoming undermined.

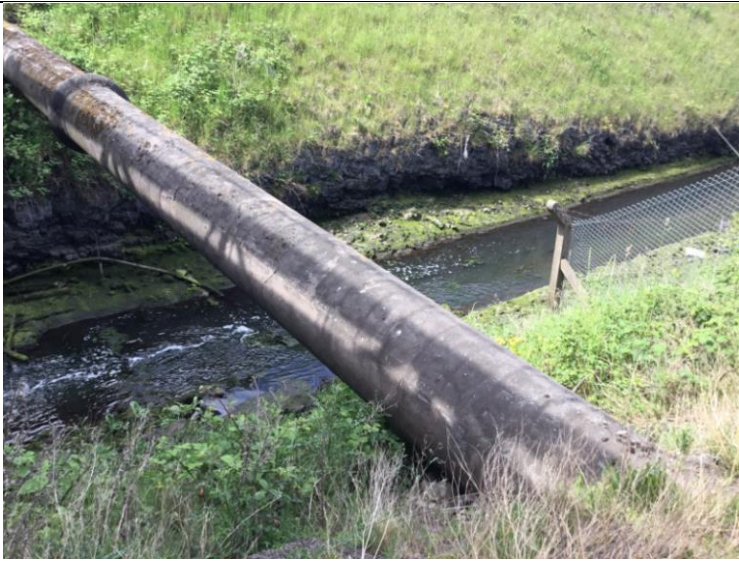
6 Looking downstream on Lackenby from right bank. This reach is outside red boundary towards Tees Port.
Closer look at the pipe asset to be considered and undercutting of protective grassed banks on left bank.

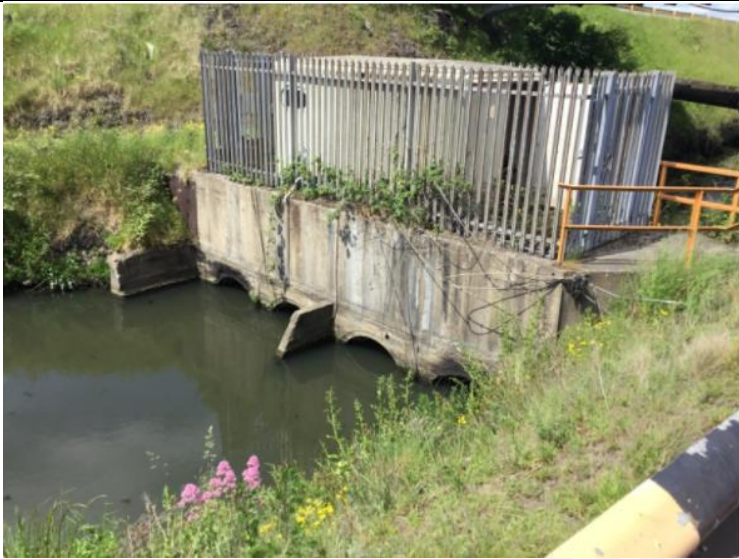
8 Looking downstream on Lackenby channel at potential flow/tidal control structure

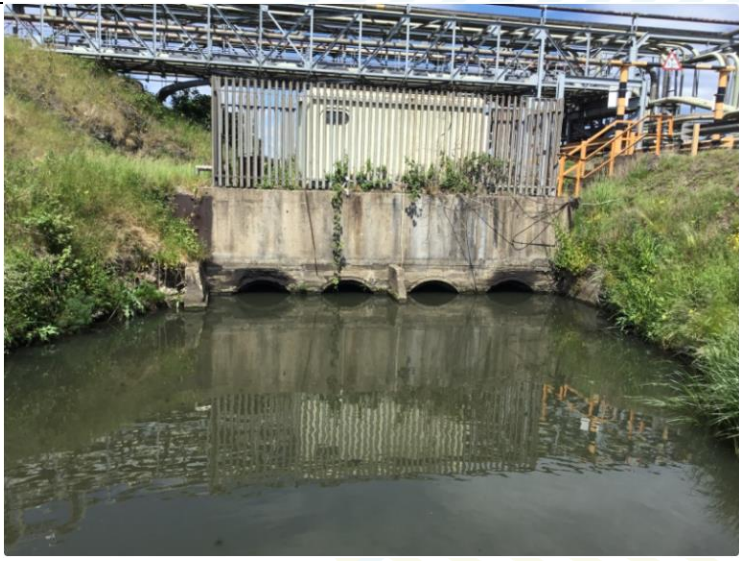
8 Looking downstream on Lackenby channel at potential flow/tidal control structure

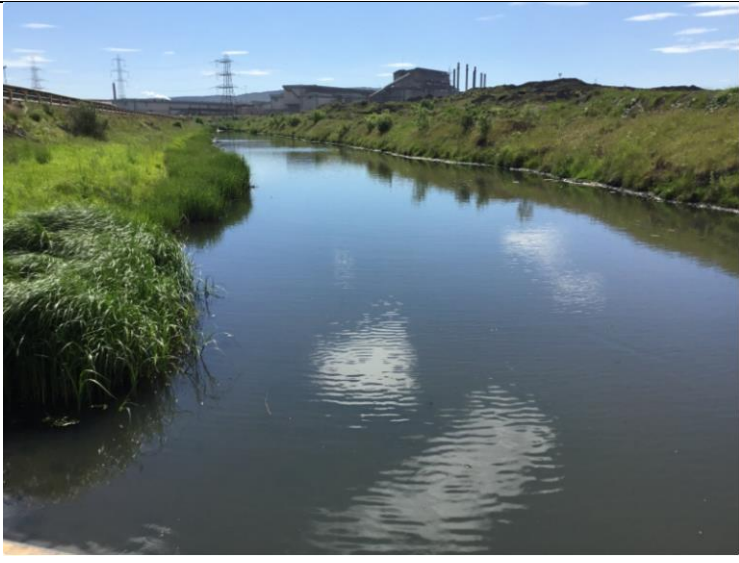
8 Looking upstream on Cleveland channel from footbridge on Lackenby channel.
Reach is over wide and terraced.
Reedbeds are developing on the right bank.

The water appears clearer upstream.

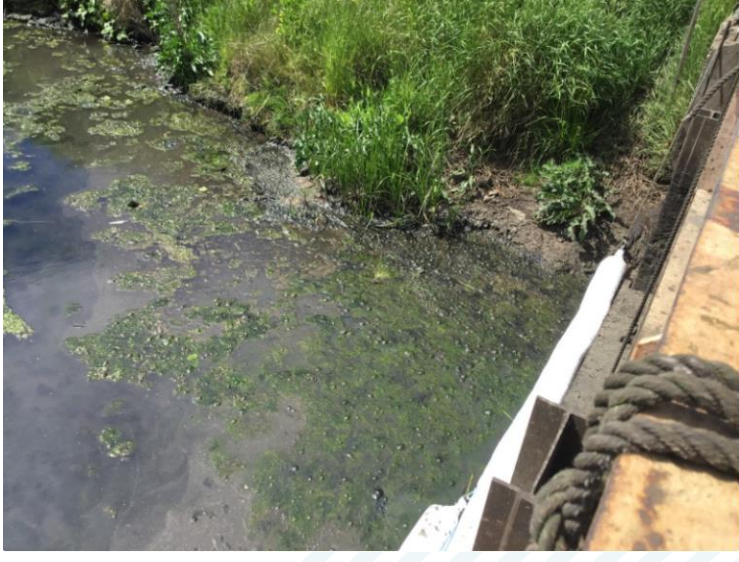
8 Looking at left bank of Cleveland channel from footbridge on Lackenby channel.

Algal scum and maybe other pollutants caught in this slack area. Deposition of mud also visible.

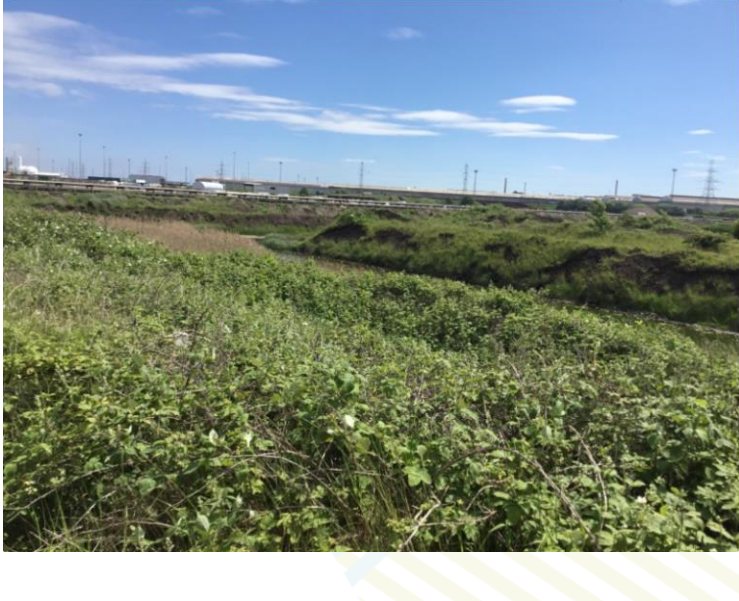
9 Looking downstream Cleveland channel from left bank.

The valley is wide in this reach and has succeeded by reedbeds with a confined channel/thalweg on the right bank.

Another opportunity is to diversity the flow and encourage erosion into reedbeds to create multi-thread channel and increase the ability of the reedbed to cleanse the watercourse.

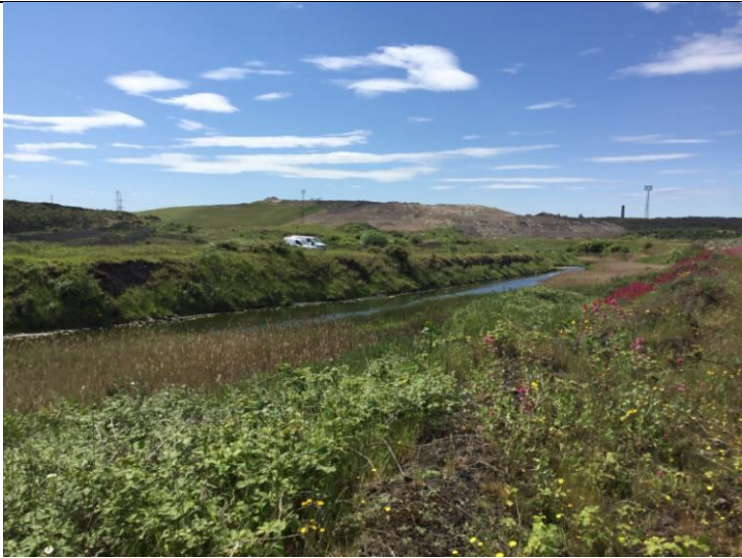
9 Looking upstream Cleveland channel from left bank.
Walking upstream the watercourse and riparian habitat becomes more biodiverse.

Evidence of banks slumping in and opportunity to enhance geomorphological processes and increase sinuosity.

Watercourse confined to thalweg.

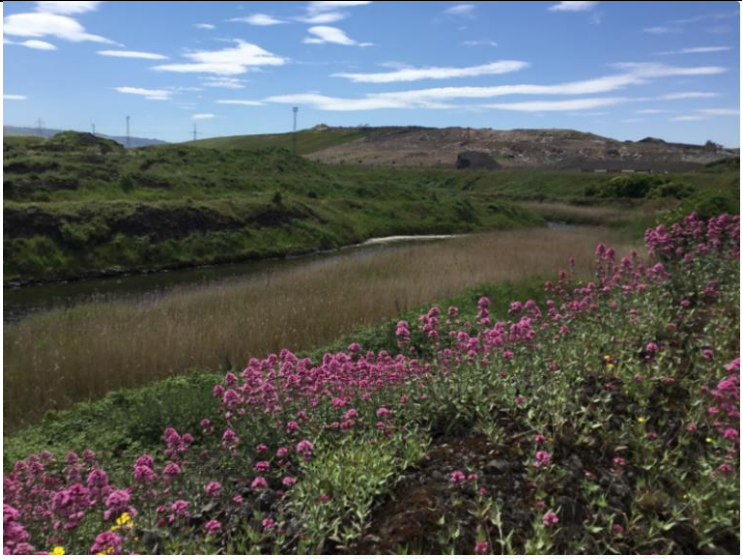
10 Looking upstream Cleveland channel from left bank.
This reach is highly biodiverse with extensive reedbeds and bank slumping.

Watercourse confined to thalweg.

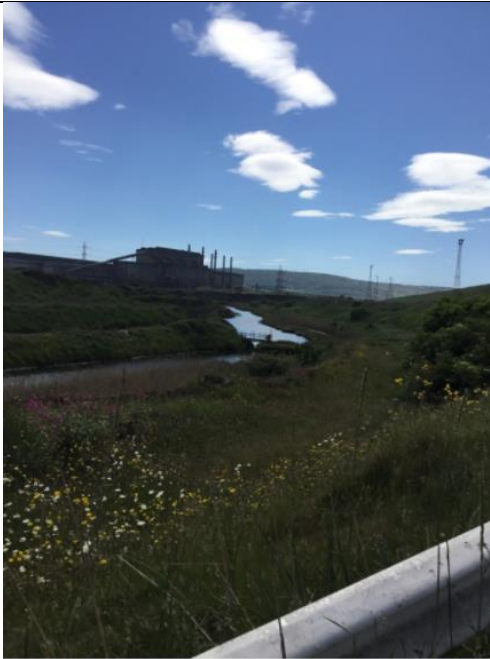
11 Looking upstream Cleveland channel from left bank.

High biodiversity upstream and extensive reedbed.

Watercourse confined to thalweg and straightened planform. Some minor evidence of watercourse attempting to draw in banks and increase sinuosity

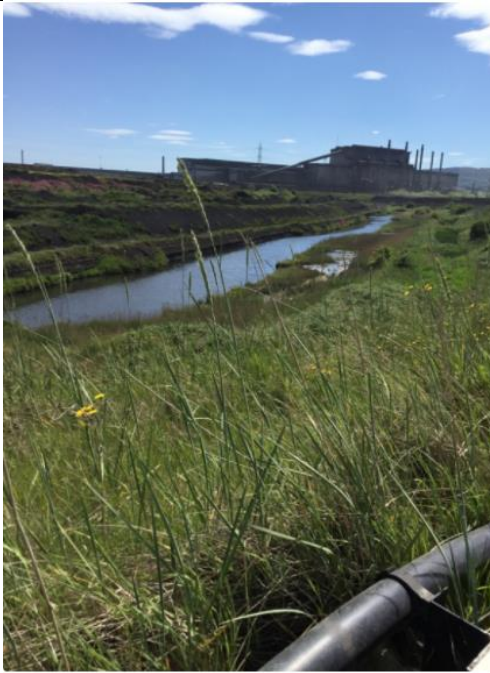
12 Looking upstream Cleveland channel from left bank.

High biodiversity upstream and extensive reedbed.

This was the furthest upstream available to survey due to hazardous dust from site development in the area.
