THE FORMER SSI STEELWORKS, REDCAR: PRIORITY AREAS WITHIN SSI LANDHOLDINGS CONTRACT 1 AND 2A

Contract 1 and 2A Site Condition Report

South Tees Site Company Limited

REPORT NO. Redcar Steelworks-AUK-XX-XX-RP-GE-0001-02-SSI1_SSI2A_GI_SCR

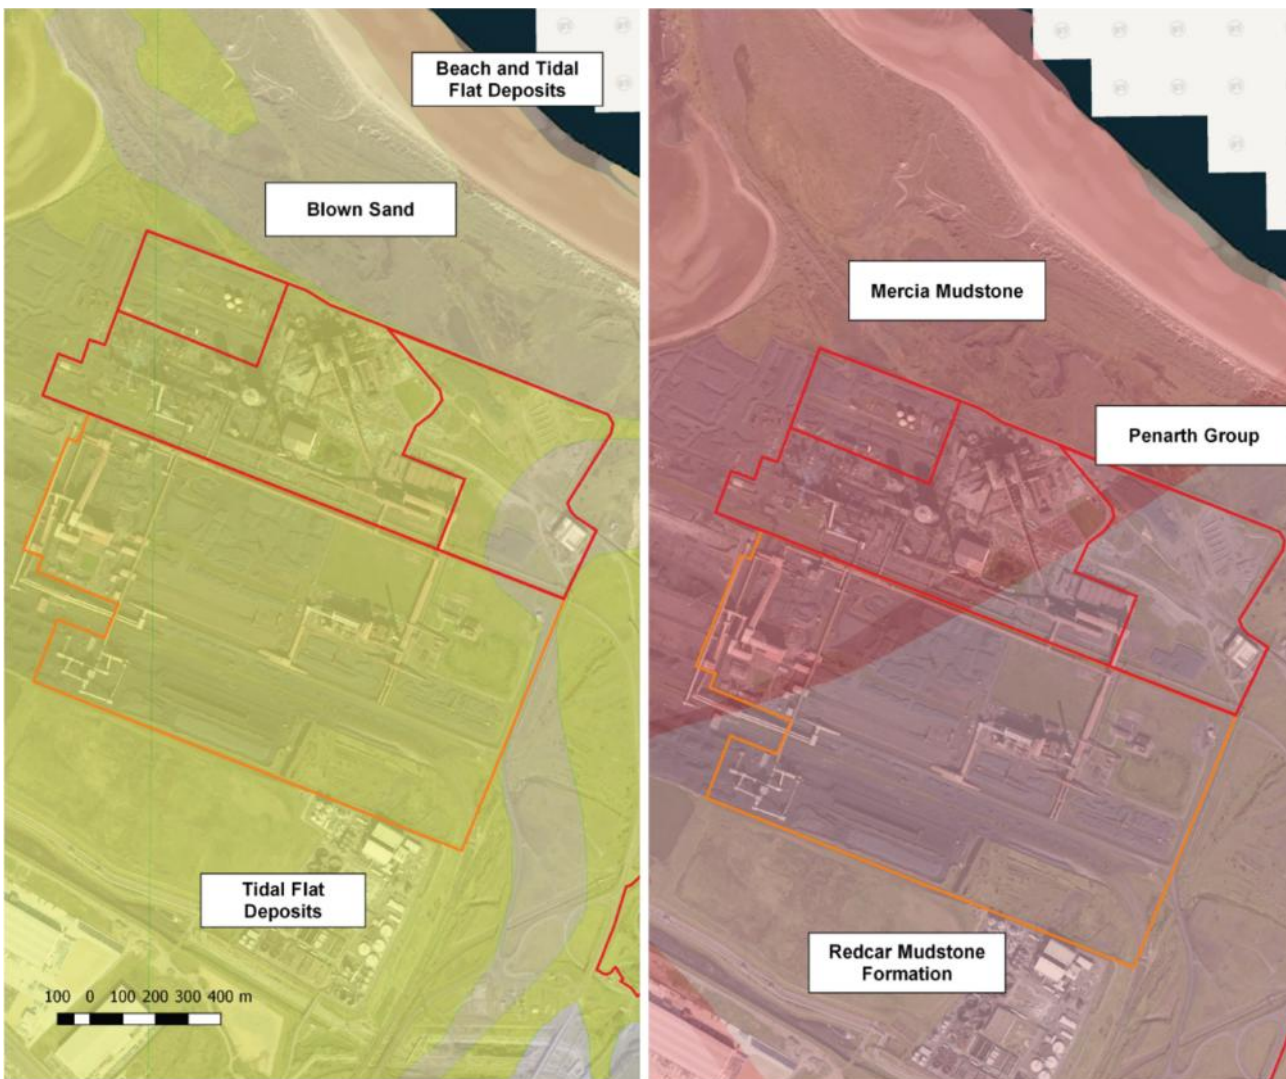
Figure 2: Extracts from BGS Mapping

The desk study suggests that bedrock is dipping approximately 14 degrees to the north-northwest. However, it is considered more likely that the bedrock is dipping to the east, possibly with a northerly component.

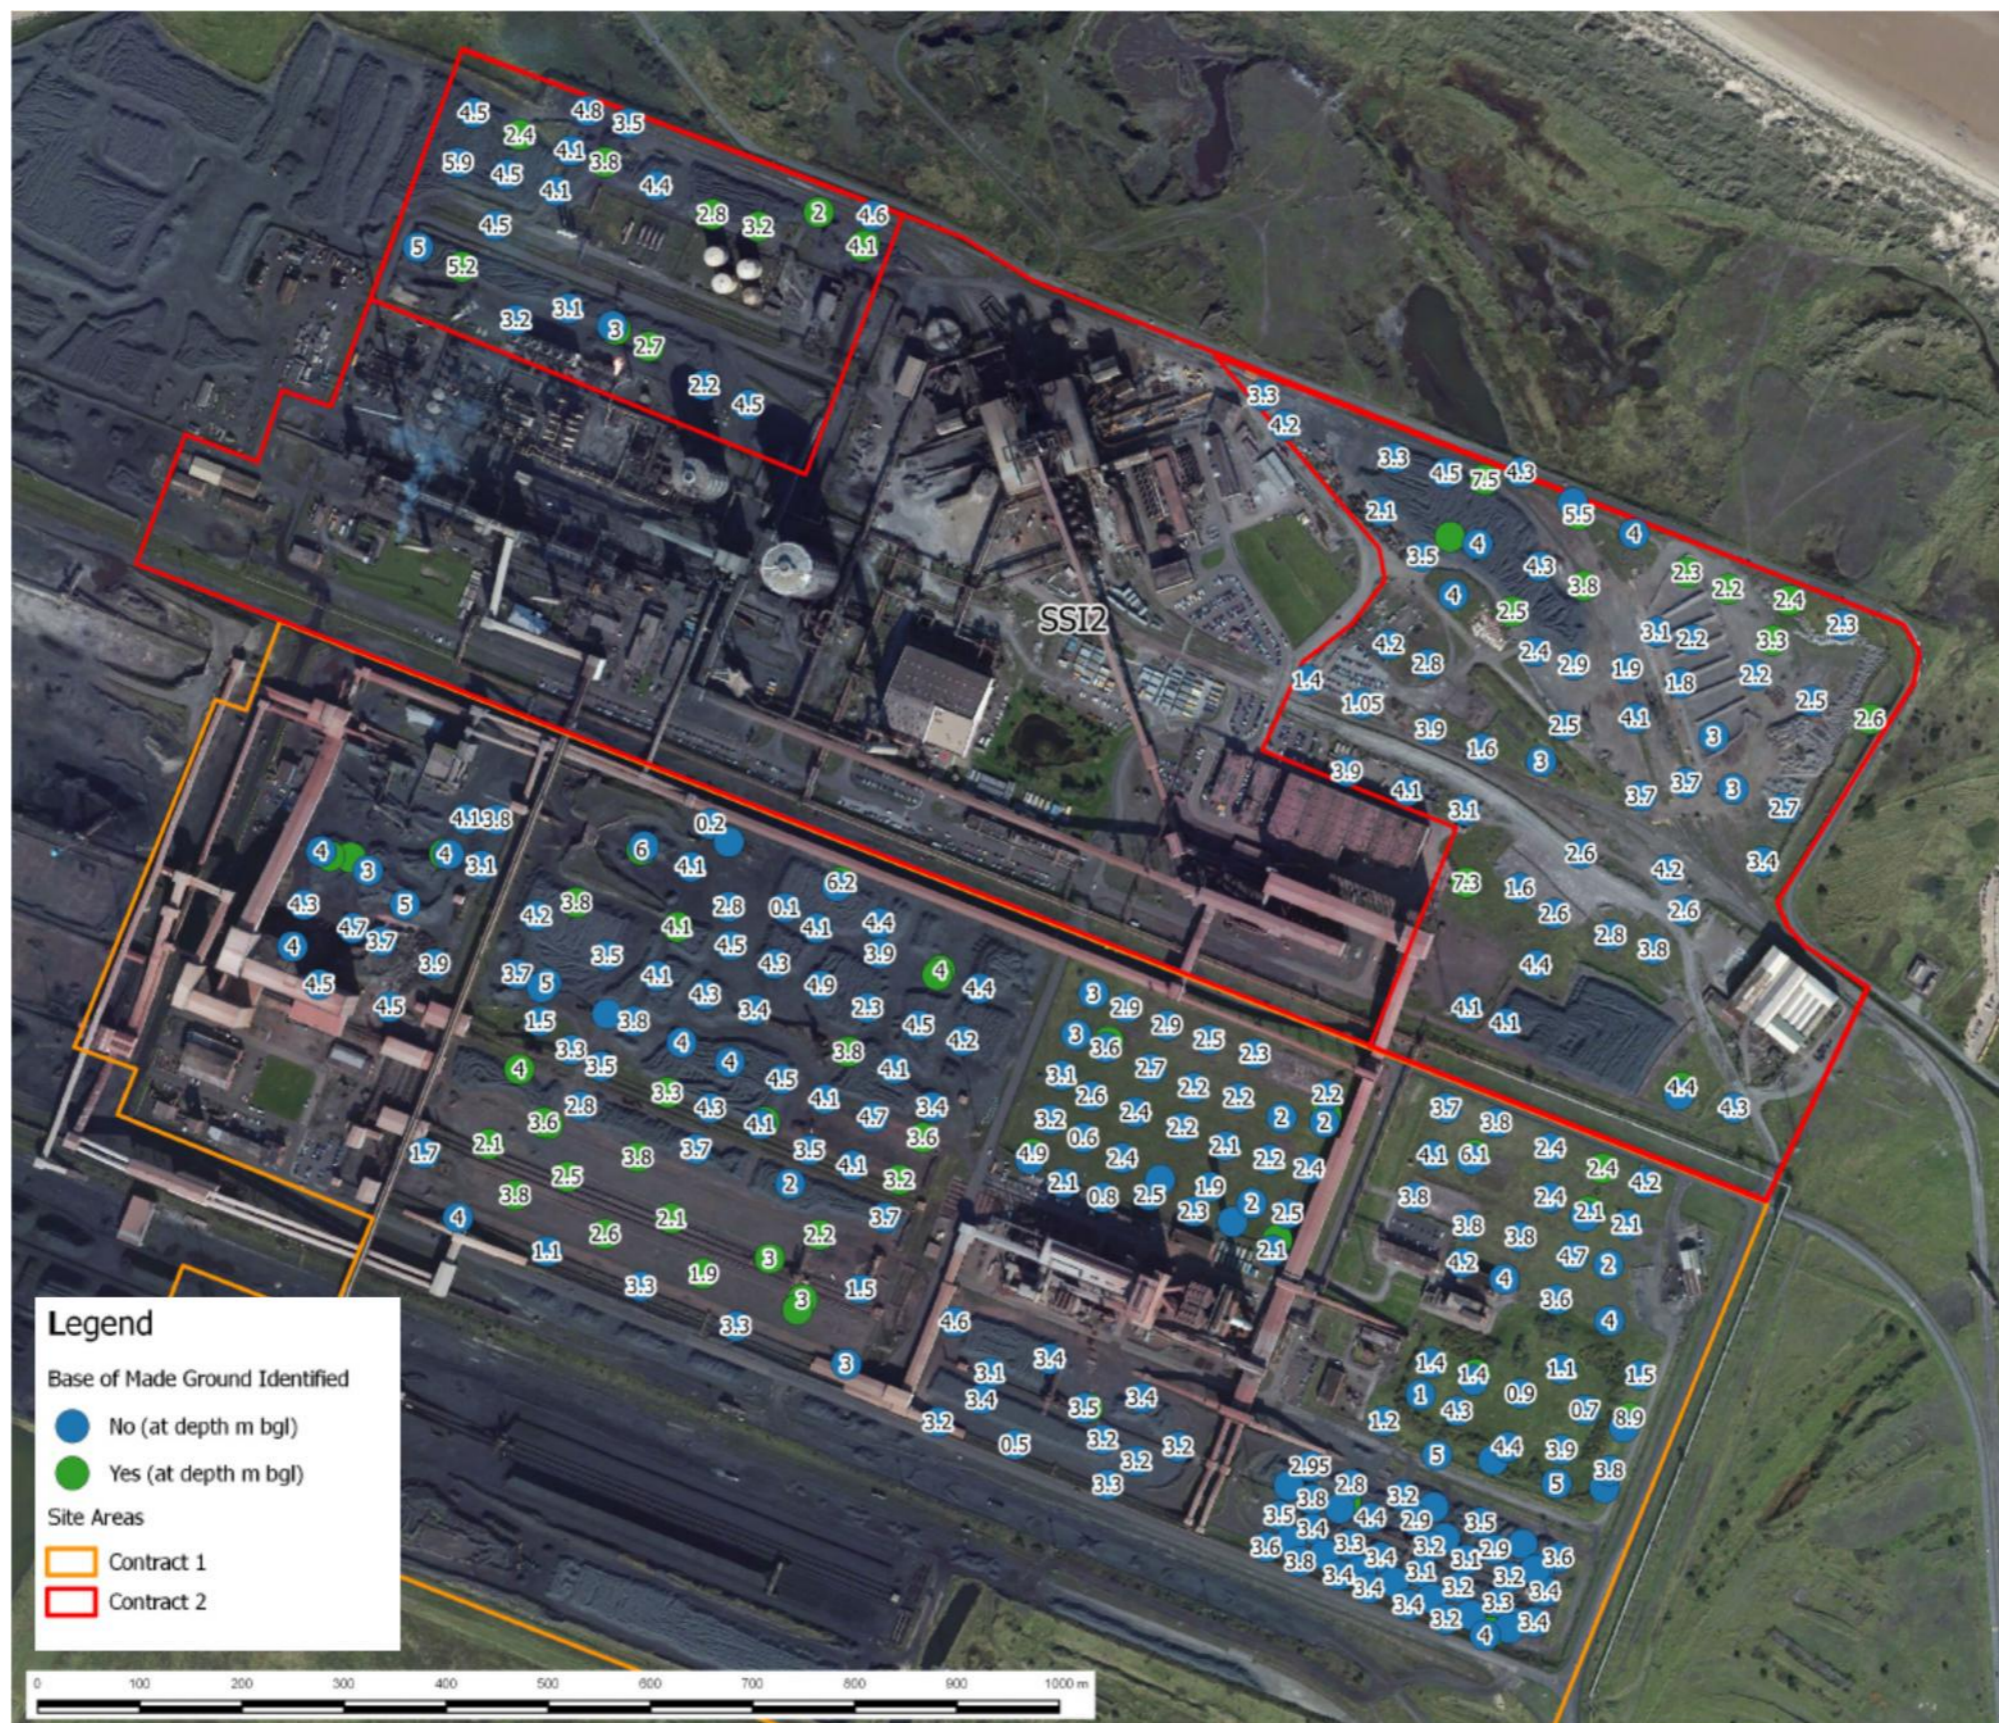
SSI3A Figure 3 – Depth of Made Ground Encountered

Made Ground was encountered in all intrusive locations and proven to a thickness of at least 8.9m. The base of the Made Ground was not proven in the majority of the CH2M and AEG trial pits, therefore, greater thickness of material may exist across the site. These findings are broadly in line with previous investigations which identified a maximum thickness of 9m of Made Ground (BH17BB1 Enviro 2004).

A figure showing the distribution of the thickness of Made Ground is presented as Figure 3 below and in Appendix C, this illustrates that the greatest depths of Made Ground were identified in the east of the site around the SSI2A Redcar Coke Ovens Area and around section F and the northern half of section E of SSI1. This is broadly consistent with areas previously part of the Tees Estuary, recorded Made Ground thicknesses were slightly shallower in the south of Area E potentially due to the difficulties differentiating between hydraulic fill and natural deposits.

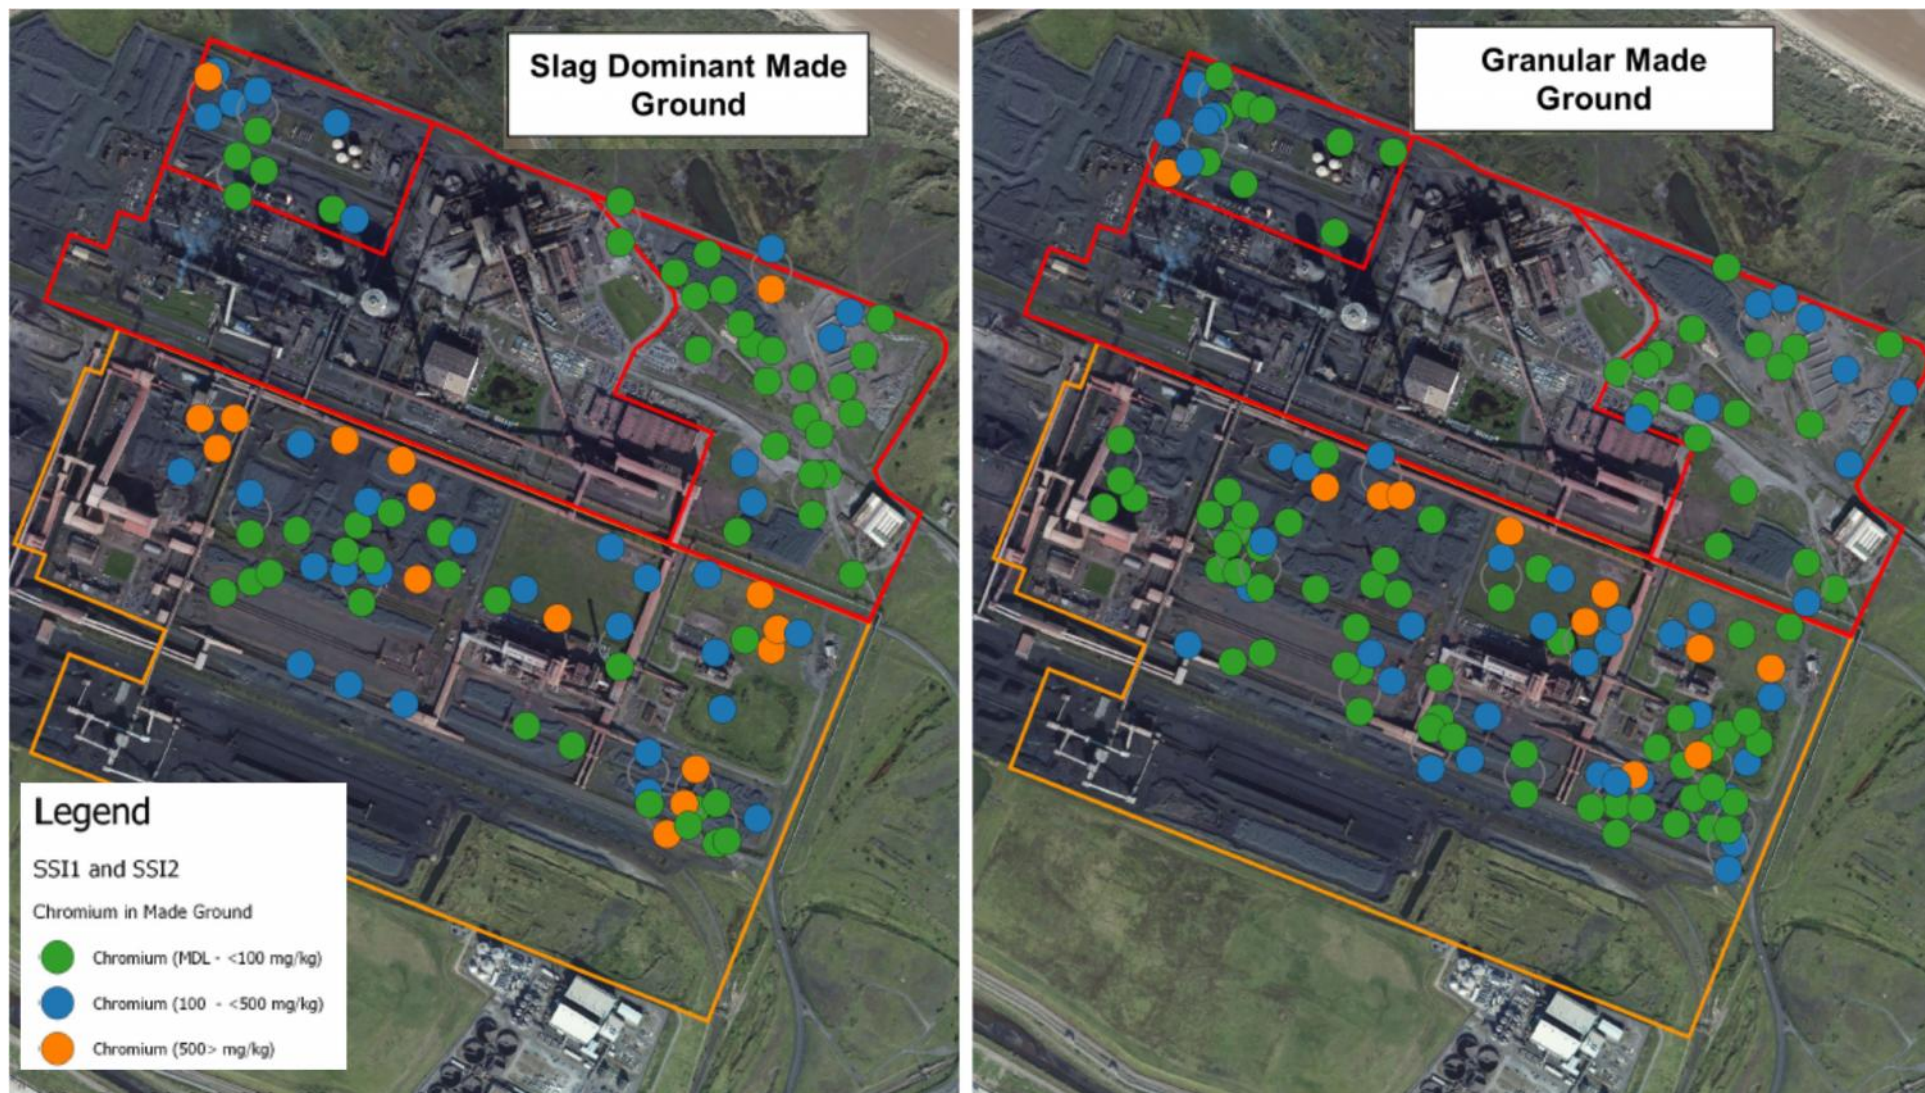
Figure 10: Chromium in Made Ground

Statistical analysis showed that the highest average (mean) metal concentrations were identified in the slag dominant materials, particularly for copper, chromium, iron, and vanadium, however the copper result is affected by a hotspot in one trial pit and is consistent if this is removed. Nickel was noted to be higher in granular made ground than slag. A distribution plot for chromium is presented as Figure 10 below and in Appendix C; further plots for lead, and vanadium are presented as Figures 11 and 12 in Appendix C.

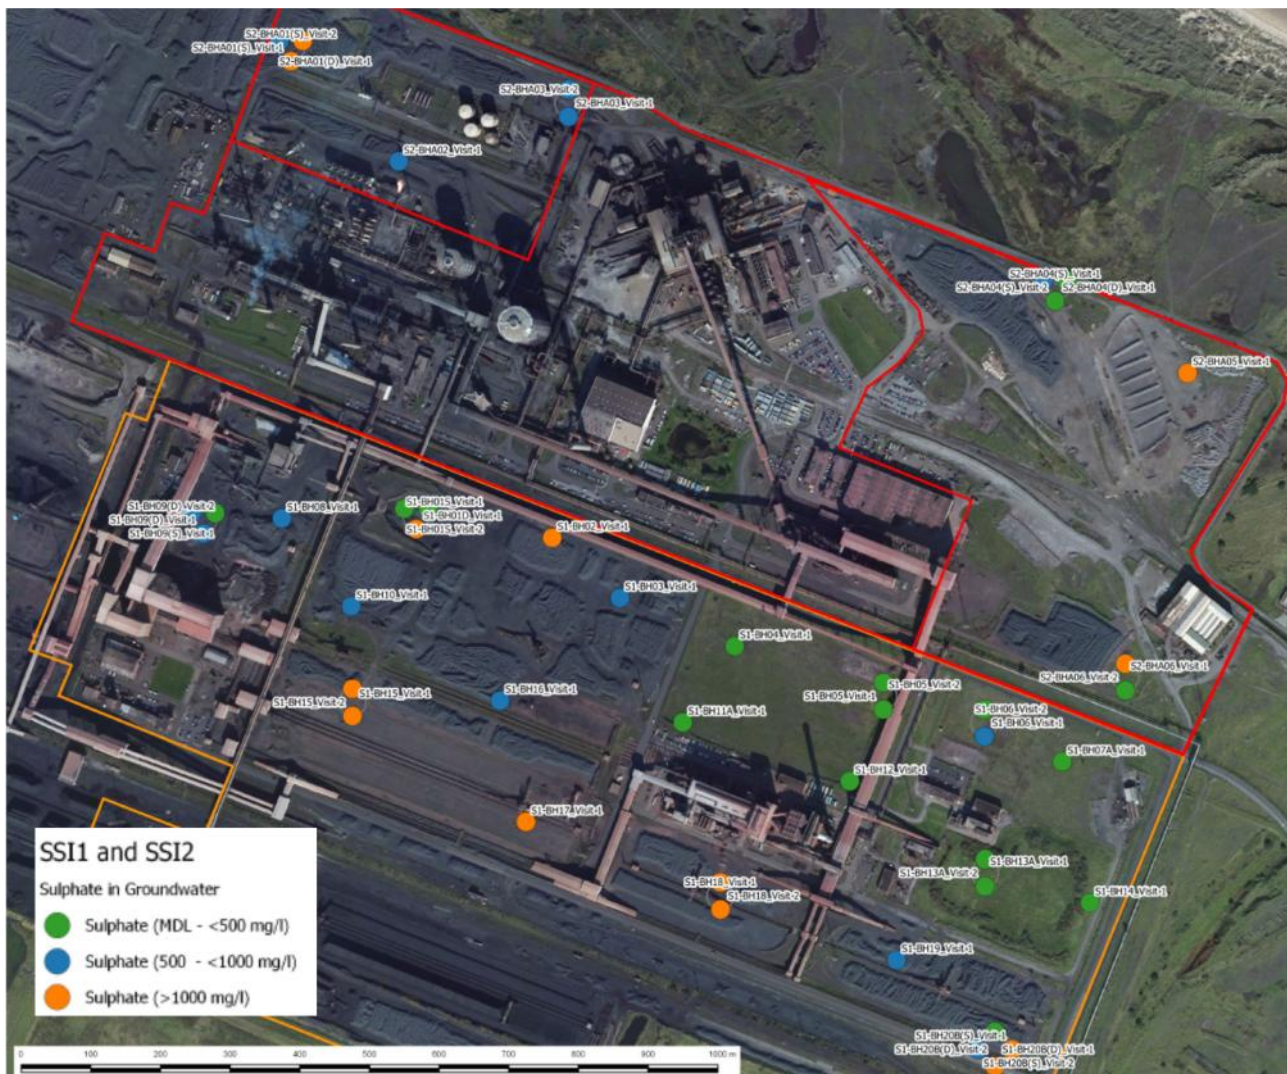
Figure 14: Sulphate in Groundwater

Levels of sulphate were measured above the MDL in all wells during both visits and were noted to range over two orders of magnitude, chloride was detected over a similar range of concentrations but less frequently in approximately 75% of samples. Elevated cyanide was noted in S2-BHA01, and S2-BHA04, the cyanide was primarily complexed. Groundwater pH ranged between neutral (7.5) and strongly alkaline (12.4). A plan showing the distribution of sulphate in groundwater is shown as Figure 14 below and in Appendix C.

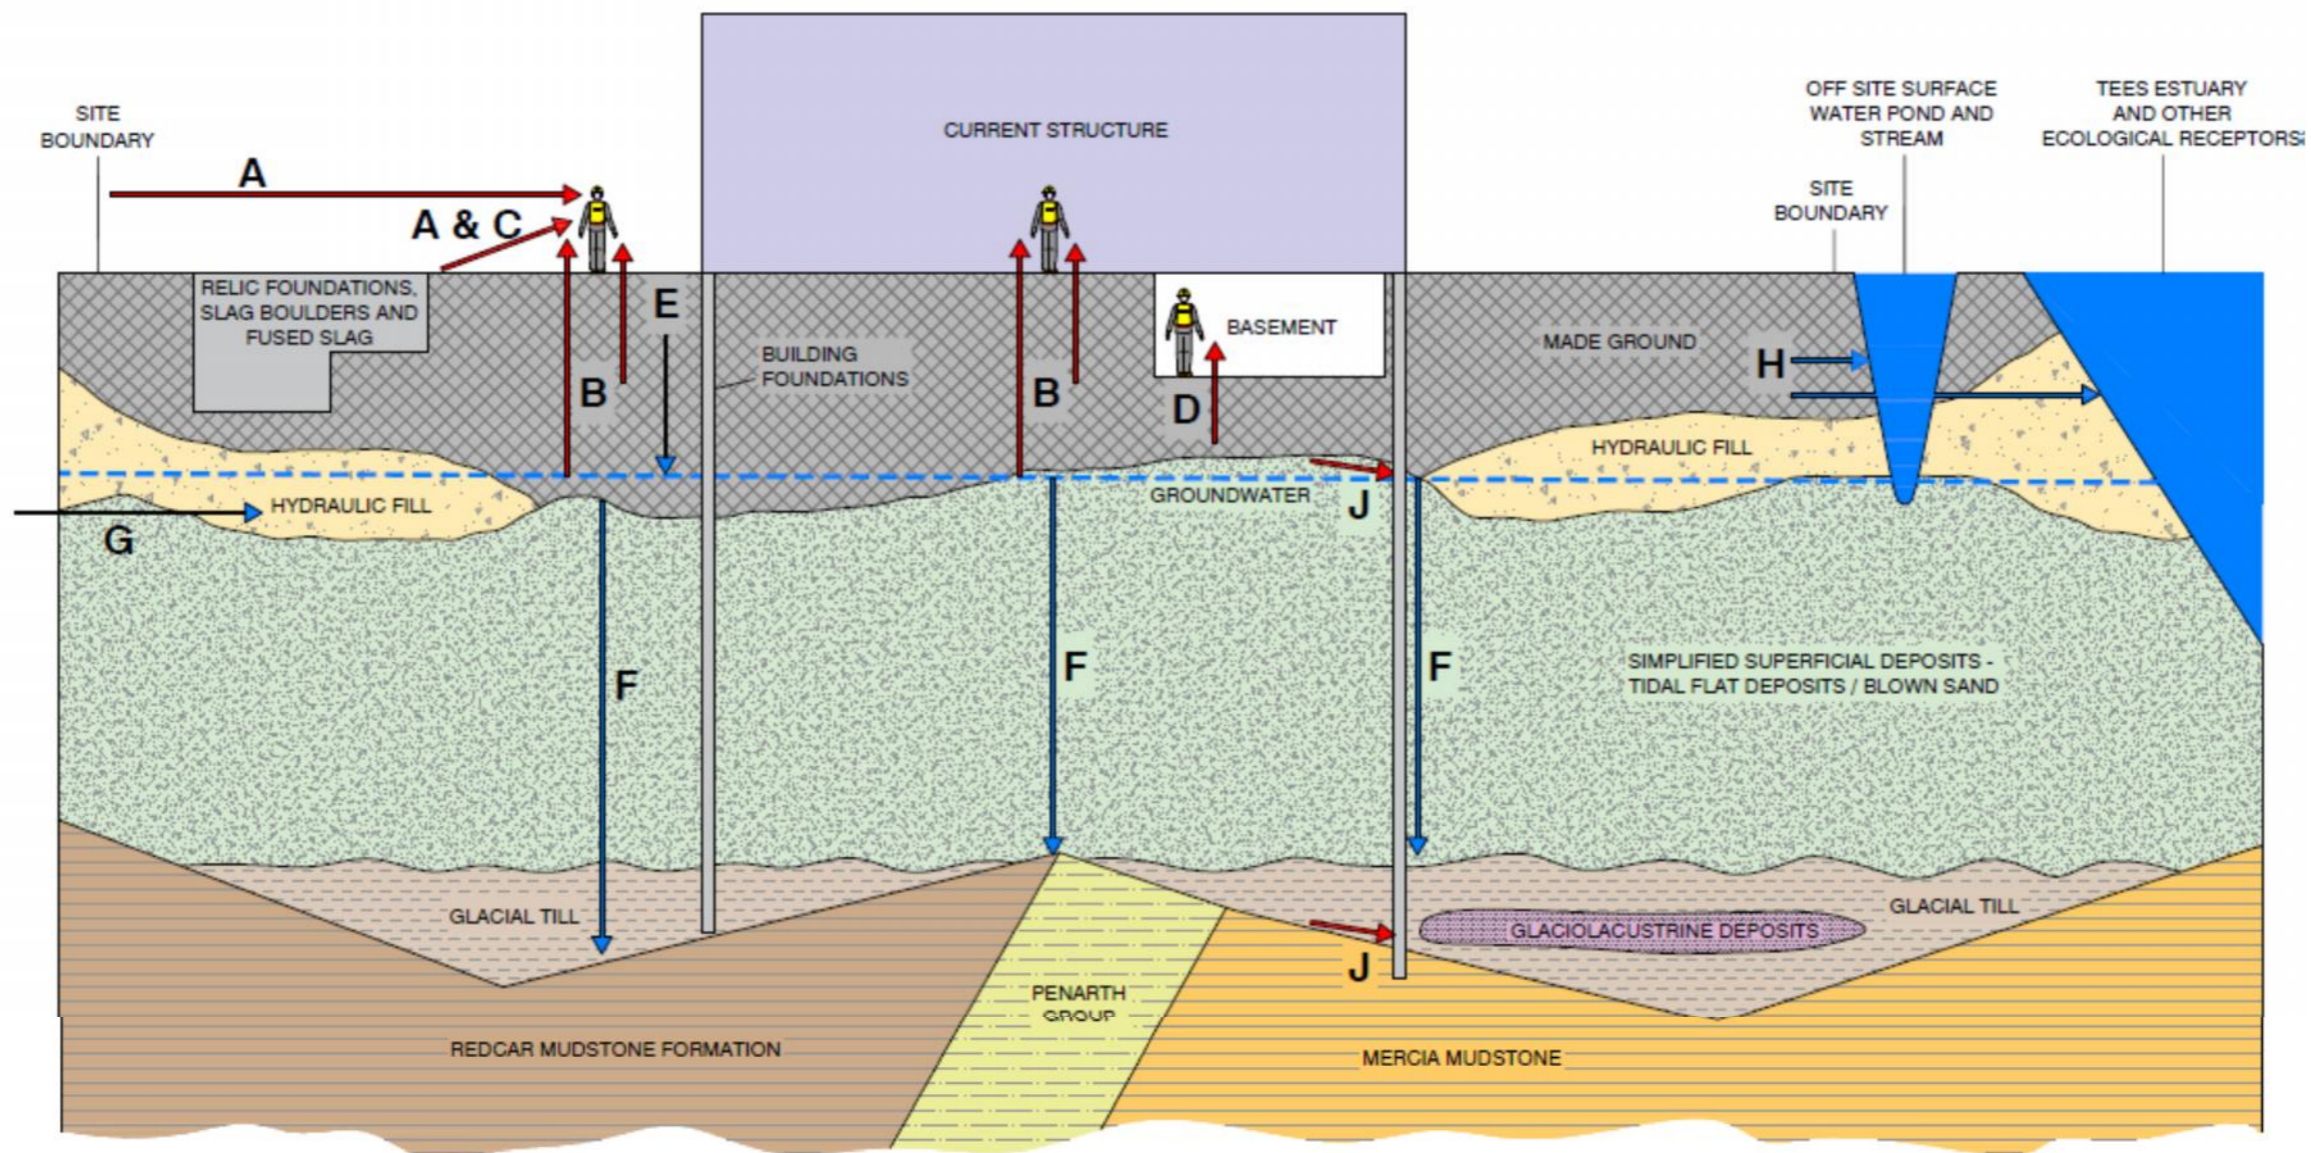
Figure 8: CSM

- J = Attack by contaminants of concern on foundations

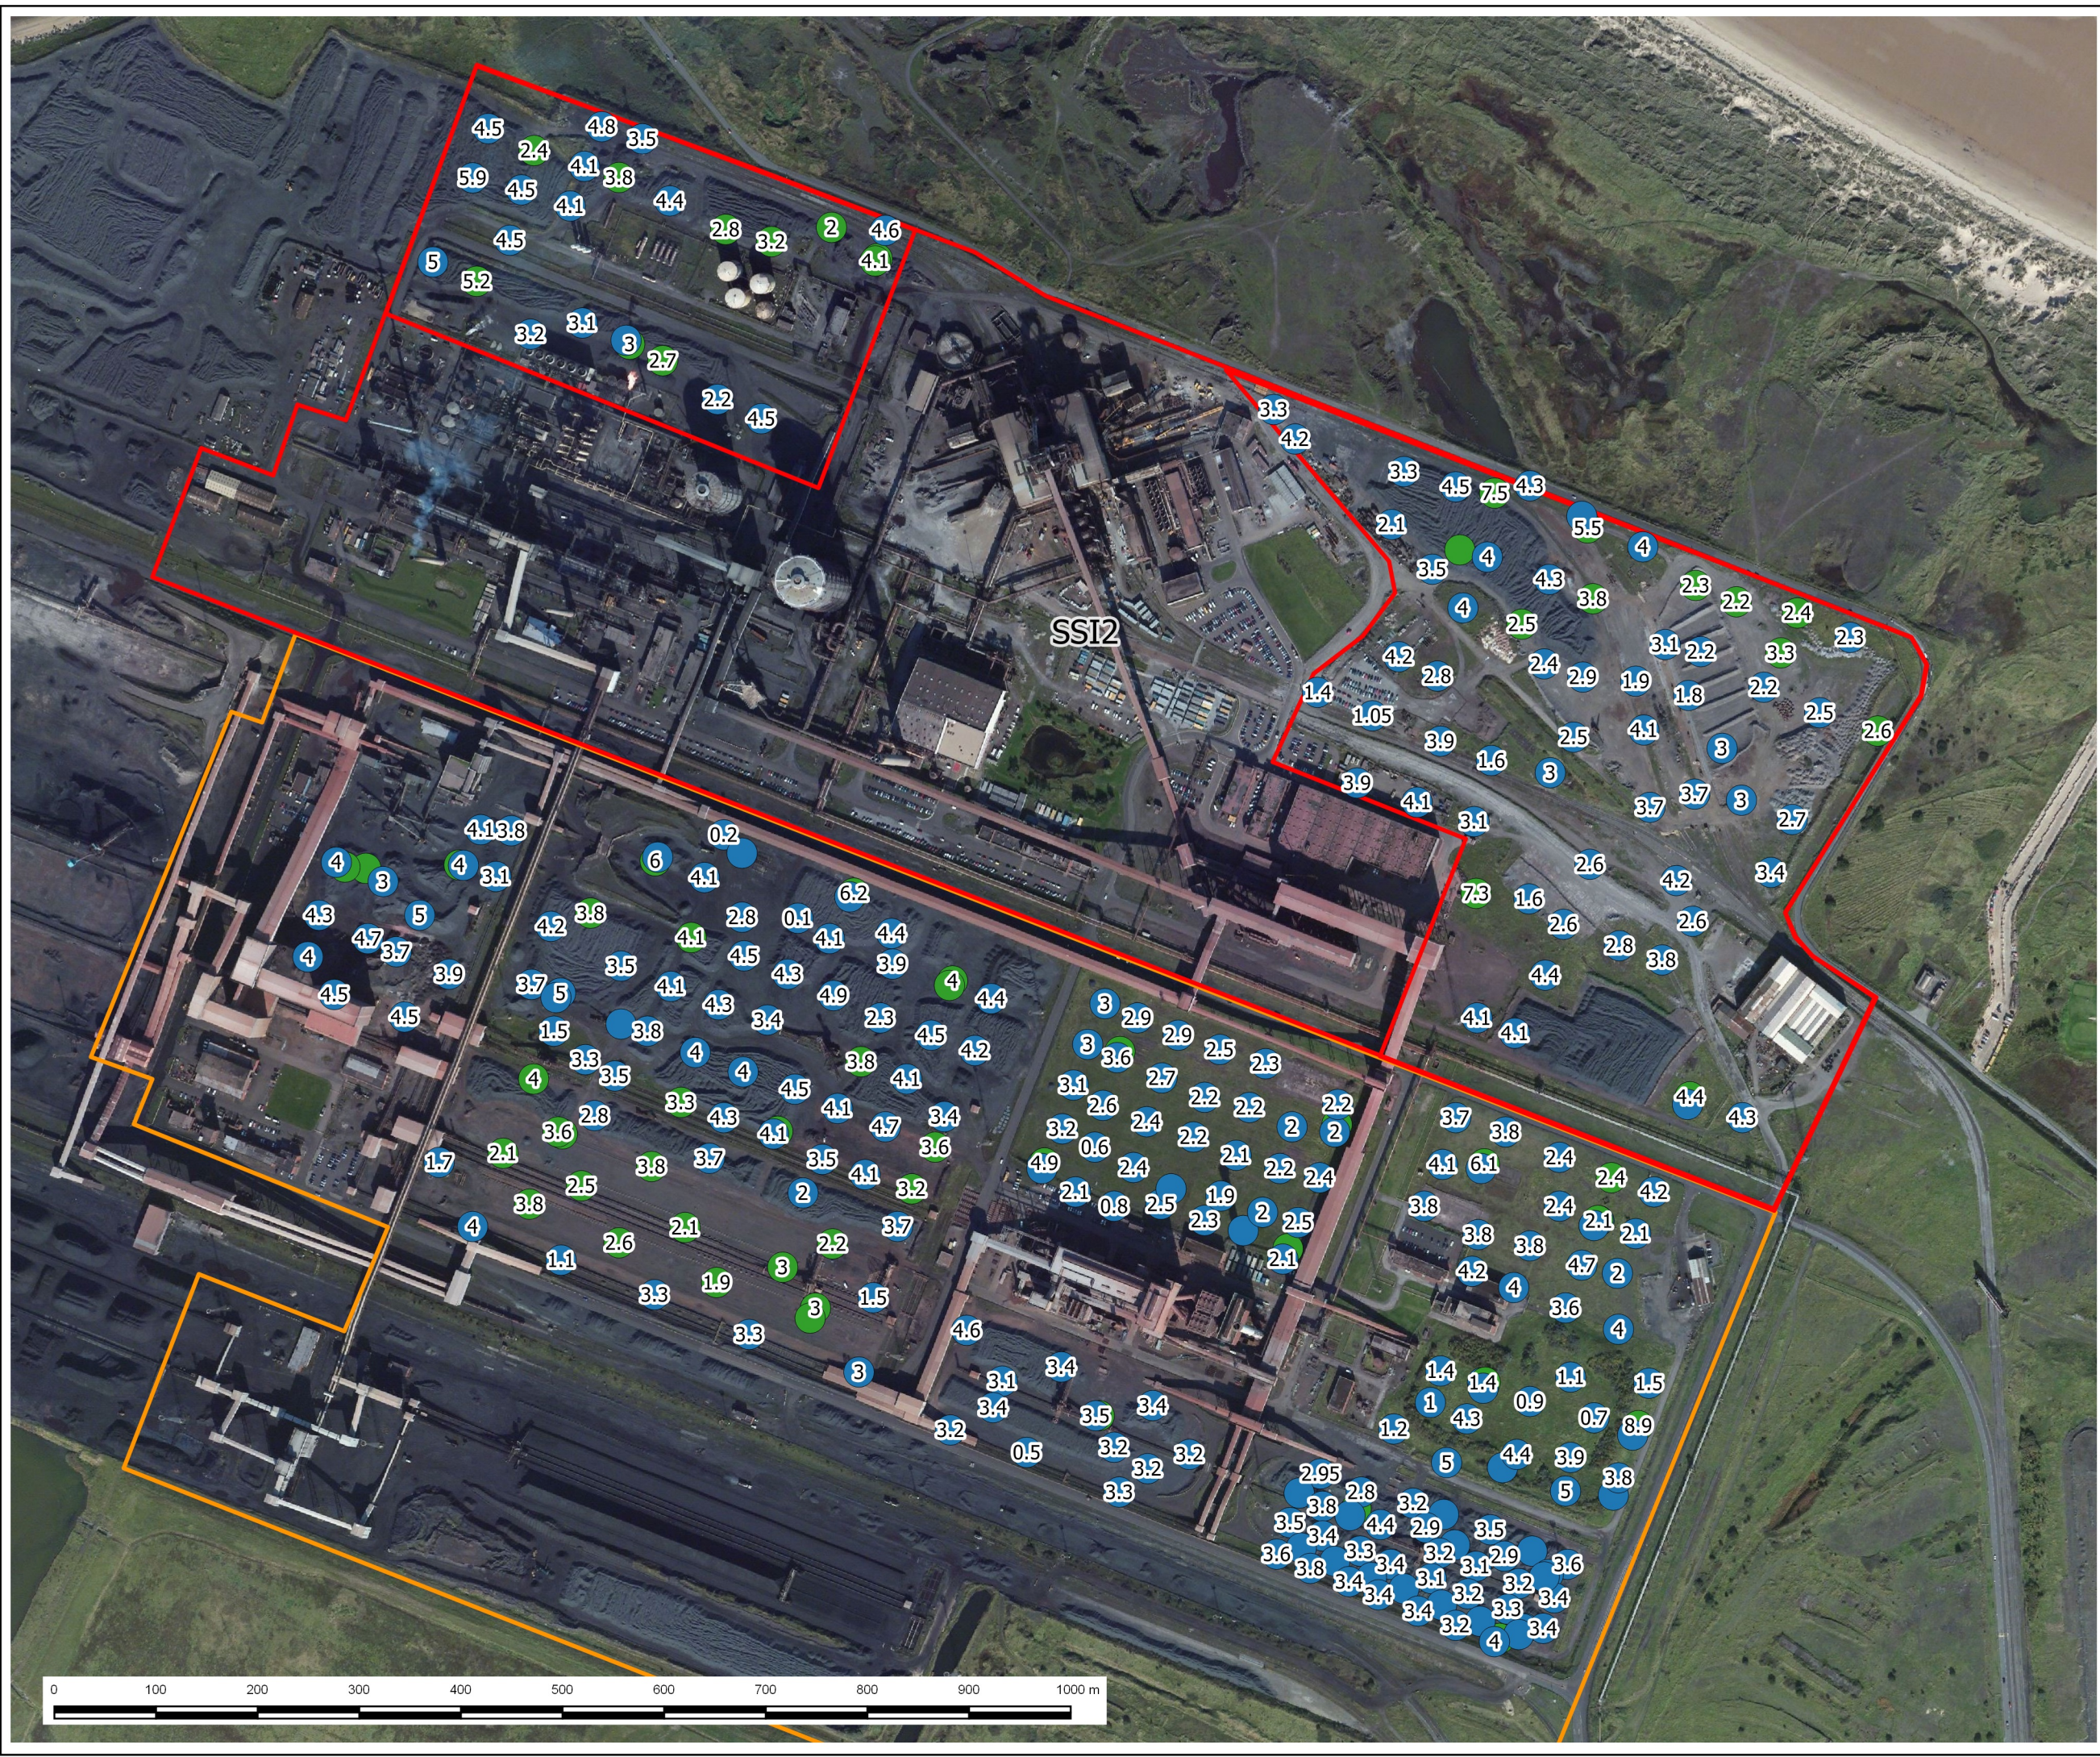
Legend

Base of Made Ground Identified

The previous investigations have identified that Made Ground is likely to be present across the whole of the site typically in the order of 4 to 6m but noted to be up to 10m thick in some areas. The Made Ground predominantly comprised slag deposits with fragments of slag ranging from gravel to boulder size and occasionally layers of fused slag, locally mixed with reworked natural sands, demolition rubble etc. Other Made Ground materials were also identified including possible 'hydraulic fill' which is anticipated to comprise material dredged from sand banks in the estuary mouth and as such is likely to appear similar in nature to natural ground.

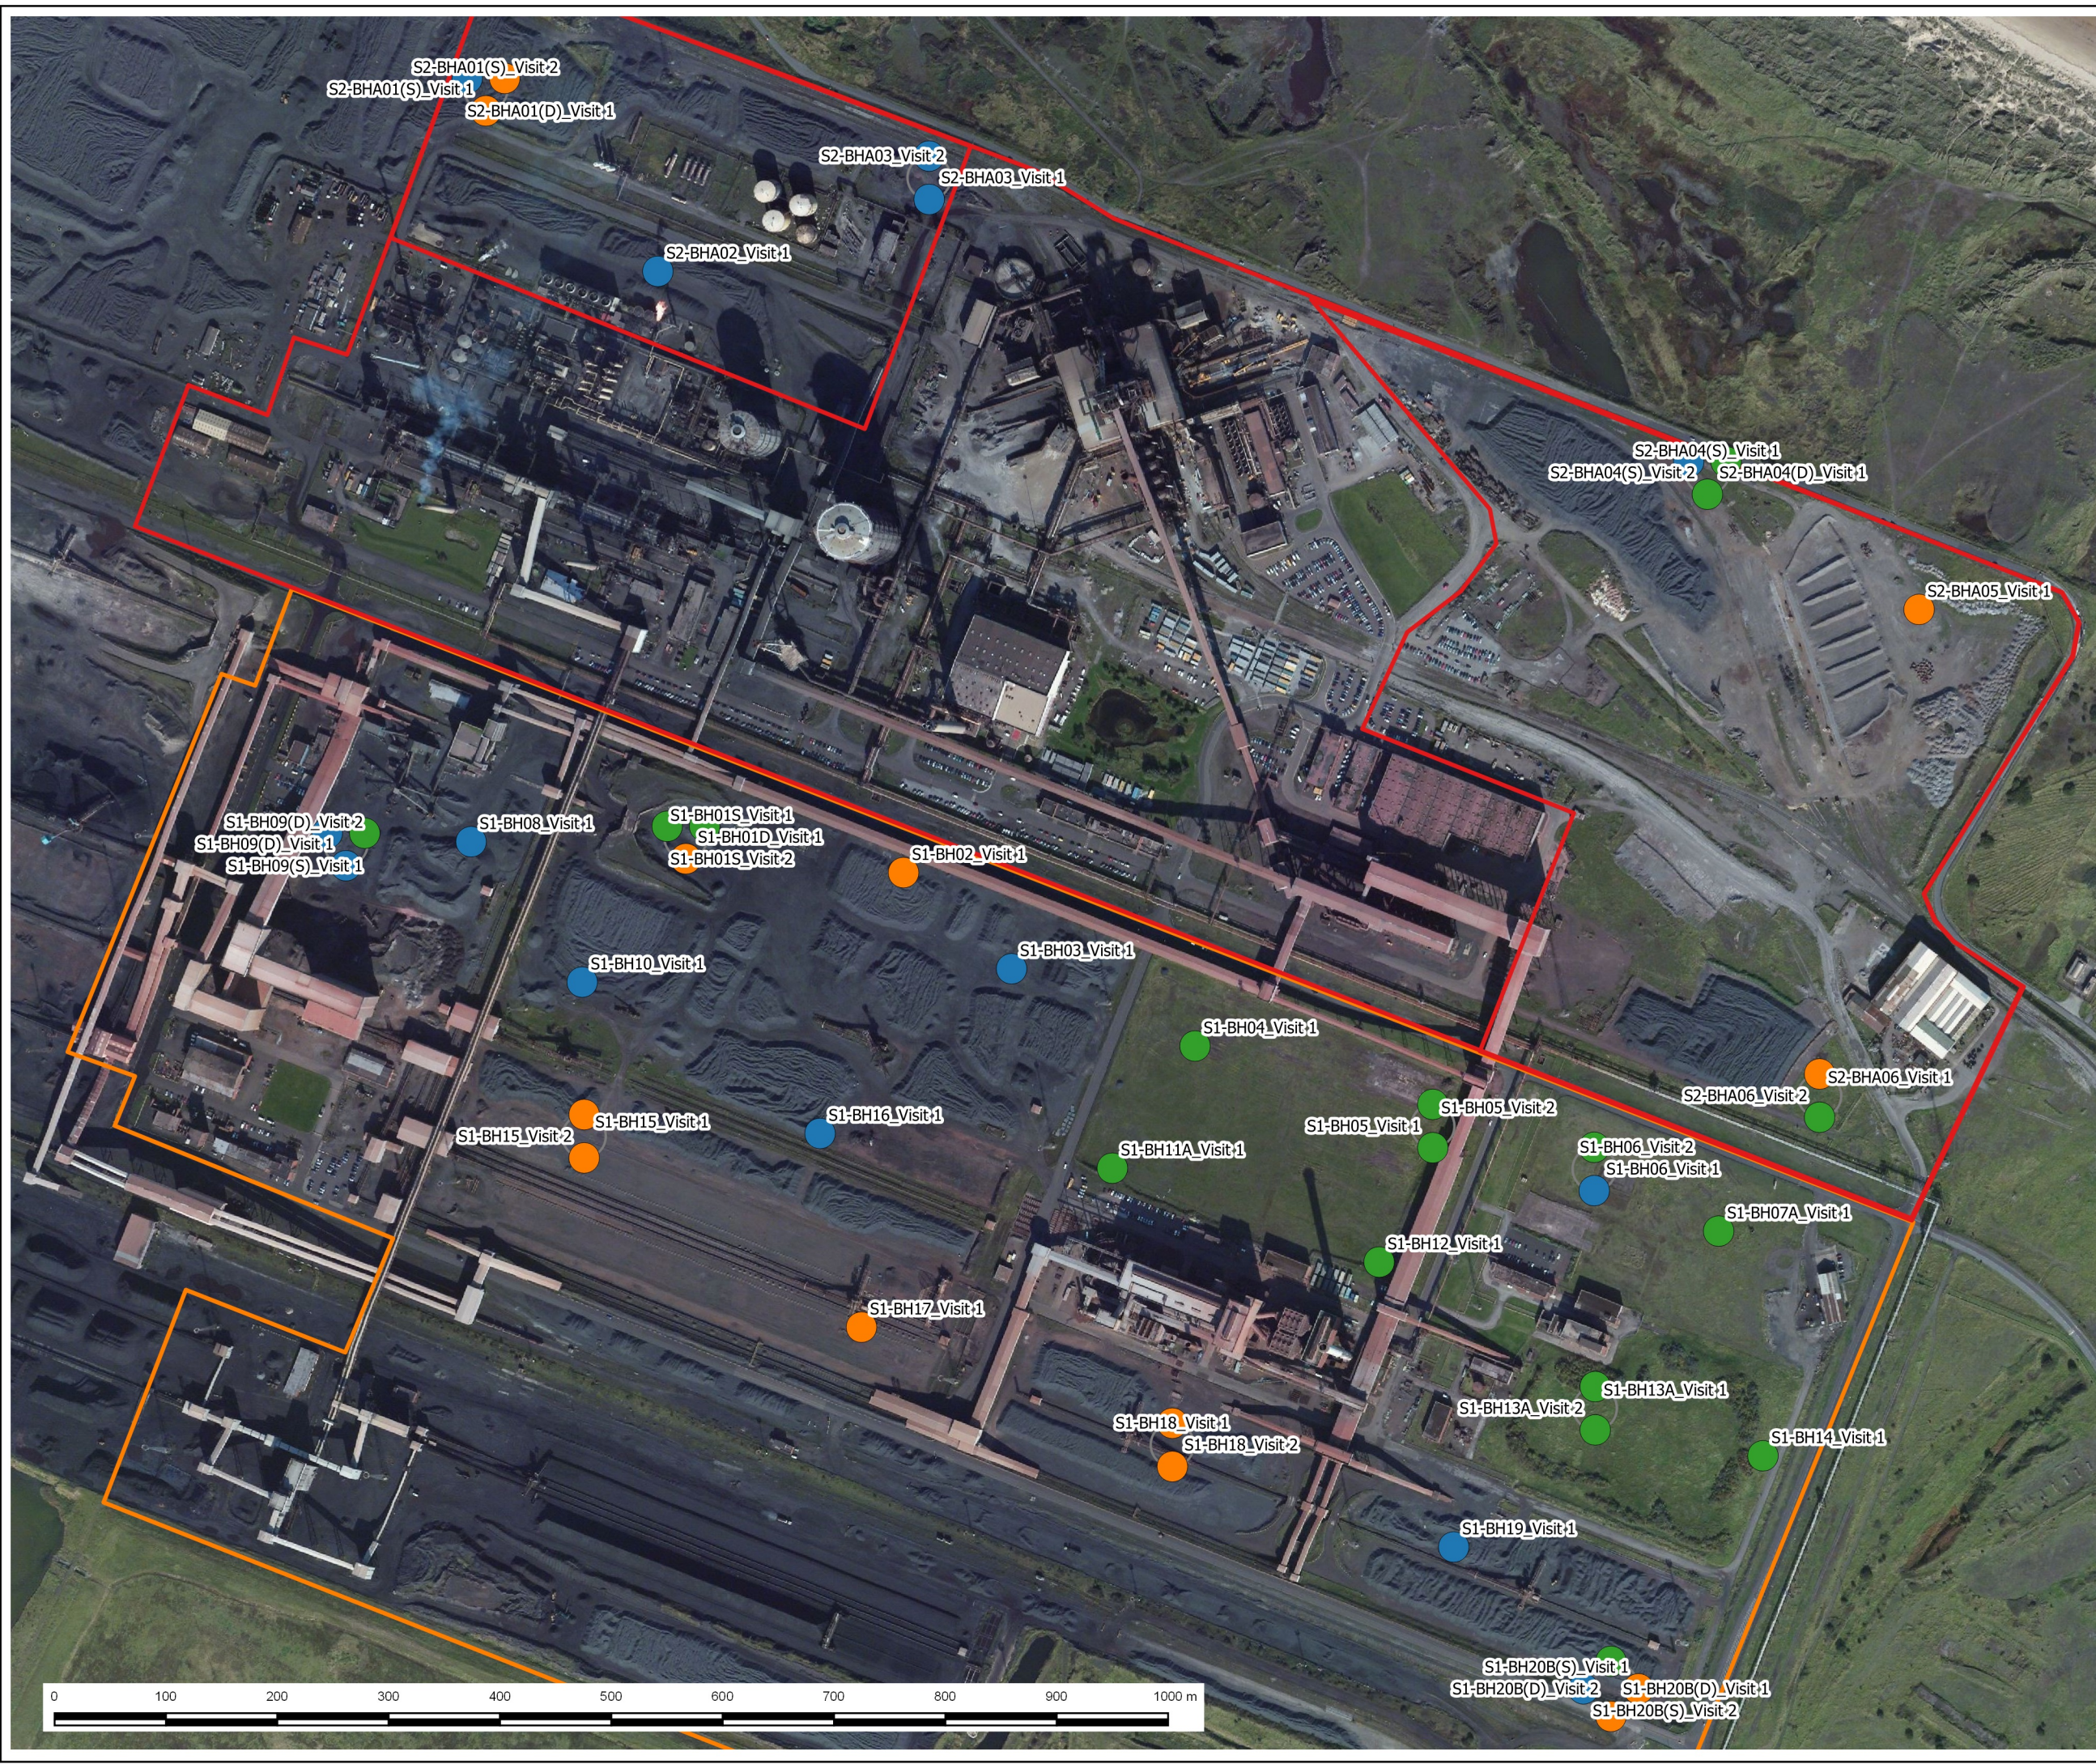
Figure 13: Areas of Elevated Hydrocarbons

The locations of elevated TPH and PAH are shown on Figure 13 below and in Appendix C.
