**Title: Prairie Phase 4 - Sample Location Plan**

**Site:**  
Teesworks - Prairie Phase 4

Draft Factual Report  
(Rev.00)

<b>Contract Title</b>	<b>Prairie Phase 4</b>
<b>Contract Number</b>	4355
<b>Location</b>	<b>Former Redcar Steelworks, Redcar</b>
<b>National Grid Reference</b>	NZ 548 211

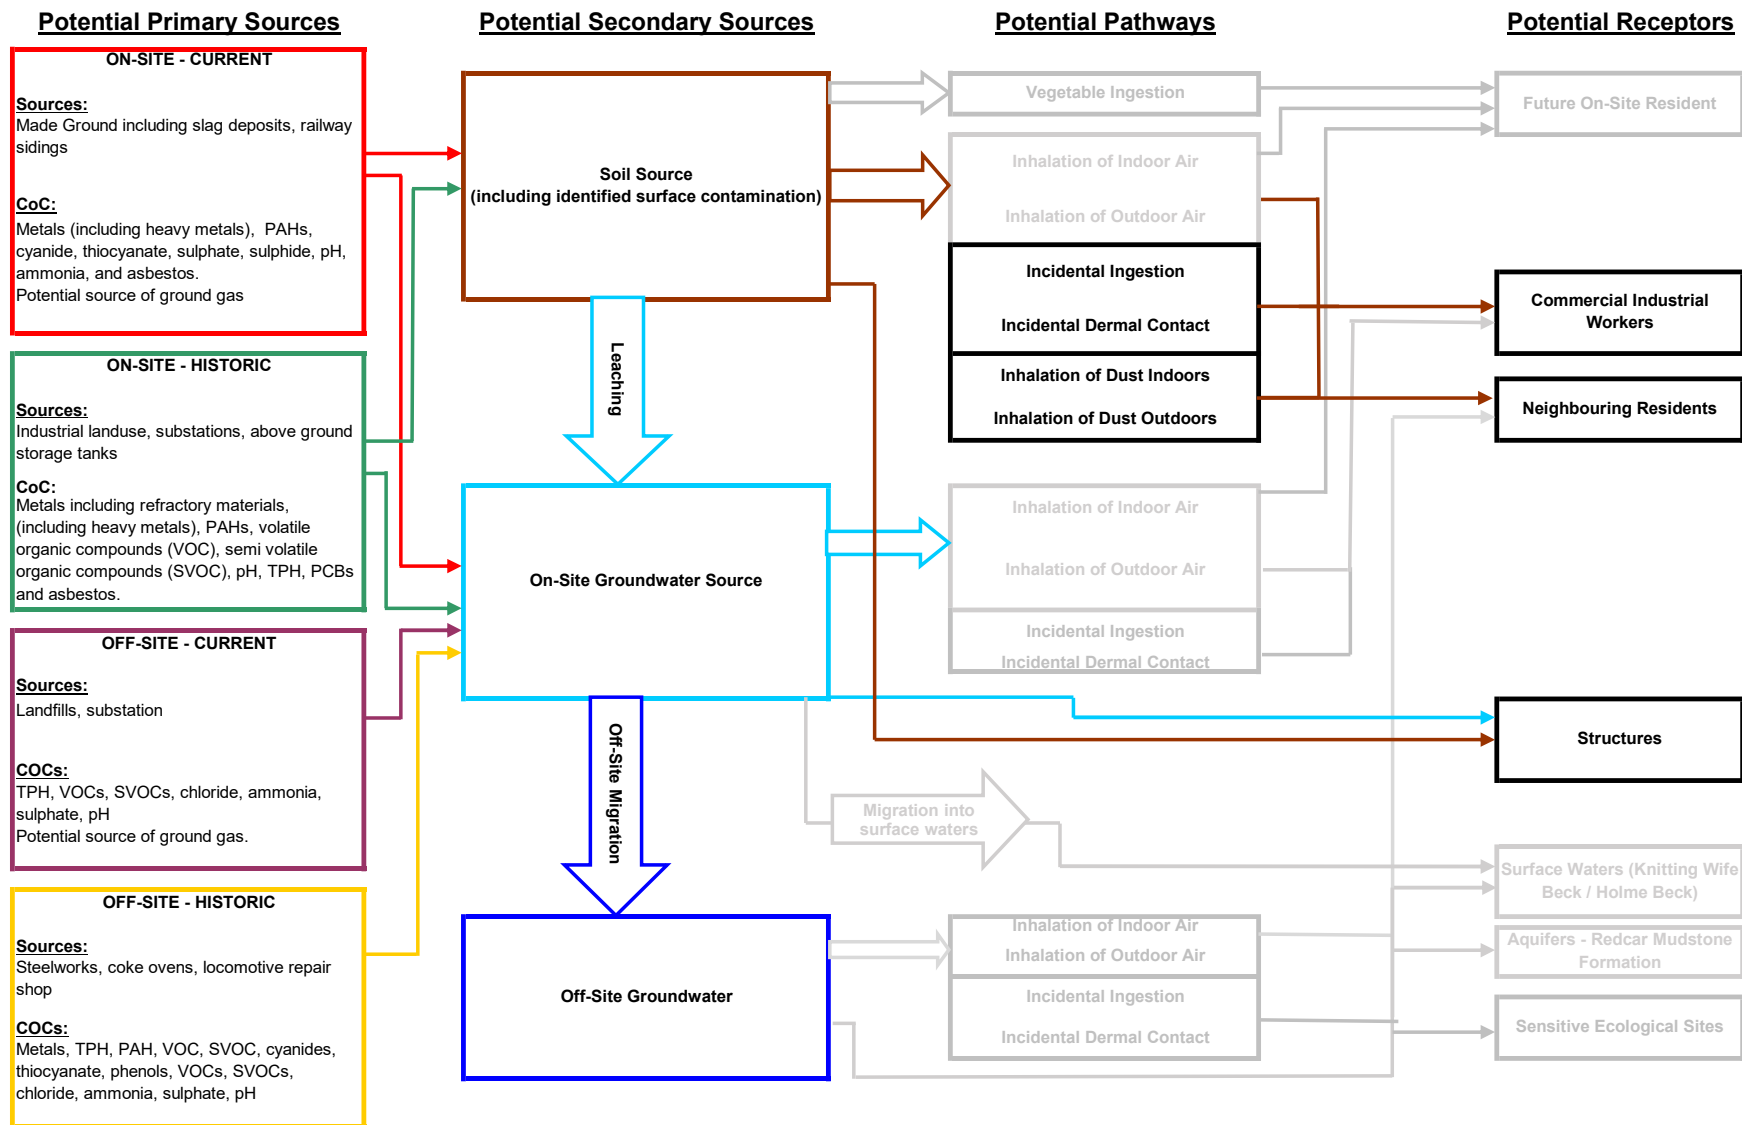
**Figure 4**  
**Refined Conceptual Site Model - Commercial Industrial End Use**

Key: — Pollutant linkage not considered to present a significant level of risk

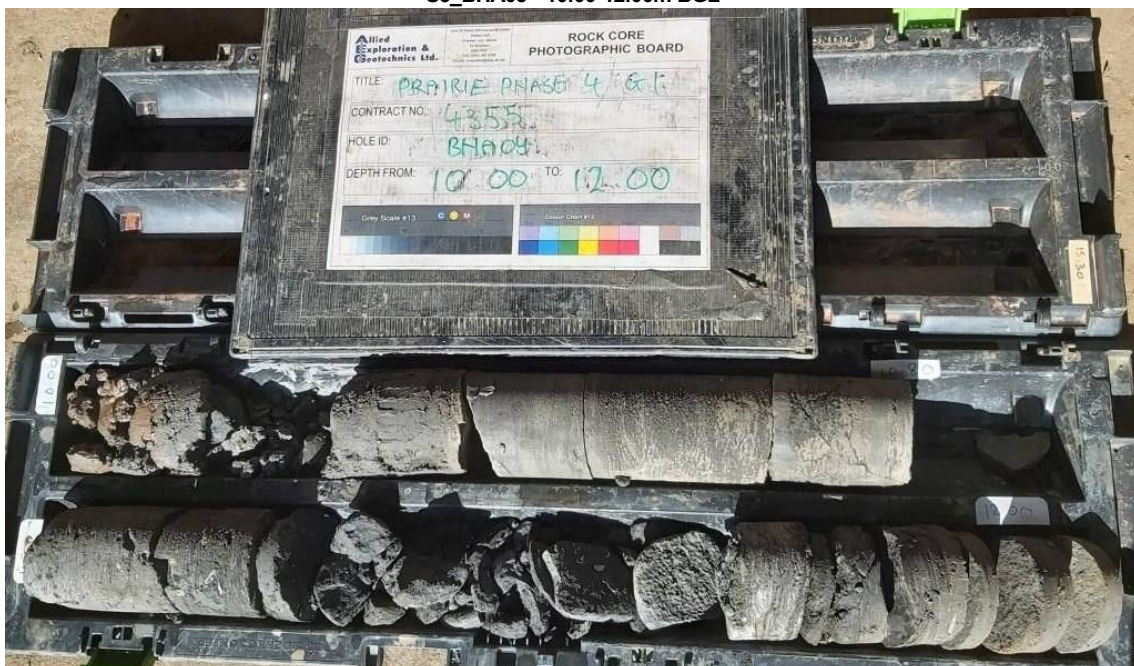
Figure S3\_BHA03.4  
S3\_BHA03 - 10.00-12.00m BGL

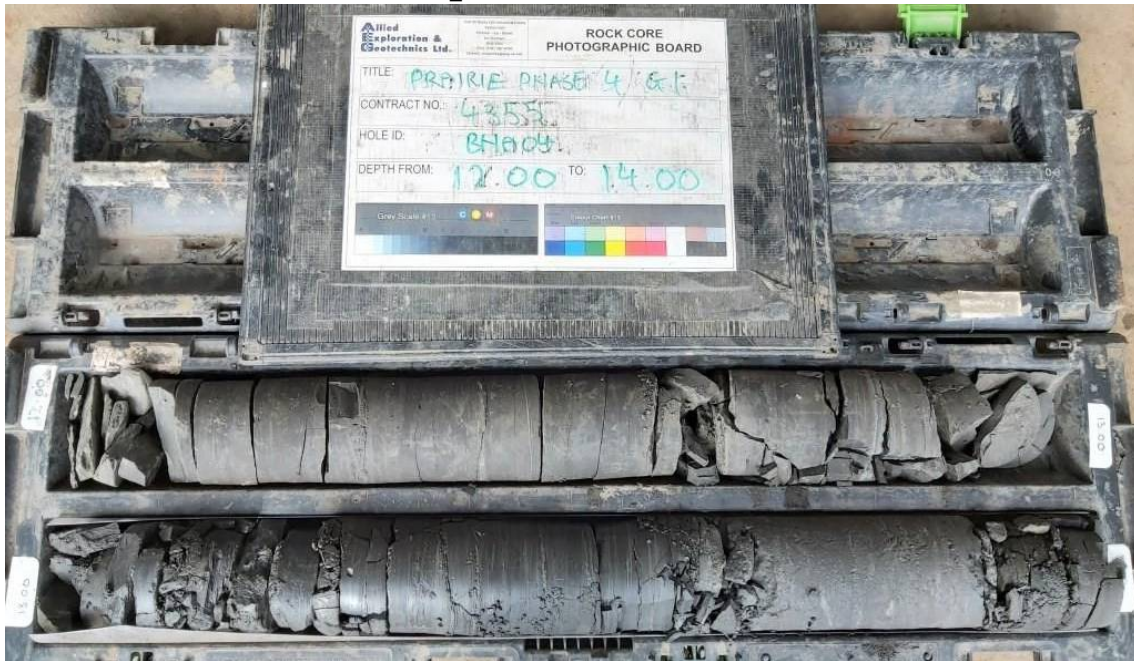
Figure S3\_BHA03.5  
S3\_BHA03 - 12.00-14.00m BGL

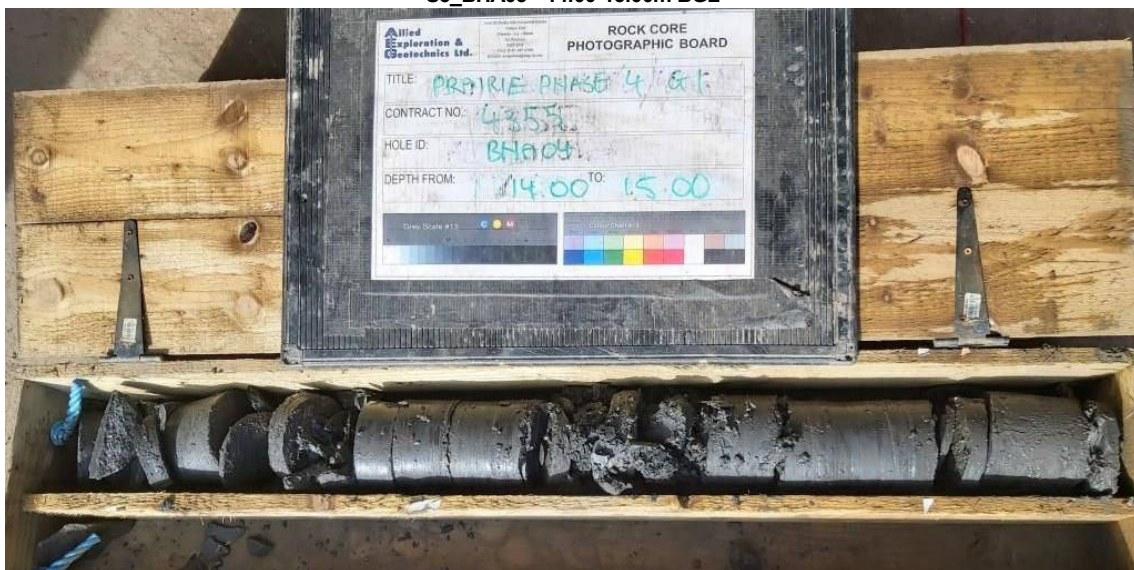
Figure S3\_BHA03.6  
S3\_BHA03 - 14.00-15.00m BGL

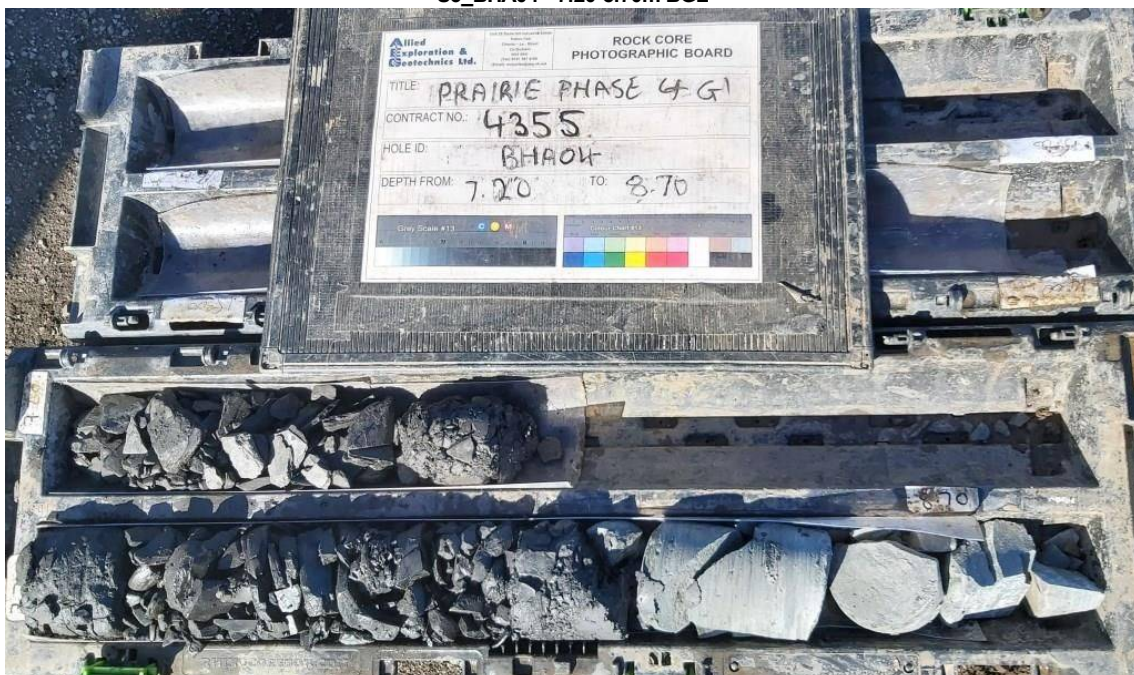
Figure S3\_BHA04.4  
S3\_BHA04 - 7.20-8.70m BGL

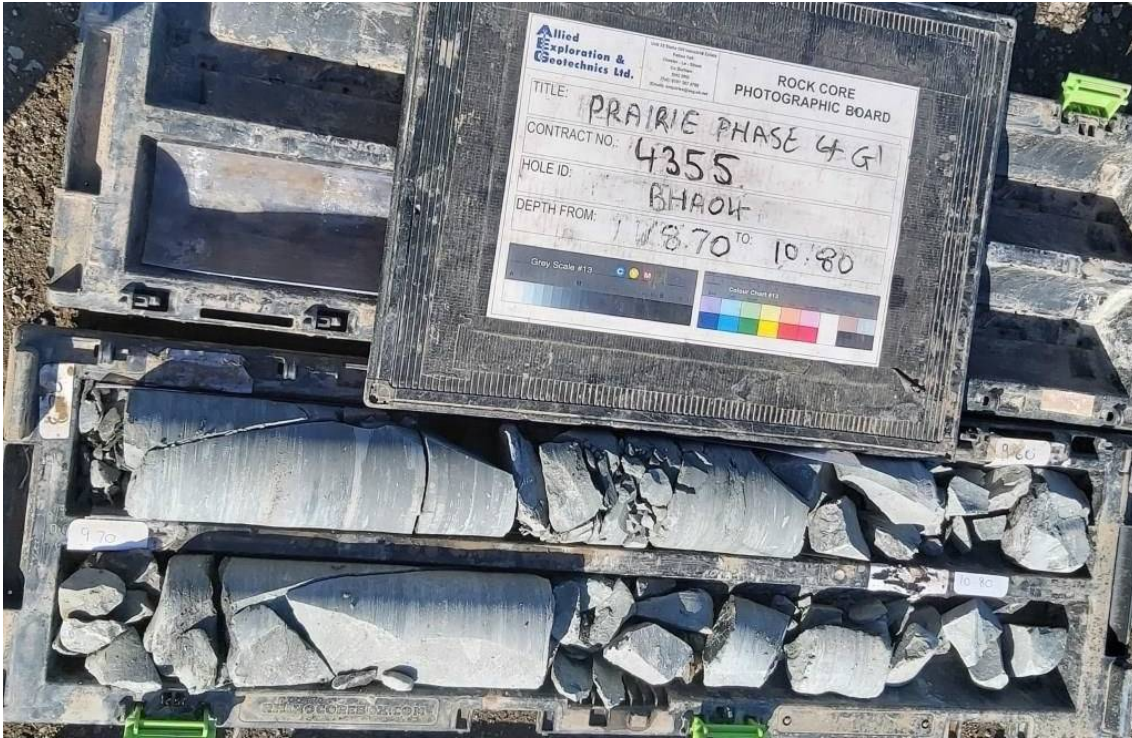
Figure S3\_BHA04.5  
S3\_BHA04 - 8.70-10.80m BGL

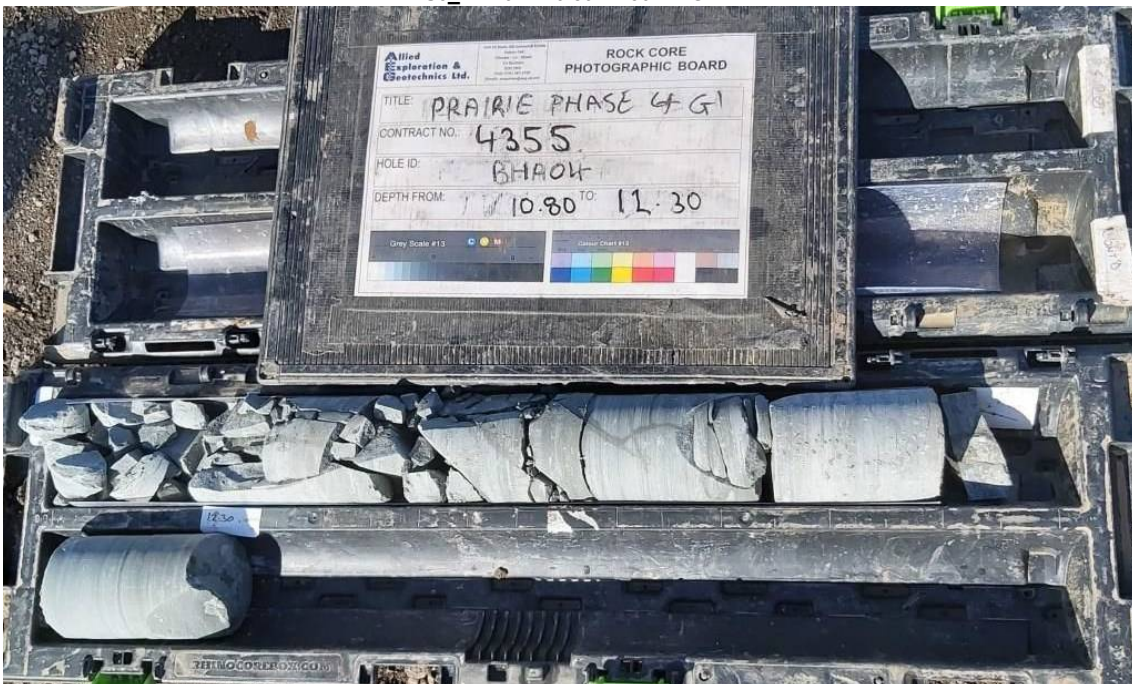
Figure S3\_BHA04.6  
S3\_BHA04 - 10.80-12.30m BGL

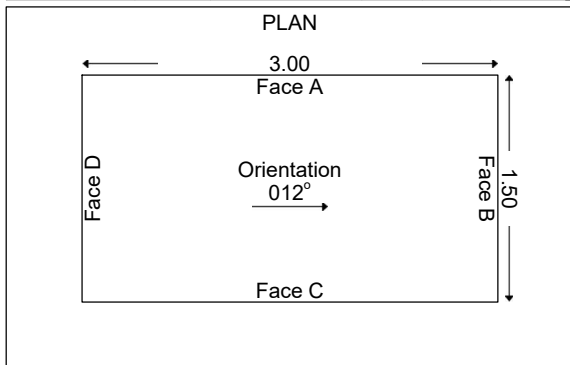
SAMPLES & TESTS			STRATA				
Depth	Type No	Test Result	Water	Reduced Level	Legend	Depth (Thickness)	Description
0.20 0.20 0.20 0.20	J1 B2 ES3 PID	<0.1ppm		8.73		1.00	MADE GROUND (Dark brown slightly clayey sandy gravel with medium cobble and boulder content and timber, rebar, ceramic and glass fragments. Gravel is fine to coarse angular to subangular and includes brick, concrete and slag. Cobbles and boulders are angular to subangular and include brick and concrete. Slag content is 0-25%. Slag is dark grey mostly vesicular).
1.10 1.10 1.10 1.10	J4 B5 ES6 PID	<0.1ppm		8.23		1.50	Firm to stiff thinly laminated dark yellow brown sandy silty CLAY with interlaminations of fine grey brown sand.
							<i>Complete at 1.50m BGL.</i>

**GROUNDWATER**  
No groundwater inflow observed.

**STABILITY**  
Pit sides and base stable throughout excavation.
