STEEL HOUSE EAST MOUNDS, TEESWORKS, REDCAR

Ground Investigation

South Tees Development Corporation

10047374-AUK-XX-XX-RP-ZZ-0524-02-Steel House East Mounds GI

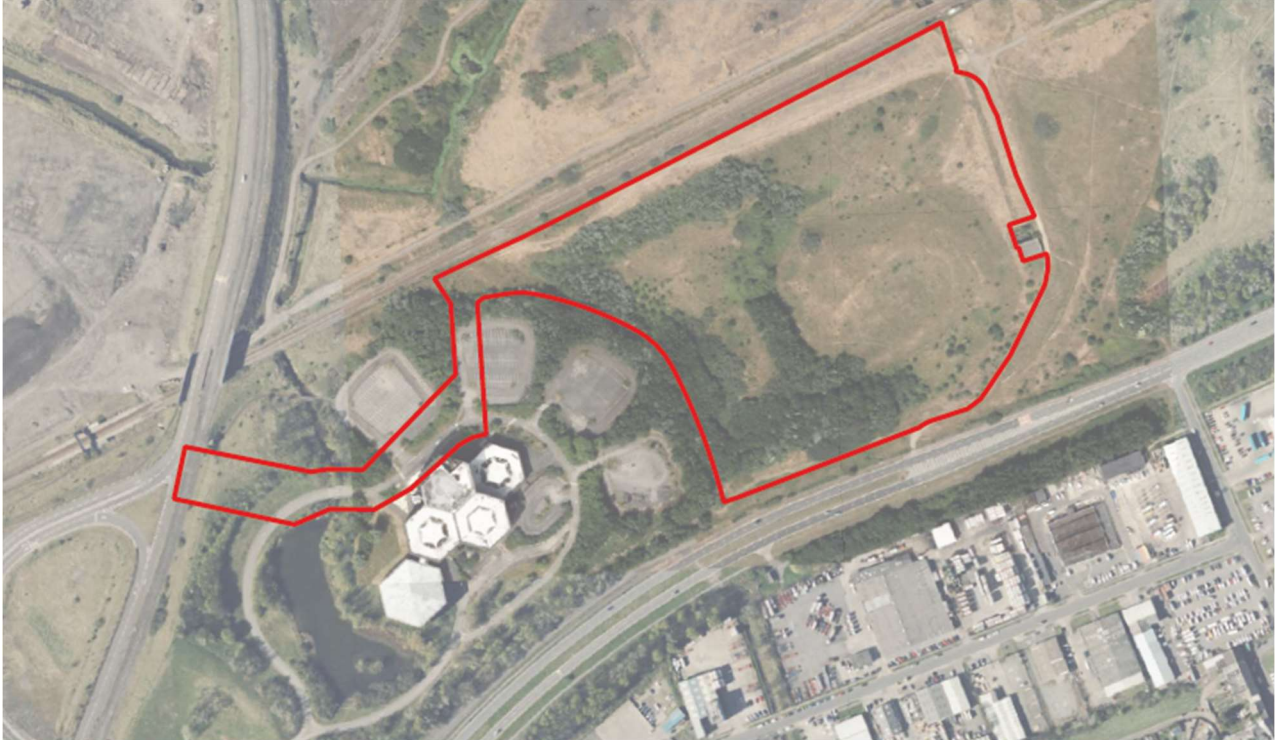
Figure 1: Land East of Steel House – Approximate Redline Boundary

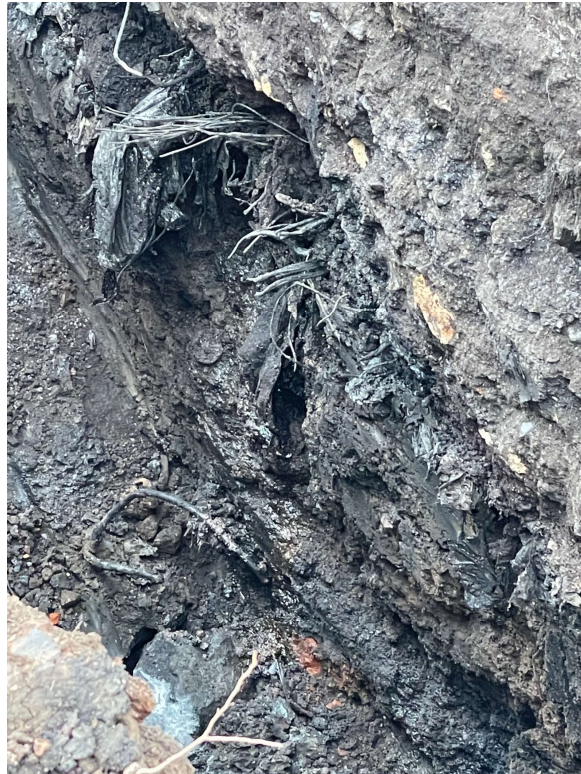
Plate 1: Potential hydrocarbon impact identified within SHO-TS1_AUK_TP102

During the ground investigation suspected hydrocarbon contamination (observed as non aqueous phase liquid (NAPL)) was identified within SHO-TS1_AUK_TP102. To delineate the potential impact, SHO-TS1_AUK_TP108 to SHO-TS1_AUK_TP111 were excavated at the four compass points around the location.

A strong hydrocarbon odour was noted within SHO-TS1_AUK_TP109 to the north. No other potential hydrocarbon impacts were noted during the investigation.

Based on the spatial spread of the identified hydrocarbon impact, it is suspected that it is related to a discrete dumping event and is localised around the SHO-TS1_AUK_TP102 area within a waste rich layer between 2.00 to 4.00m bgl based on soil samples taken from this horizon. A sample was collected from the underlying horizon at 4.70m bgl and reported lower concentrations of TPH and PAH.

Hydrocarbon impacts were noted locally around SHO-TS1_AUK_TP102 alongside a discrete horizon of waste. Concentrations of hydrocarbons measured in soil samples are not thought to pose a risk to human health based on a commercial / industrial end use scenario.

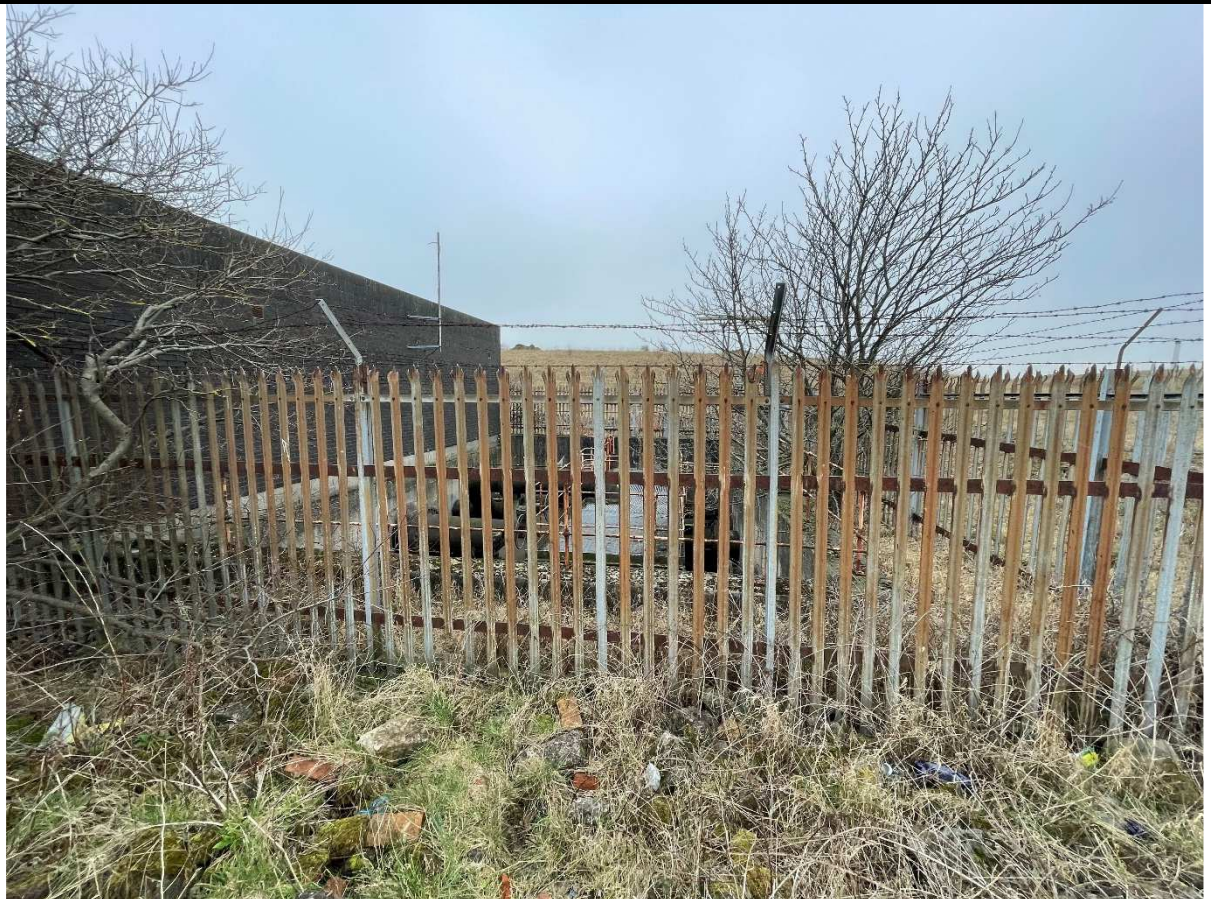
Disused gas
governor on
eastern
boundary.

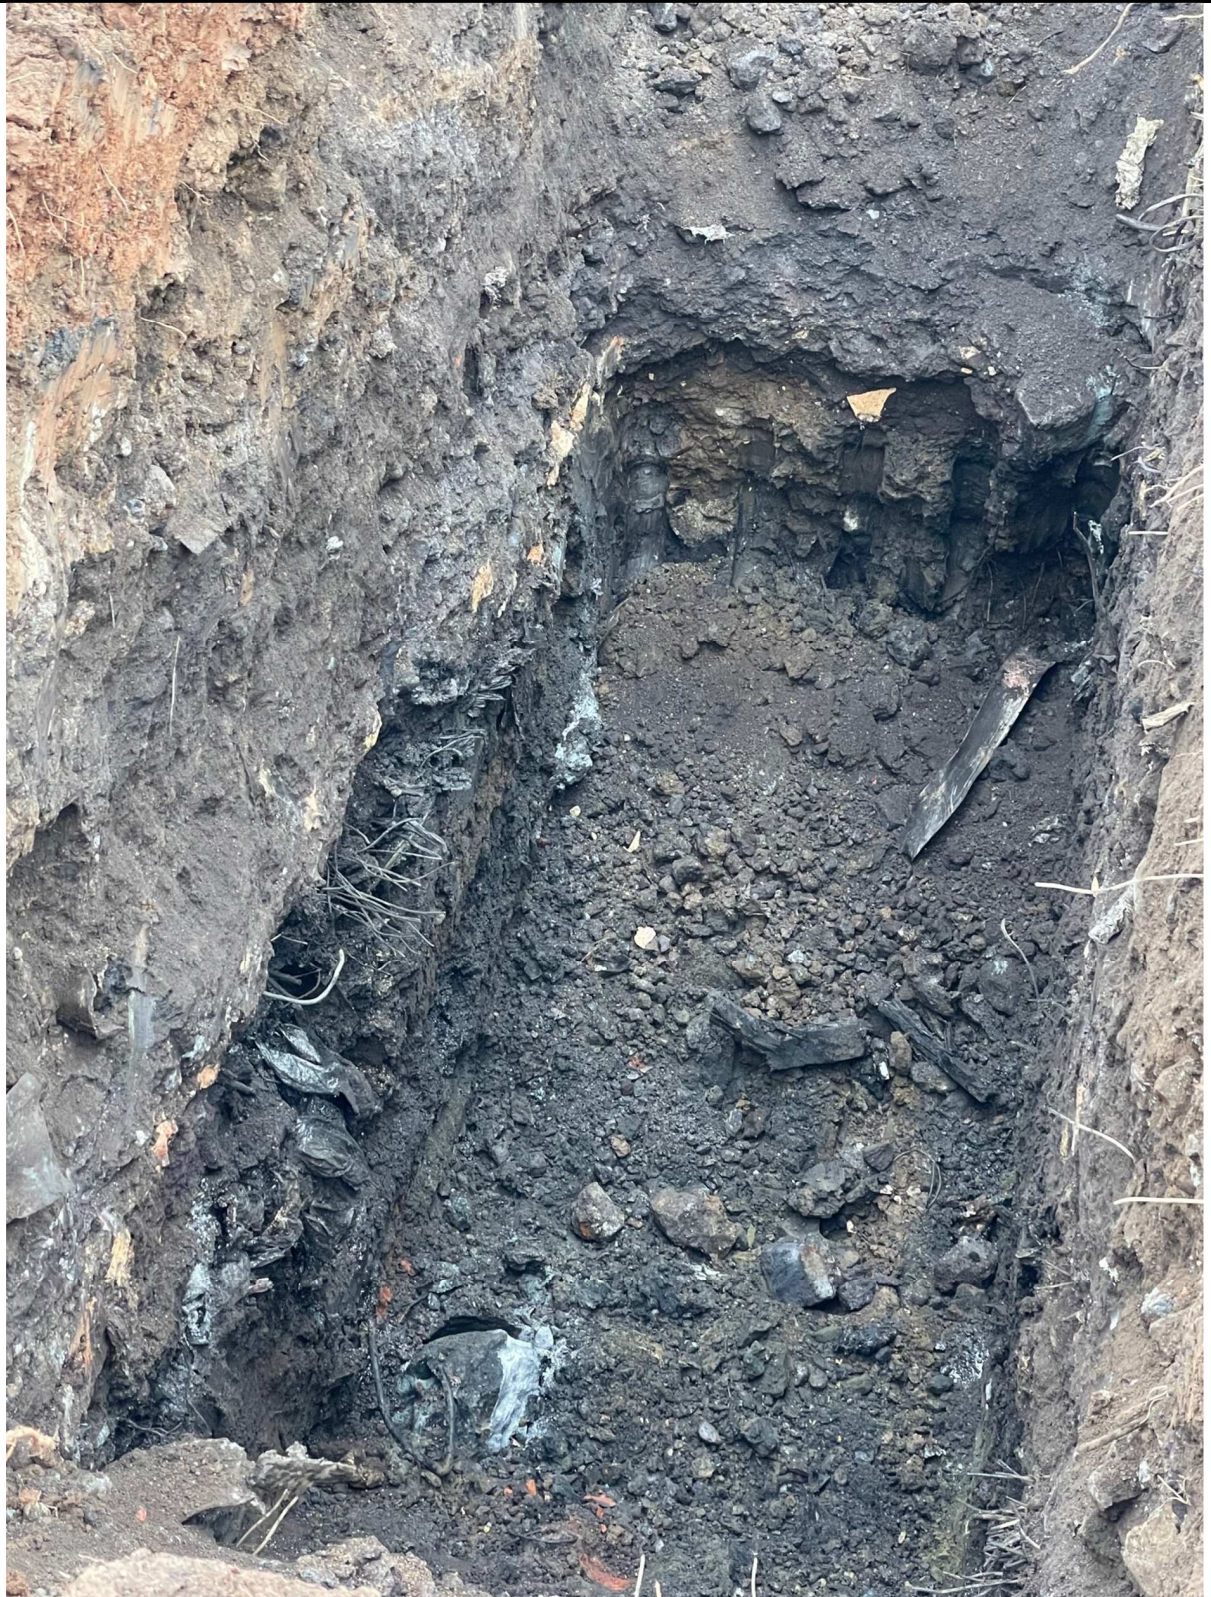
Layer of NAPL
contaminated
material
TP102.

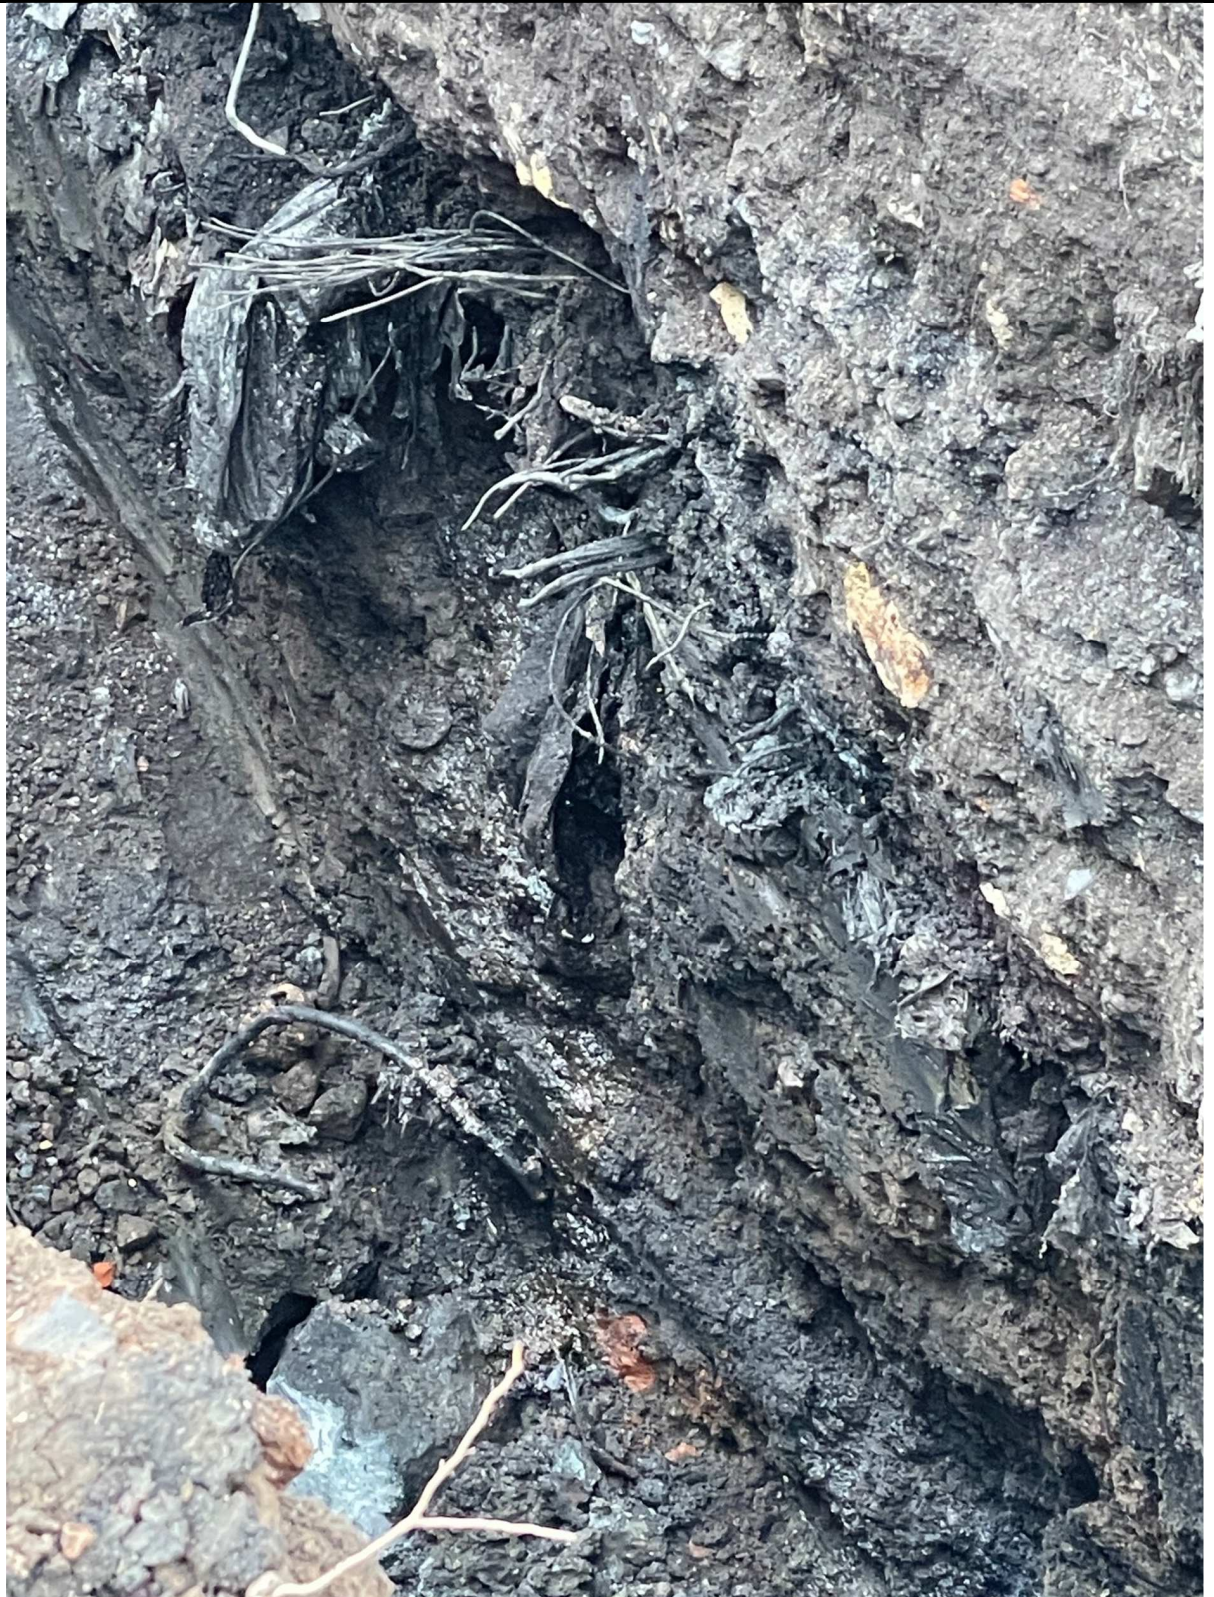
TP102. NAPL
contaminated
fill.

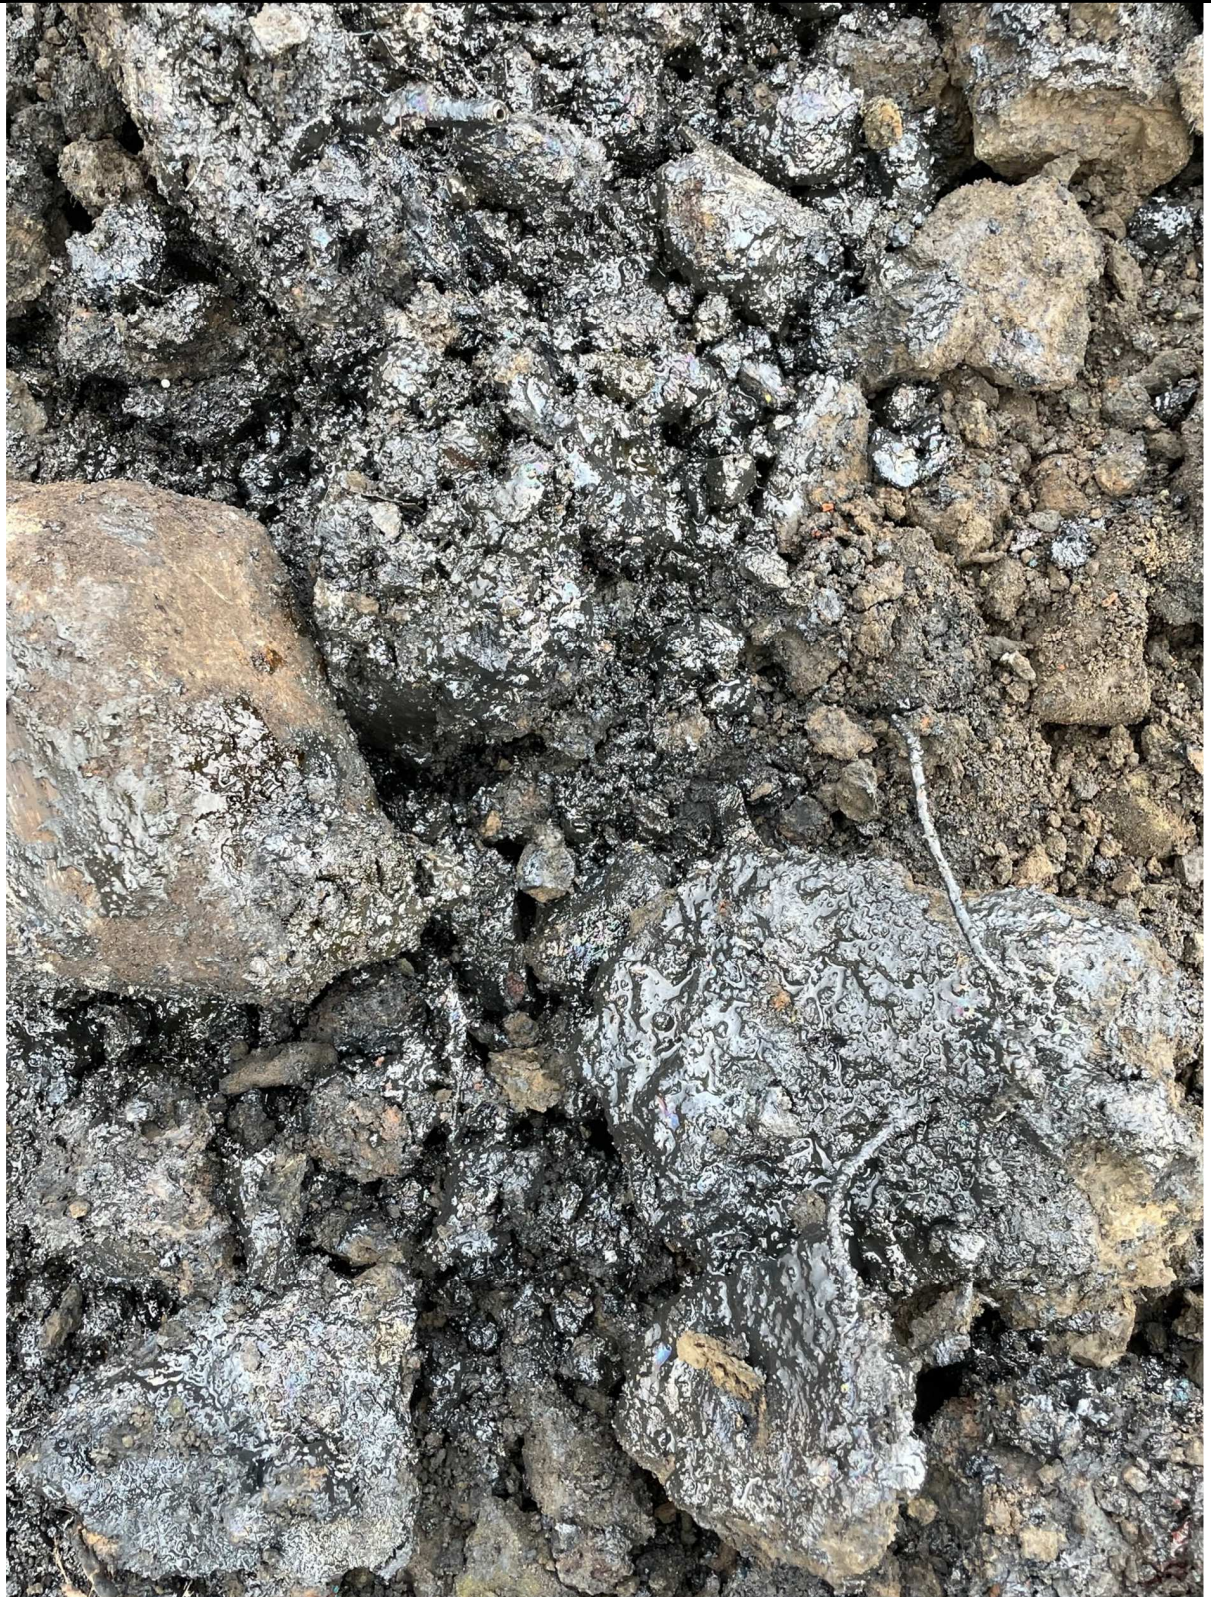
TP103.
Granular fill

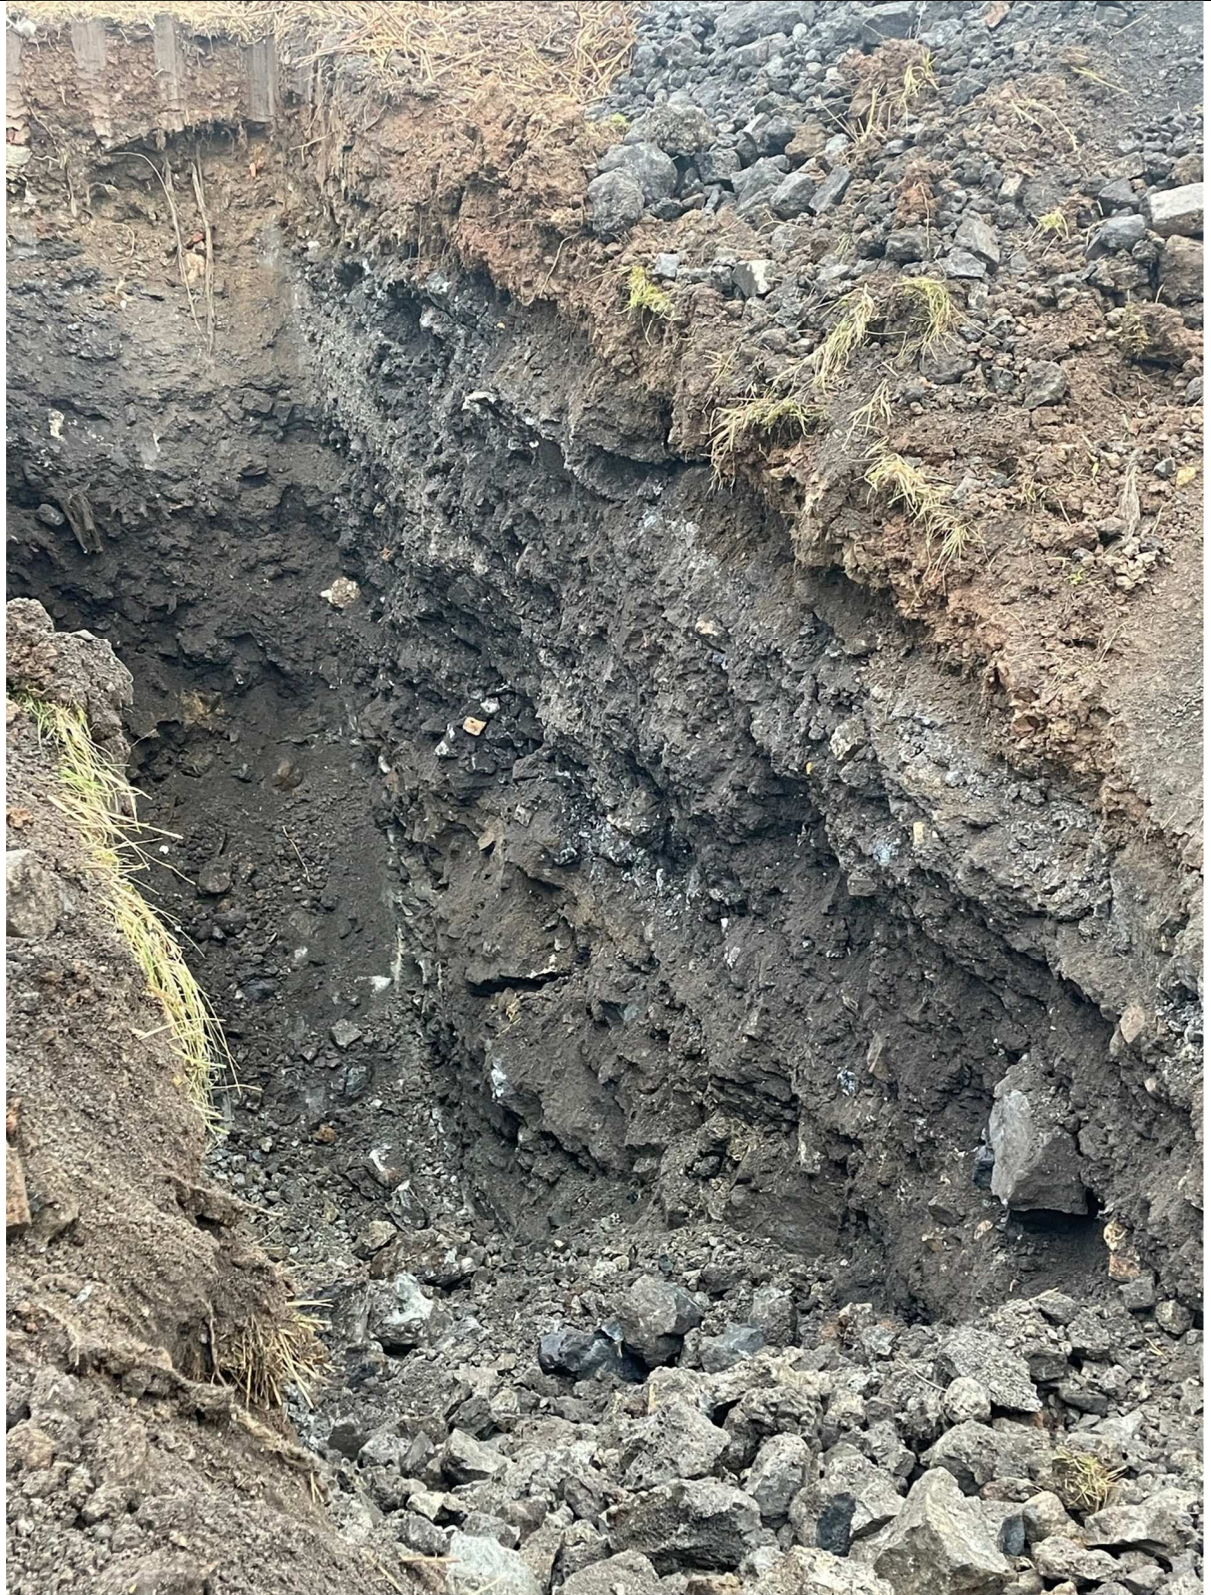
TP103
arisings.

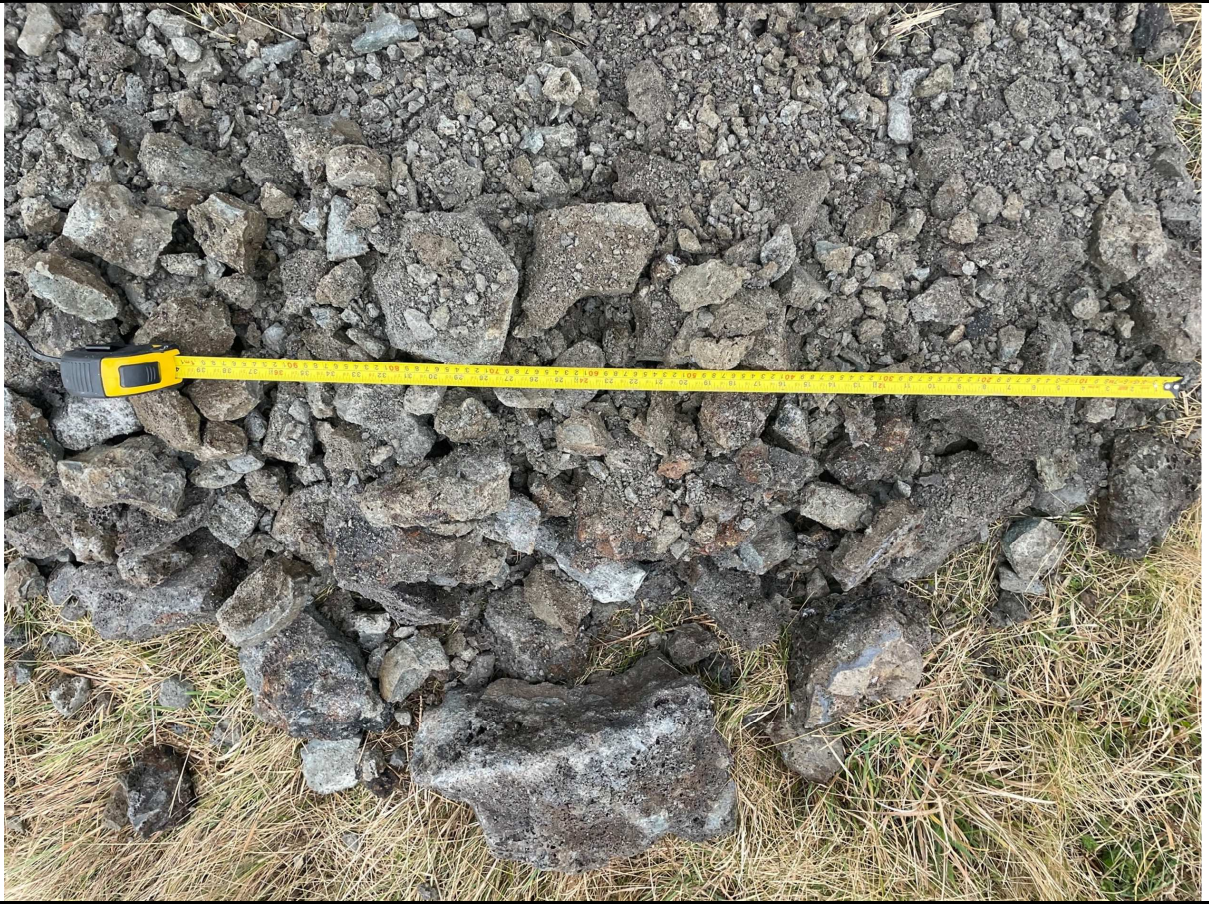
TP109 mixed
fill.

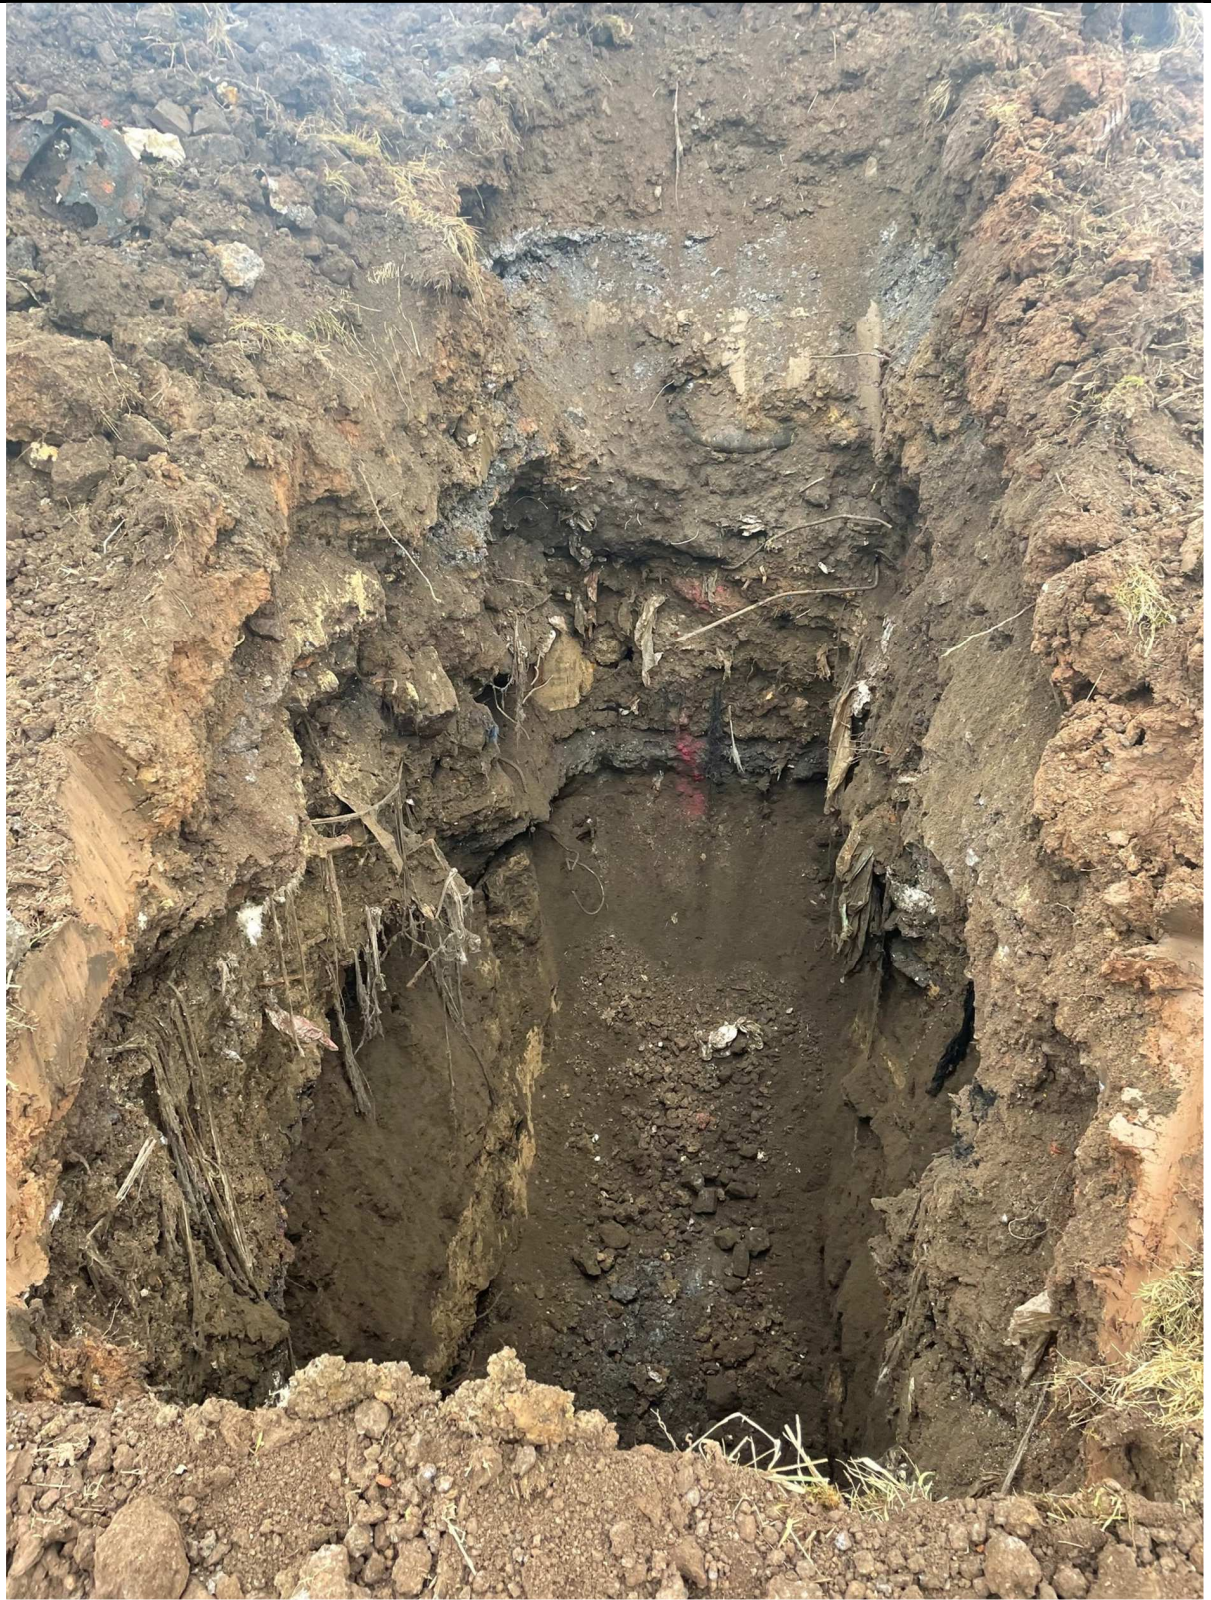
TP109
Arisings. Note
tyre and pipes.

Waste horizons have been identified in limited locations within the mounds overlying the site, waste material is unsuitable for reuse and will need to be segregated and appropriately disposed of. The waste material has predominantly been identified in the north of site near to SHO-TS1_AUK_TP102. Presence of NAPL and loose asbestos insulation within the waste horizon mean this material is likely to be considered hazardous waste and may need to be removed by a specialist contract licensed to handle asbestos waste.
