LAND WEST OF WARRENBY, TEESWORKS, REDCAR

Contaminated Land Generic Quantitative Risk Assessment
and Detailed Quantitative Risk Assessment

South Tees Development Corporation

REPORT NO: 10035117-AUK-XX-XX-RP-ZZ-0428-04-LWoW_DQRA

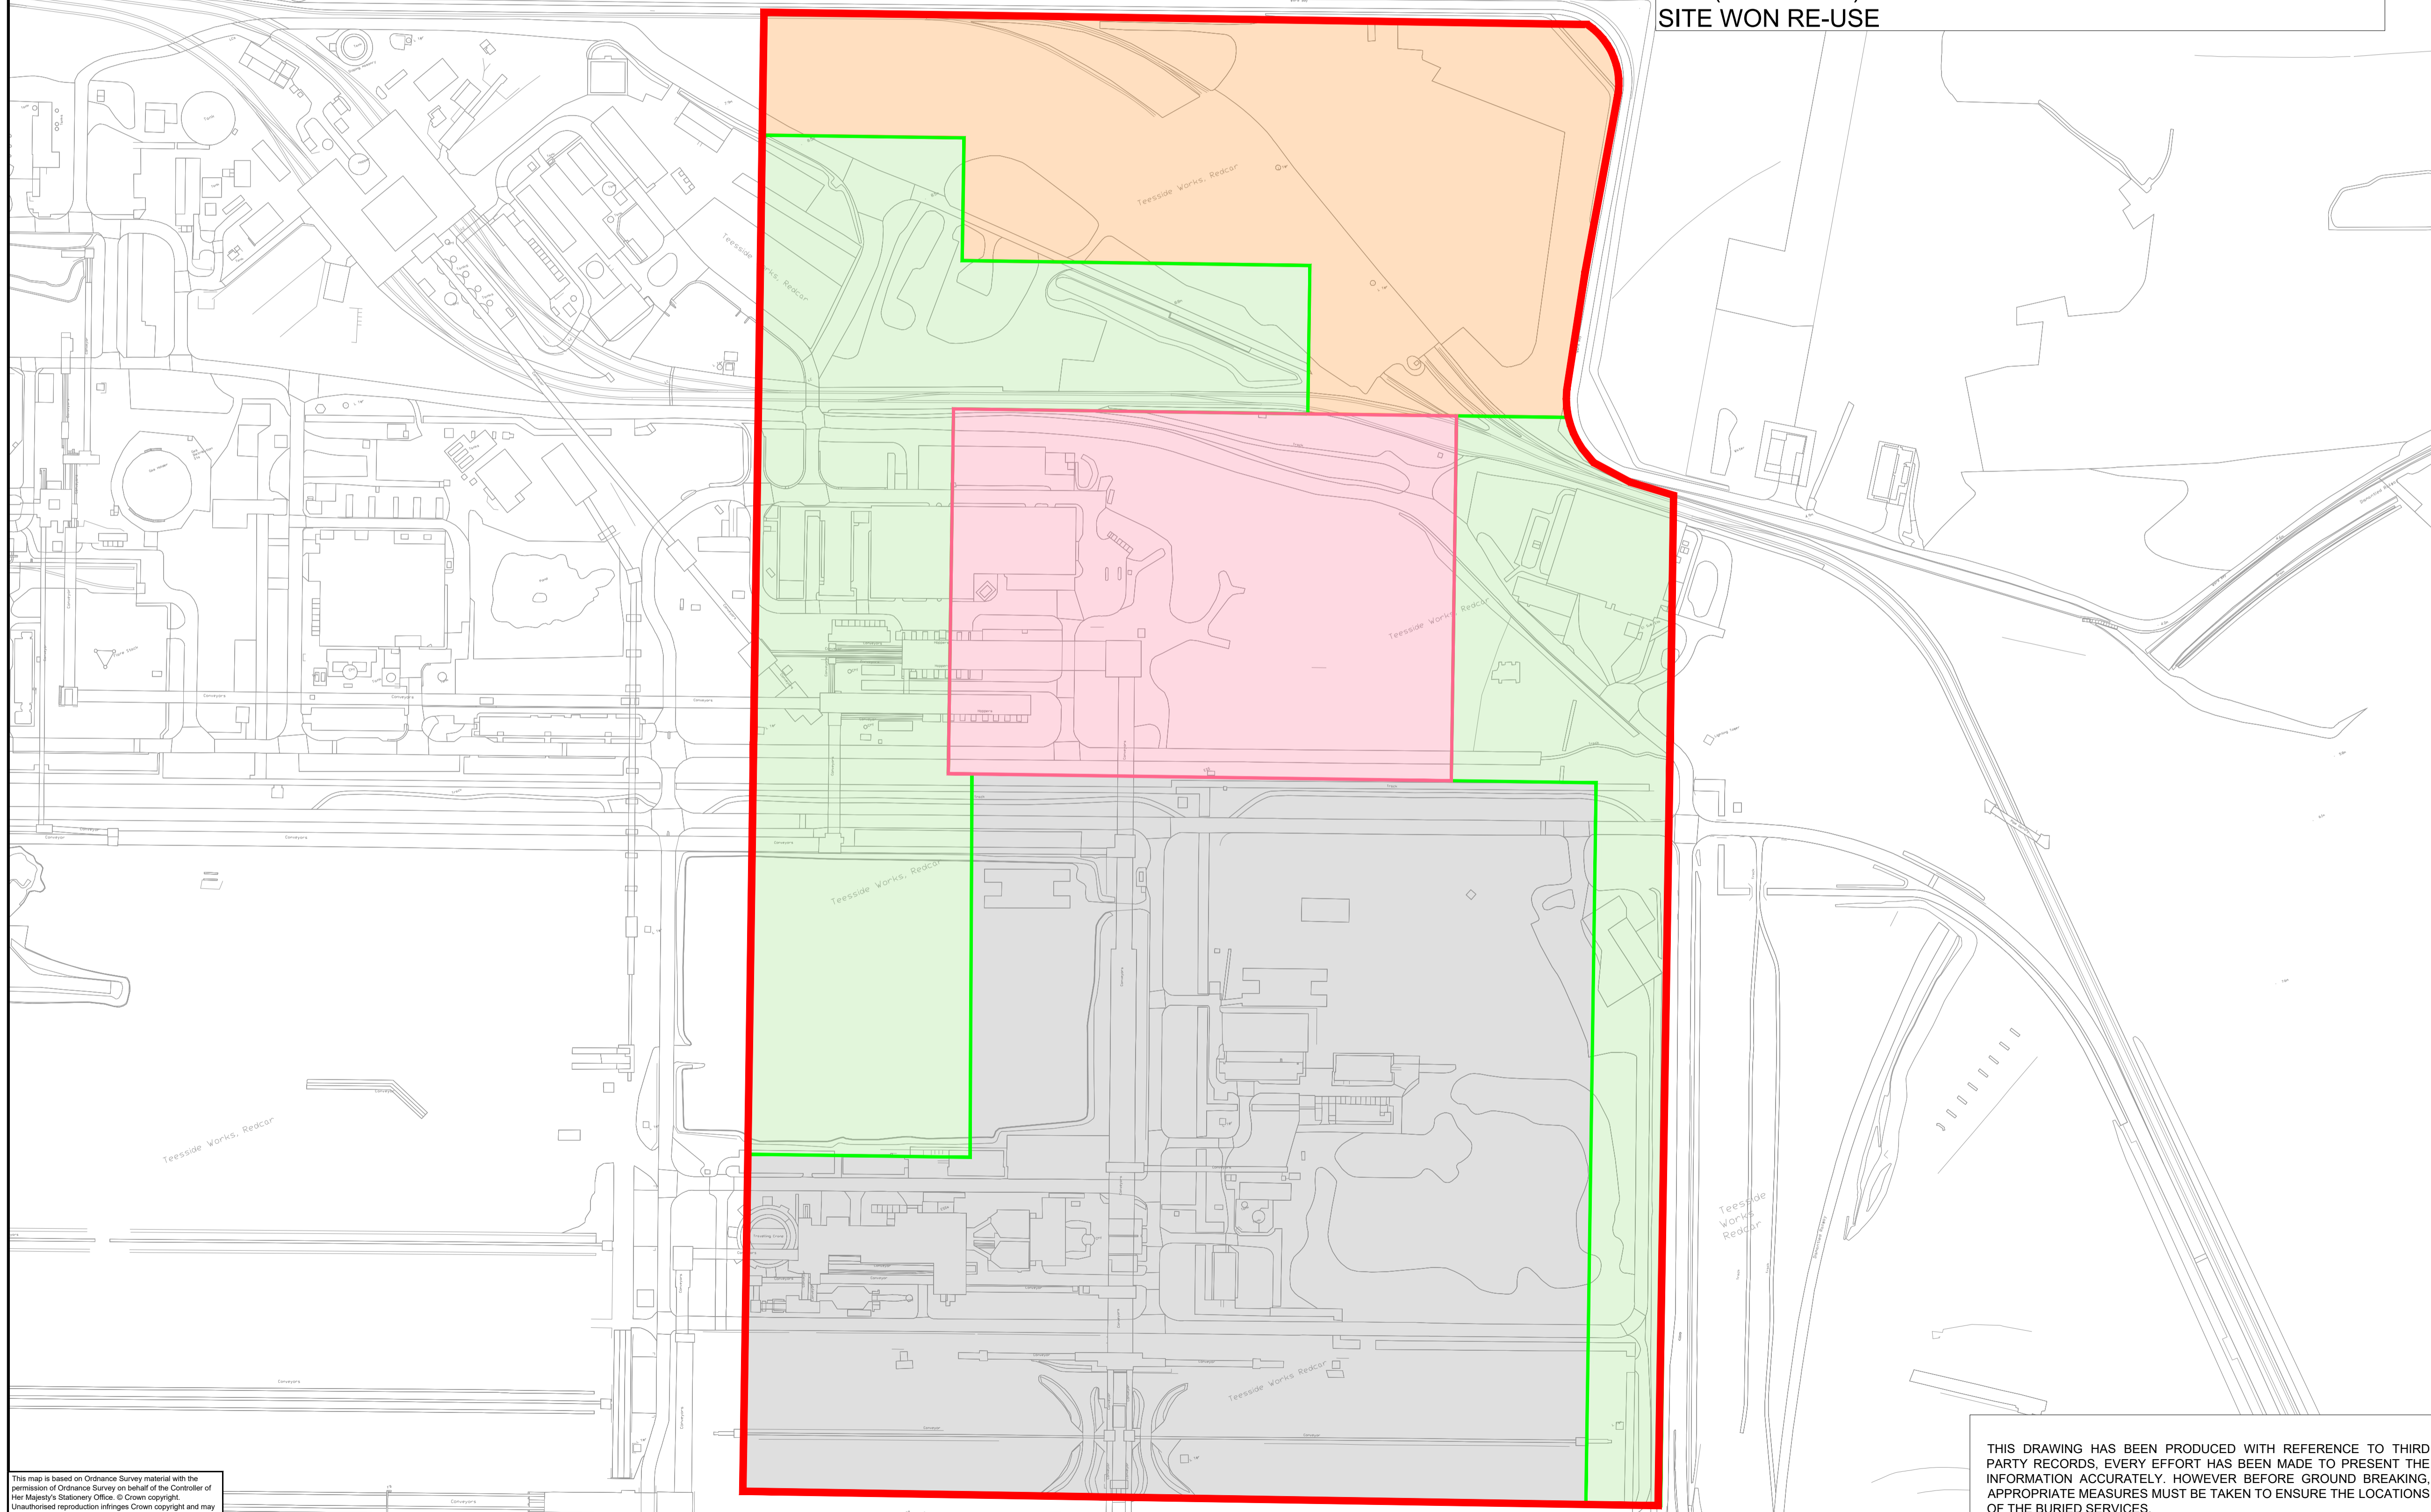
SITE AREA	PLOT REF	PLAN AREA (m2)	PLATFORM LEVEL (M AOD)	REMEDIATION DIG LEVEL (M AOD)	CUT FROM EXISTING GROUND TO REMEDIATION DIG LEVEL (M3)	FILL FROM EXISTING GROUND REMEDIATION DIG LEVEL (M3)	FILL FROM REMEDIATION DIG LEVEL TO PLATFORM LEVEL (M3)	NET (M3)	SURPLUS CUT/DEFICIT FILL	TOTAL (M3)	
Nzt OPTION 1 FGL 7.3M AOD	NET NZT GREEN	195,697	7.3	4.8	535,157	0	489,034	46,123	SURPLUS CUT	13,335	
	NZT ORANGE	110,979	7.3	4.8	215,895	2,458	278,250	-64,813	DEFICIT FILL		
	NET NZT PINK	92,296	7.3	3.8	355,060	0	323,035	32,025	SURPLUS CUT		
	VOID FILL ALLOWANCE				-	0	0	36,536	-36,536	DEFICIT FILL	-36,536
	NET TOTALS					1,106,112	2,458	1,090,319			
Nzt GREY		263,254	0.2m CUT FILL	0.2	52,651	0	52,651	0	BALANCED	0	
TOTALS					1,158,763	2,458	1,179,506	OVERALL TOTAL	DEFICIT FILL	-23,201

TOTAL CUT VOLUMES INCLUDES 7% (GREEN AREA) AND 15% (PINK AREA) BRICK AND CONCRETE ARISING FOR SITE WON RE-USE

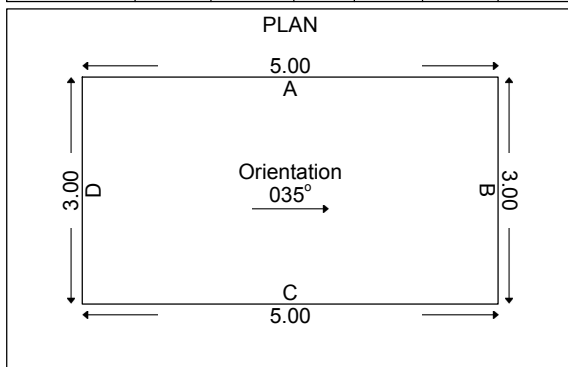
SAMPLES & TESTS			STRATA				
Depth	Type No	Test Result	Water	Reduced Level	Legend	Depth (Thickness)	DESCRIPTION
0.50	J1						MADE GROUND (Dark brown grey slightly clayey sandy gravel with high cobble and boulder content with some fragments of metal. Sand includes ash. Gravel is fine to coarse angular to subangular and includes slag, clinker and concrete. Cobbles and boulders are angular and include clinker and slag) (Engineer notes thick layers of slag throughout approx. c.20cm thick).
1.00	ES2						
1.20	PID B3	0.8ppm				(2.40)	
1.20	B3						
1.50	J4						
2.00	ES5						Trial pit terminated at 2.40m BGL - due to obstruction.
2.20	PID B6	2.4ppm		4.786	2.40		
2.20	B6						
2.40	J7

GROUNDWATER
 No groundwater inflow observed.

STABILITY
 Pit sides moderately unstable throughout excavation.

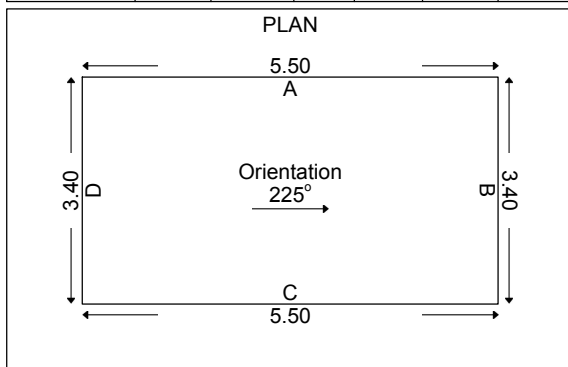
SAMPLES & TESTS			STRATA				
Depth	Type No	Test Result	Water	Reduced Level	Legend	Depth (Thickness)	DESCRIPTION
0.50	J1					(1.80)	MADE GROUND (Dark brown grey slightly clayey sandy gravelly cobbles and boulders with fragments of metal. Sand includes ash. Gravel is fine to coarse angular to subangular and includes slag, clinker and concrete. Cobbles are angular and include clinker and slag). (Engineer notes sulphurous odour throughout and possible ammonia odour).
1.00	ES2						
1.20	PID	0.3ppm					
1.20	B3						
1.50	ES4						
1.80	PID	10.0ppm		5.420		1.80	Trial pit terminated at 1.80m BGL - due to obstruction.
1.80	B5

GROUNDWATER
 No groundwater inflow observed.

STABILITY
 Pit sides unstable throughout excavation.

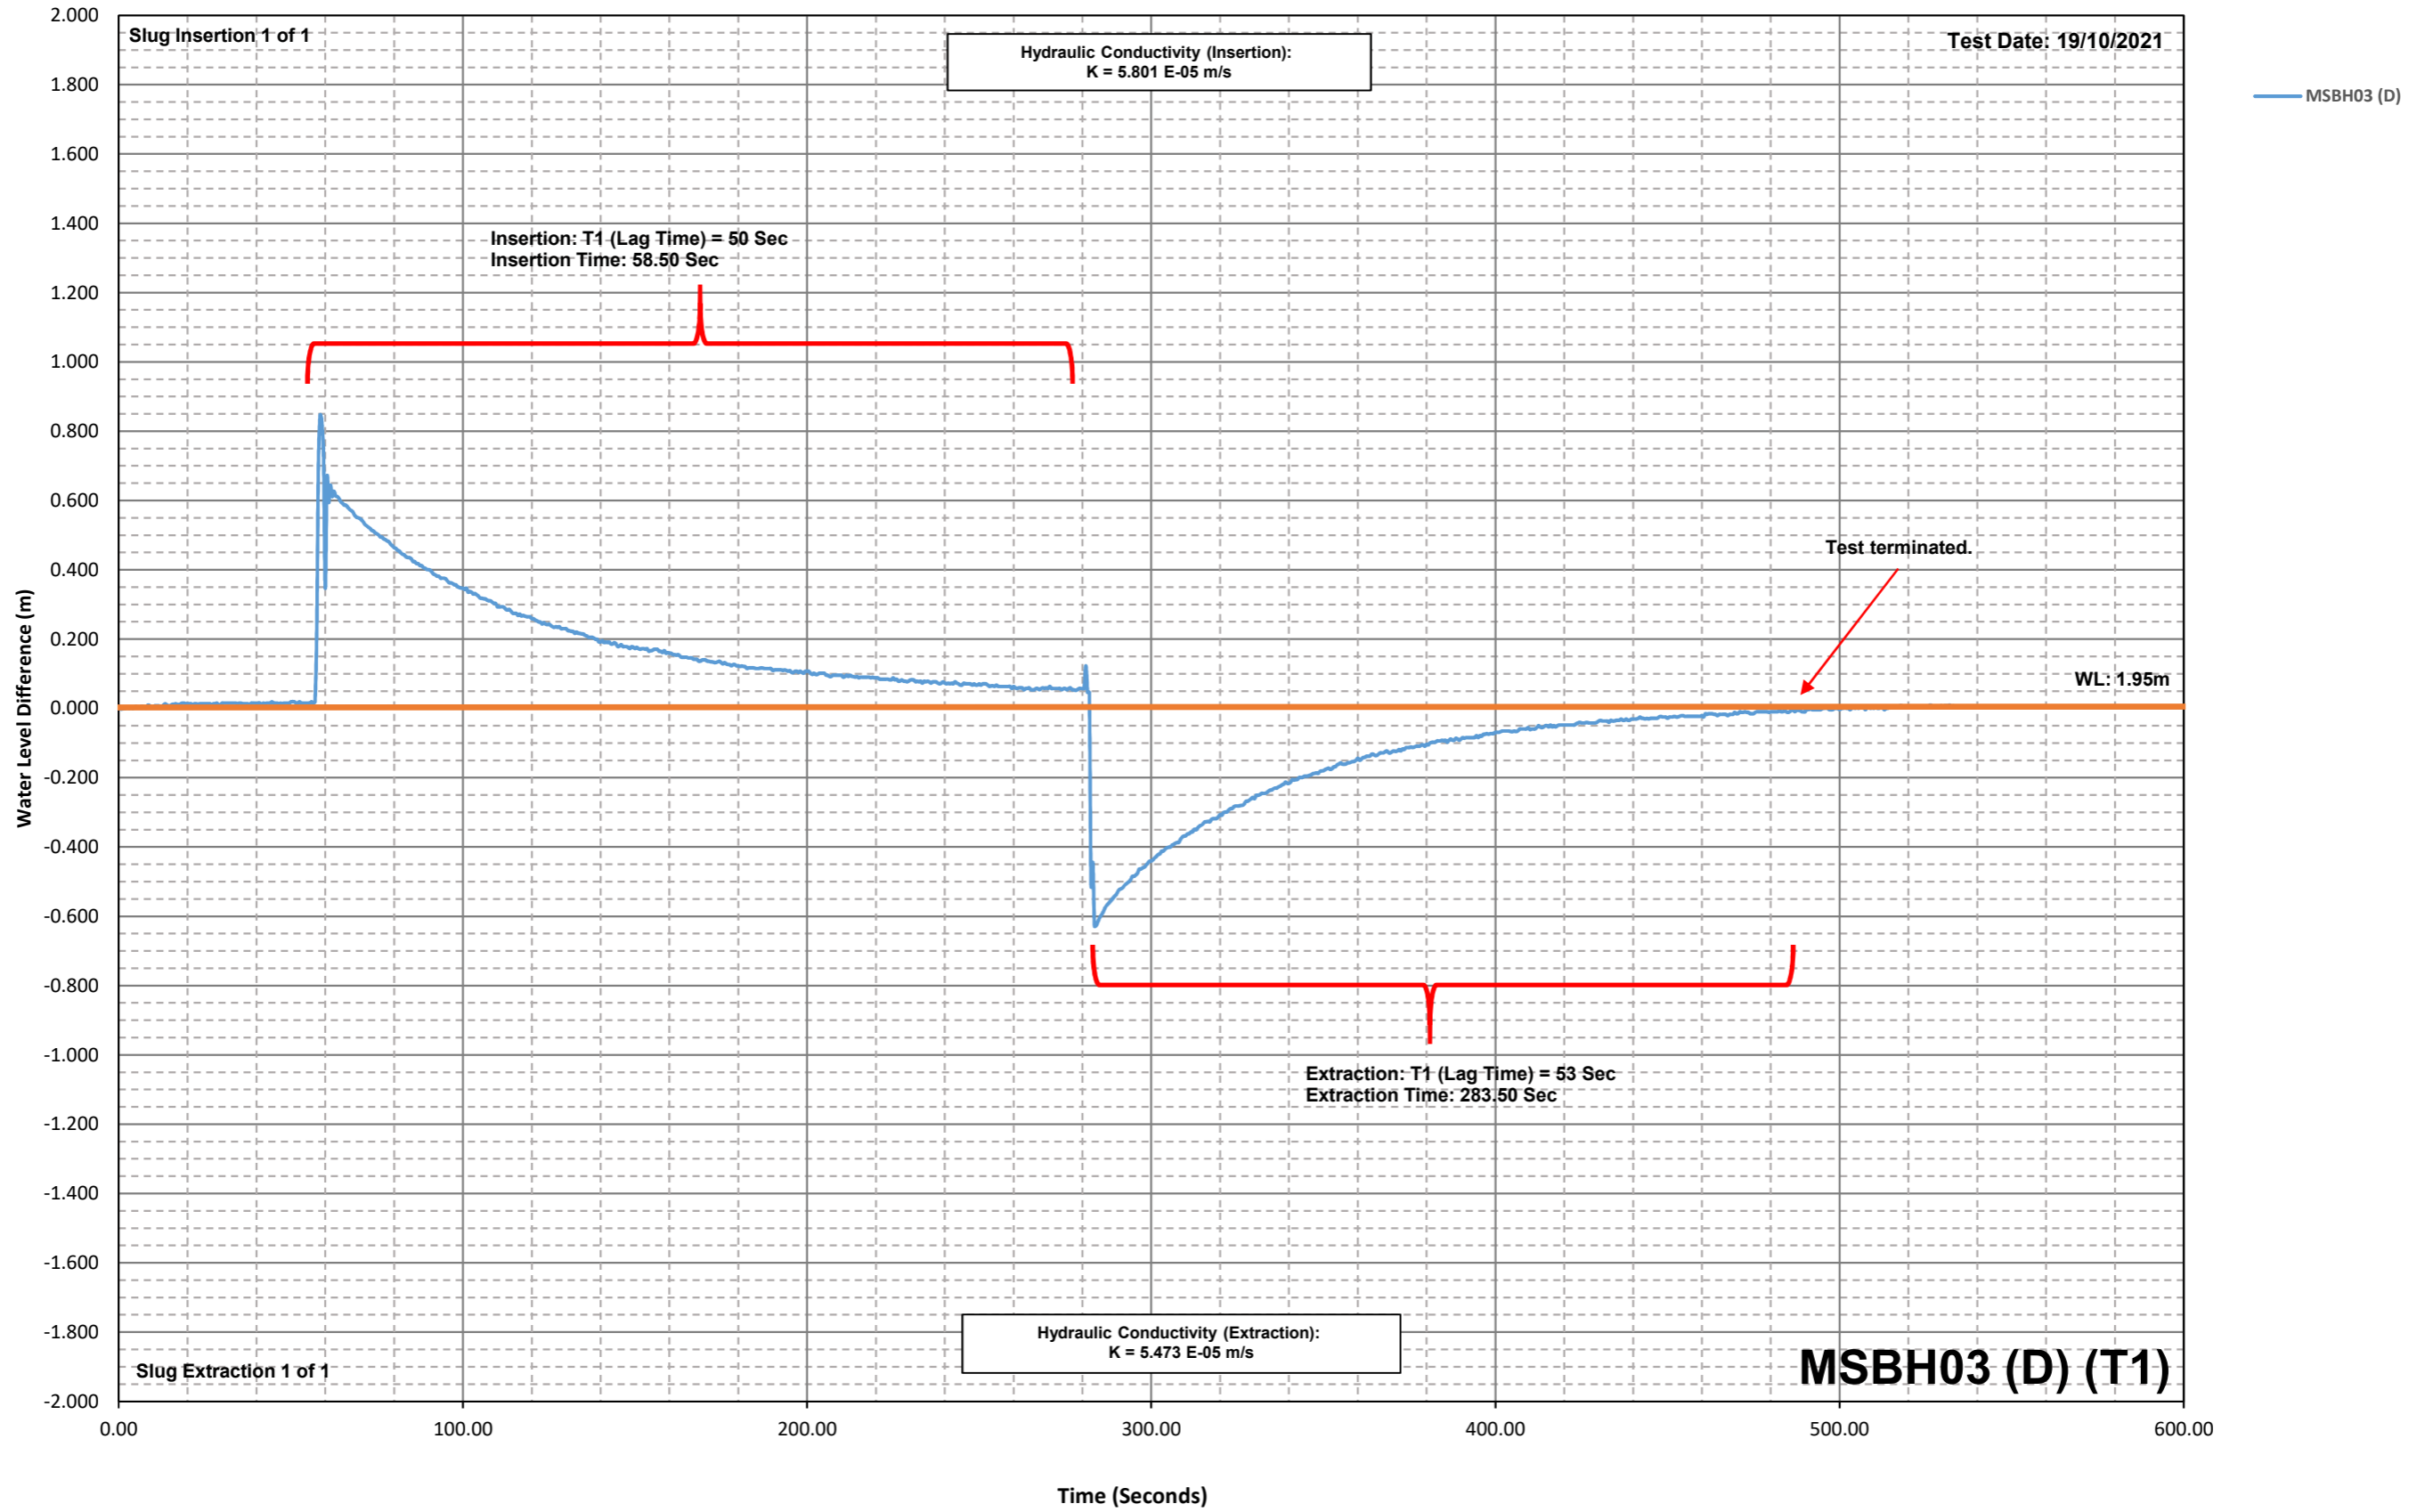
Hydraulic Conductivity: Slug Test

Hydraulic Conductivity Insertion/Extraction Data

Test Date: 19/10/2021

- Insertion 1
- Extraction 1

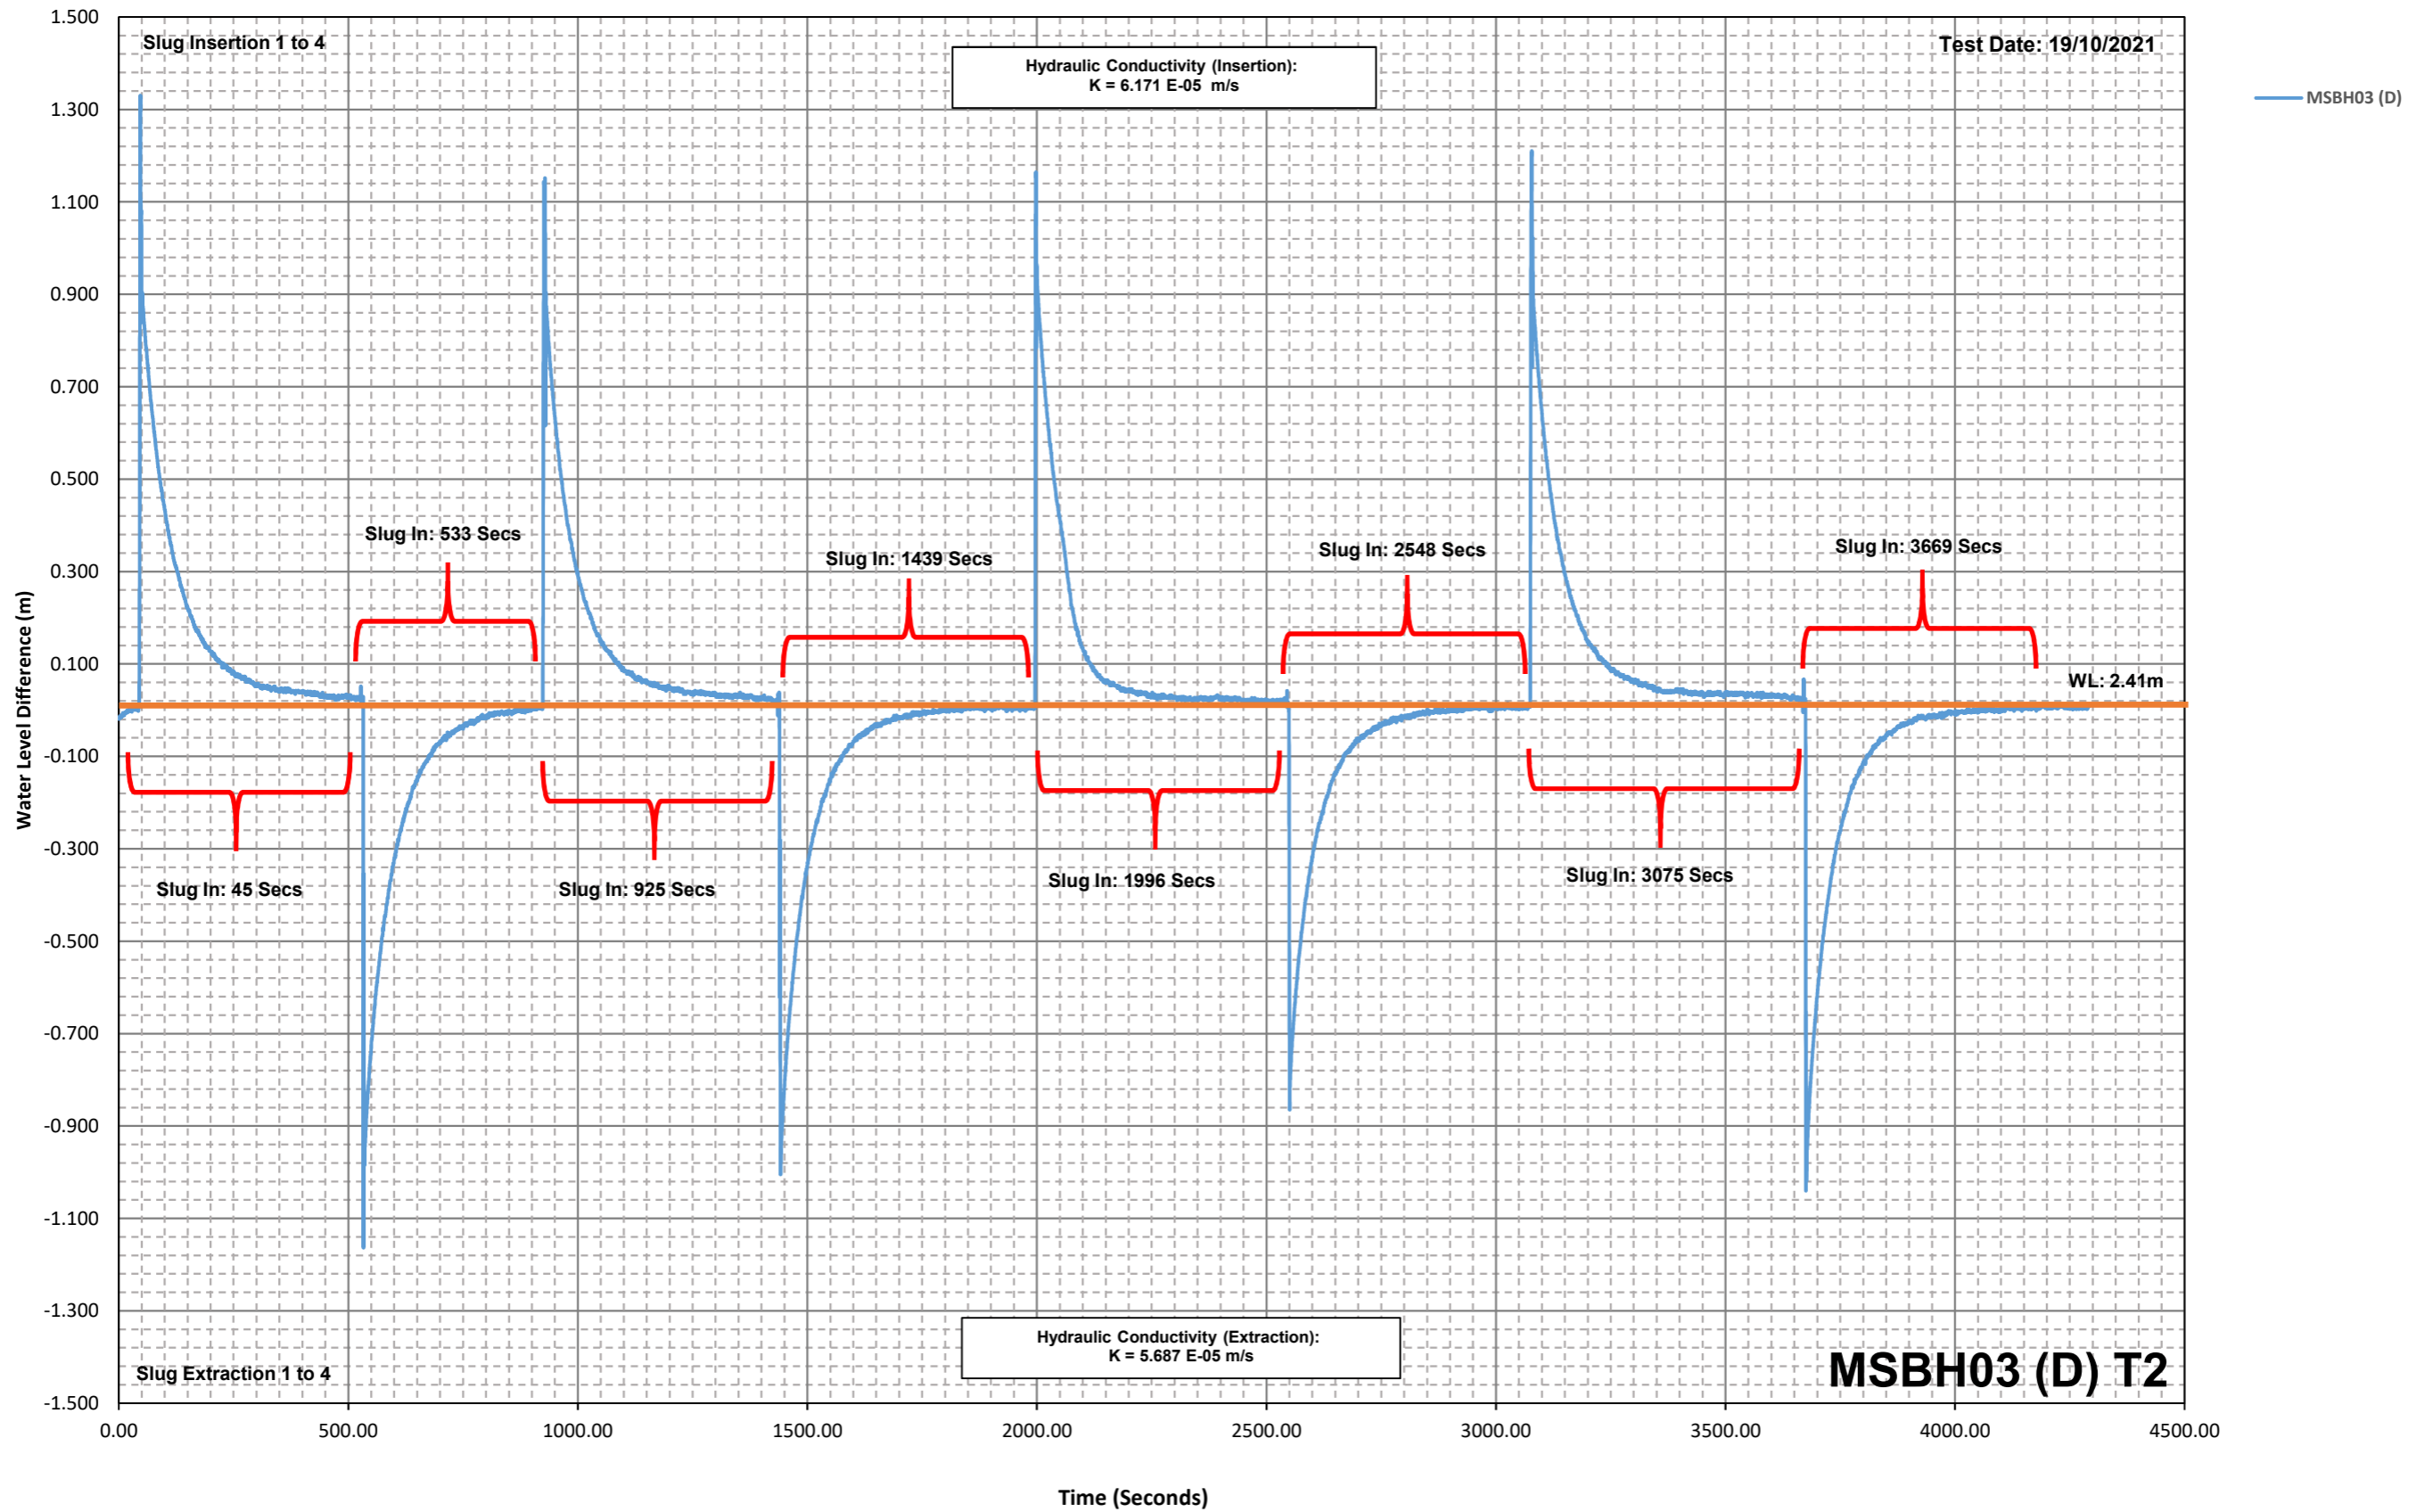
Hydraulic Conductivity: Slug Test

Hydraulic Conductivity Insertion Data

Test Date: 19/10/2021

- Insertion 1
- Insertion 2
- Insertion 3
- Insertion 4
