REDCAR ENERGY CENTRE – CONTAMINATED LAND PLANNING CONDITION

Redcar and Cleveland Borough Council

Enclosure B
Report Summary

DETAILED REPORT REVIEW: REDCAR ENERGY CENTRE

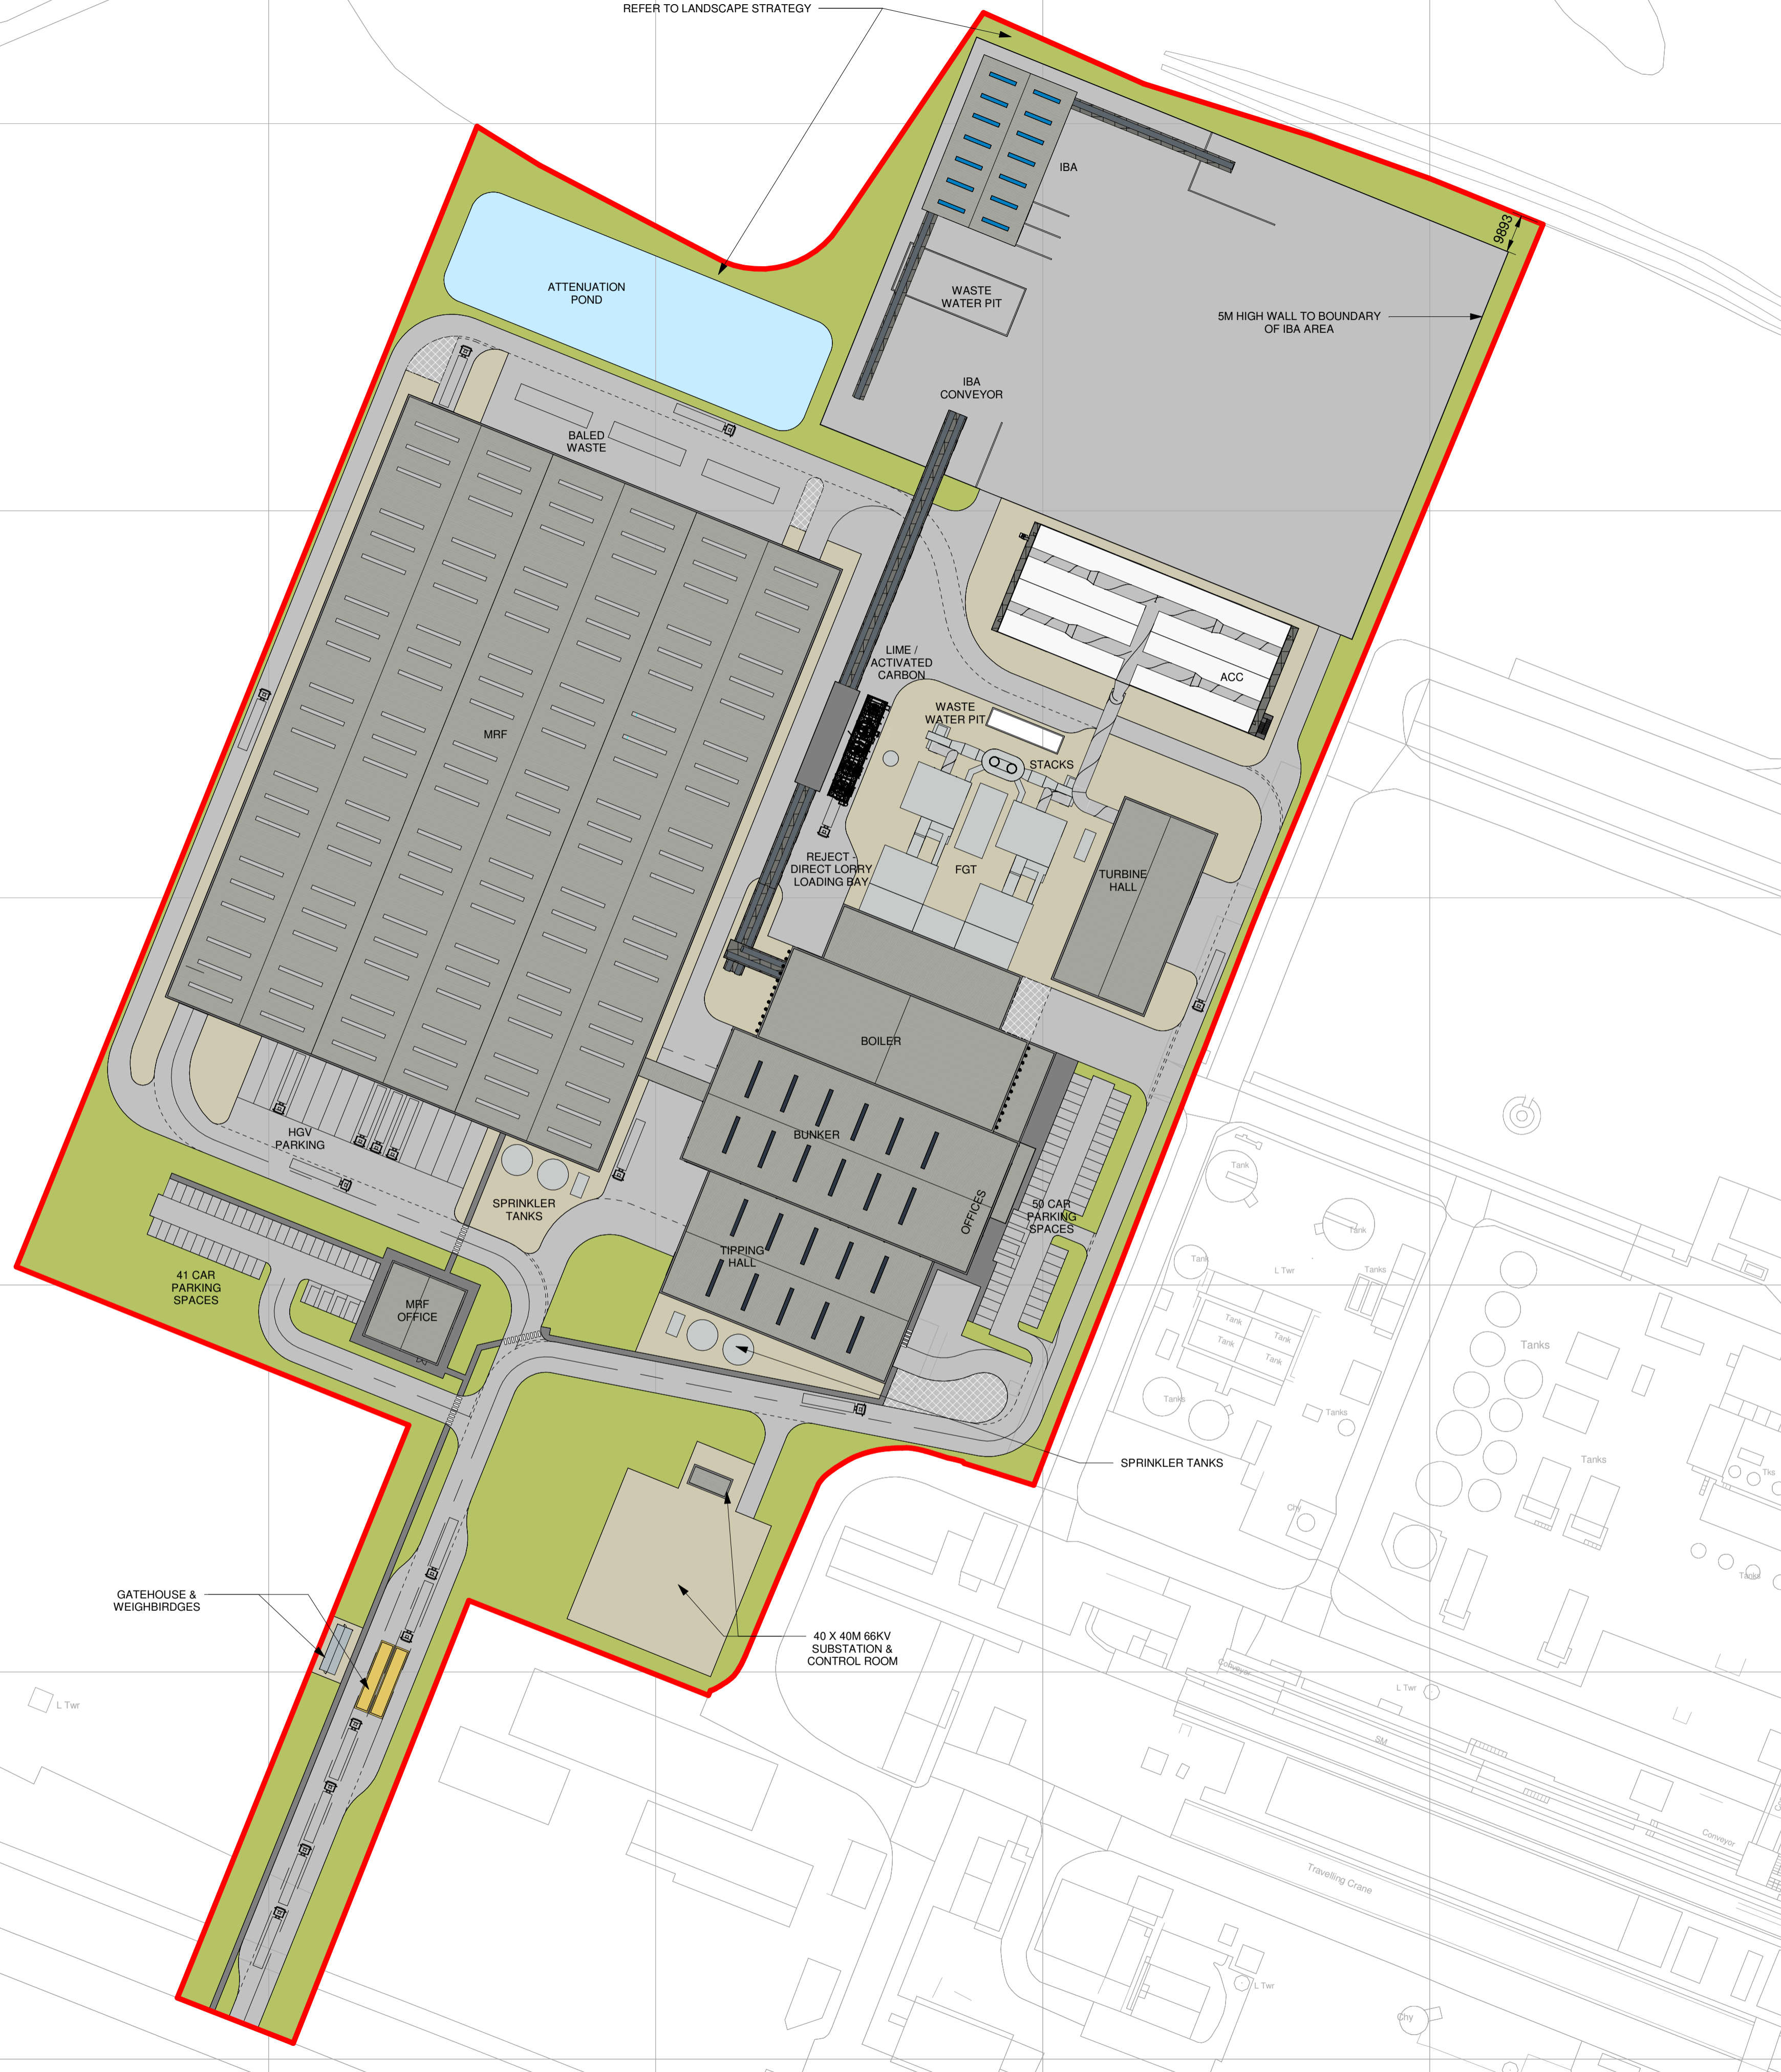
Title **Proposed Site Plan**

The area considered within this letter is set out upon the plan presented within *Enclosure A*.
