# Net Zero Teesside – Environmental Statement

Planning Inspectorate Reference: EN010103

Appendix 10A: Preliminary Sources Study Report

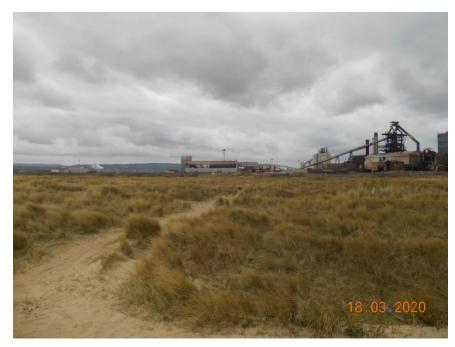
Plate 6 – View looking south southwest showing the dune habitat in the area of the proposed CO<sub>2</sub> corridor showing the proposed Main Teesworks Site in the background.

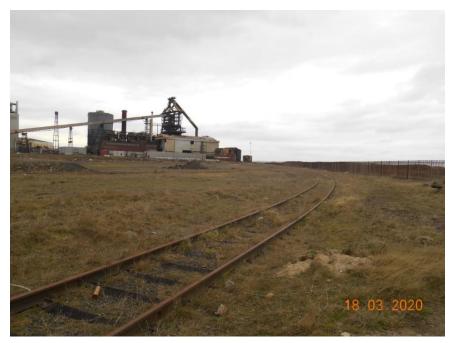
A rail siding is present running along the north boundary of the proposed Main Teesworks Site running from the blast furnaces to the west-north-west trending east southeast towards the steel 'pond' area, see Plate 12. This forms part of the Hot Metal Route railway, which was used to transport the liquid metal in the Torpedo ladles to the BOS plant located approximately 7km to the south (within the wider SSI site). This route also links to numerous other rail lines associated with the various processes that took place on Site.

Plate 12 - Rail siding running along the north boundary of the Teesworks Site.

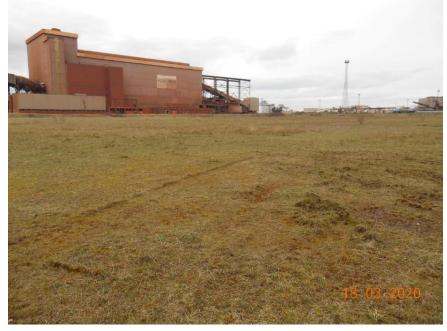
The area to the west of the office buildings comprises open vegetated soft landscaping bounded to the north by overhead equipment and the Blast Furnace Stockhouse, the Sinter Plant to the south, with conveyors and associated services to the east. The Sinter Plant is shown on Plate 21. The STSC representative described sinter to comprises small, irregular nodule shaped agglomerates of iron ore fines, limestone and coke which was used as a feedstock for the blast furnace.

# Plate 21 - View looking south west showing the Sinter Plant adjacent to the south boundary of the proposed site.

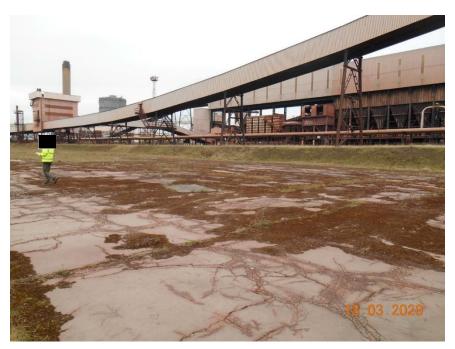
The north portion of this part of the Site in bounded by the Blast Furnace Stockhouse. An area of remnant hardstanding is present across this area, see Plate 22. It is understood that it was originally intended to construct three sinter plants across this area, however due to economic conditions and demand only one of these was constructed, with this relict hardstanding possibly associated with this.

Plate 22 – View looking north west showing area of remnant hardstanding and the Blast Furnace Stockhouse.

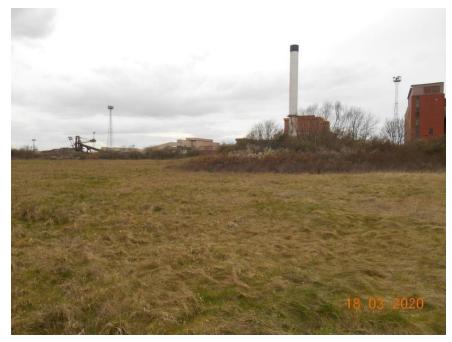
Land to the east of the STSC offices generally comprise areas of grassland and an area of remnant hardstanding. The south east corner of this part of the Site was historically occupied by a Pellet Plant demolished in the 1980s, see Plate 23.

Plate 23 – View looking south west. The Pellet Plant was located across the grassland shown on the left hand side of the photograph. There is no visible surface evidence of the former structure. The chimney stack shown in the background is associated with the Sinter Plant and is located adjacent to, but outside of, the Teesworks southern site boundary.

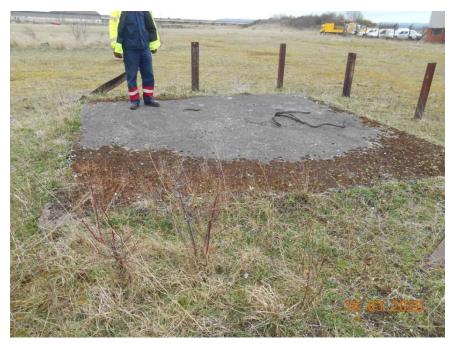
Further localised foundation bases were visible across this area, thought to be associated with former lighting columns, see Plate 25.

Plate 25 - View looking east southeast showing foundation base.

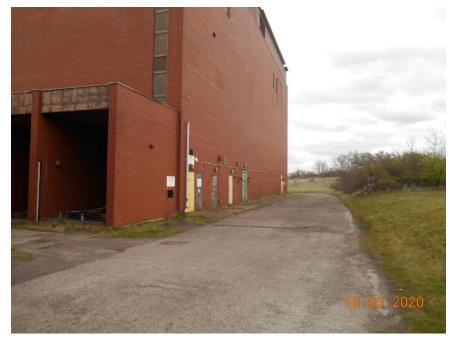
There are some large brick construction maintenance works present close to the south boundary of the Teesworks Site, see Plate 26.

Plate 26 – View looking east southeast showing a brick construction maintenance building.
