Report on the investigation of

Young Lady

Dragging anchor 5 miles east of Teesport and

Report No 3/2008
February 2008

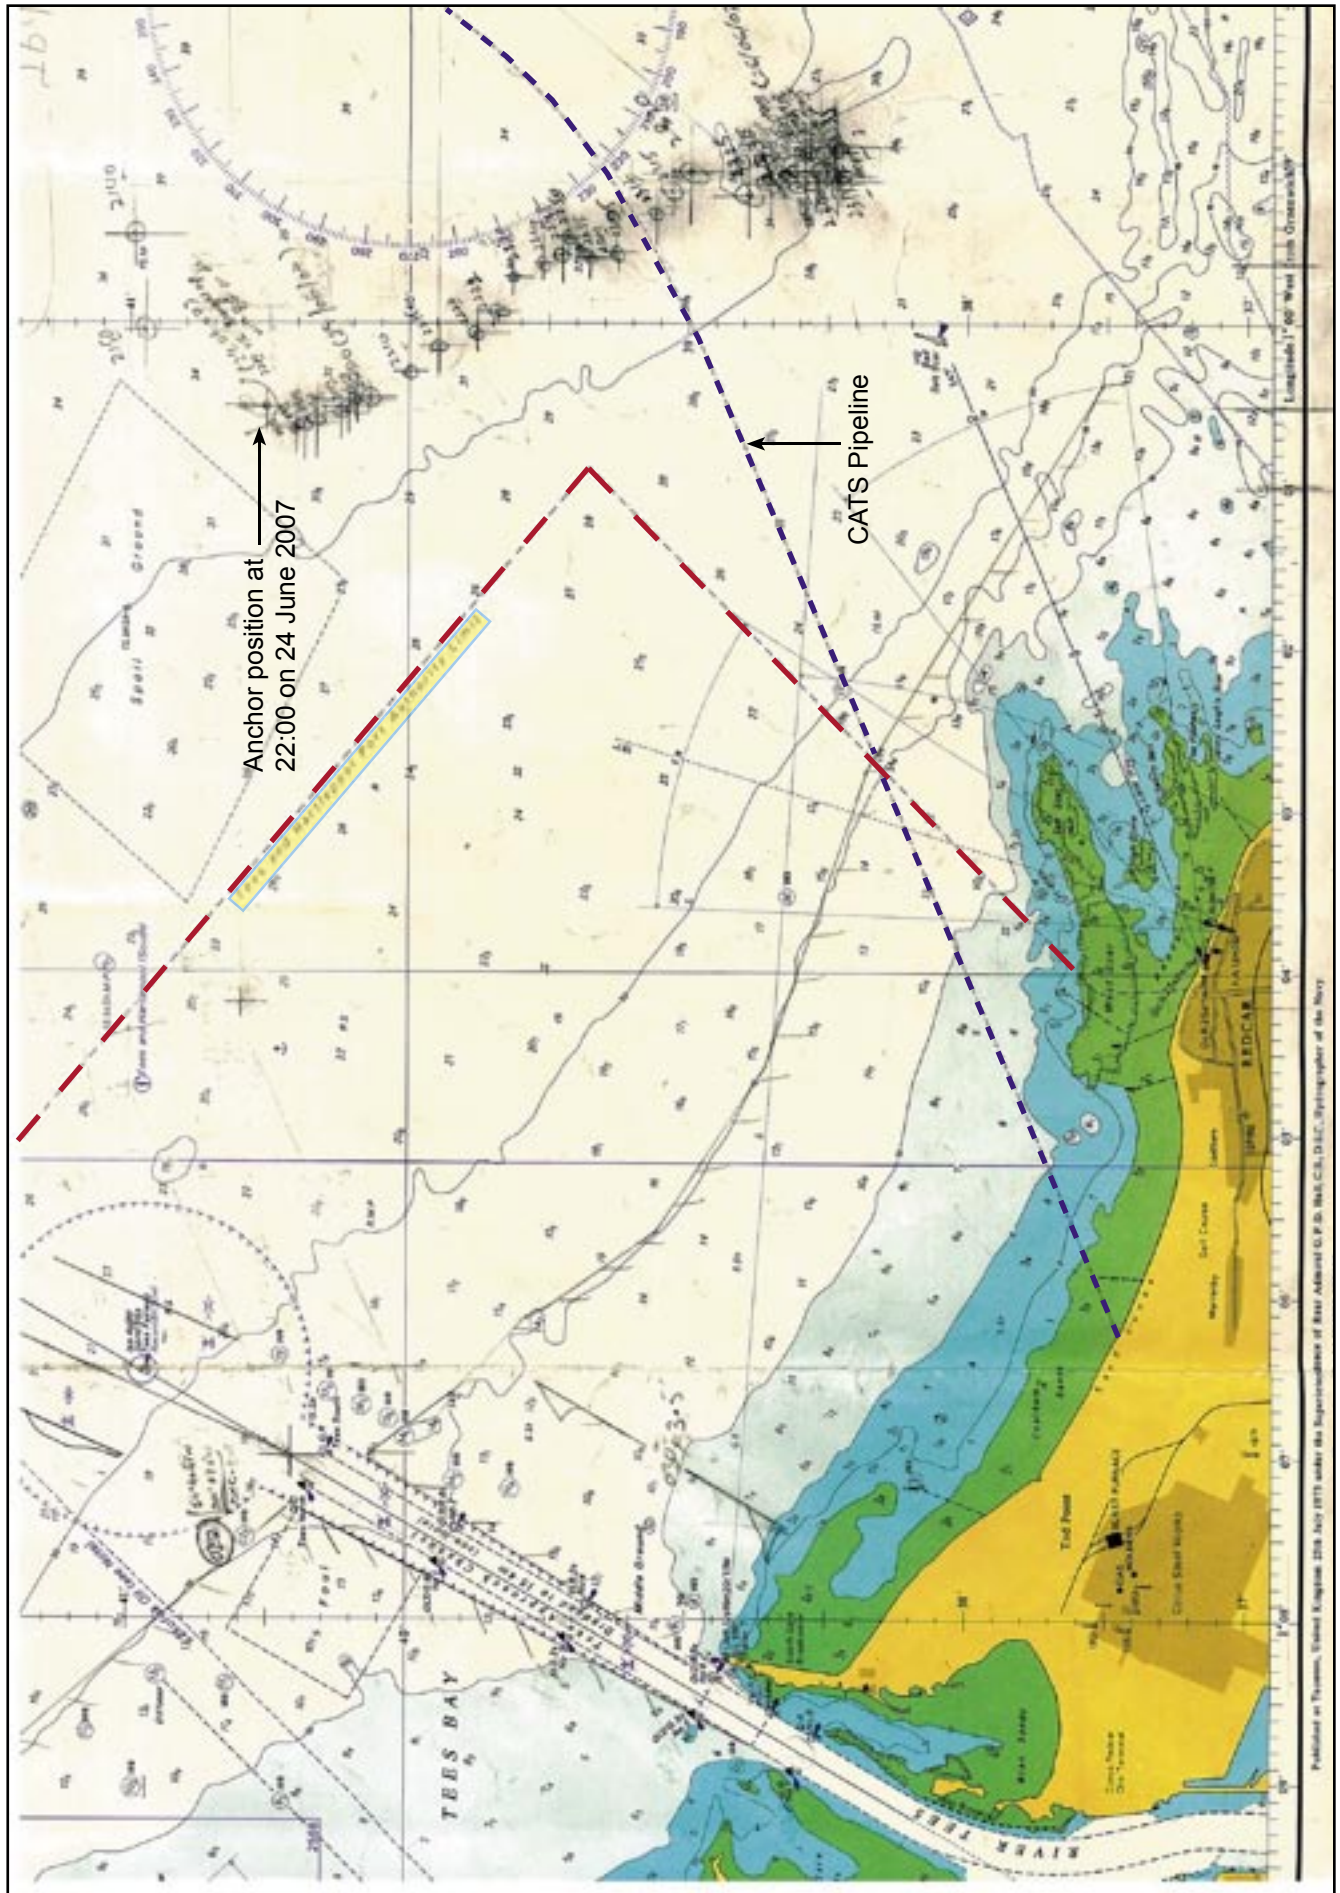
Figure 1

At 2154, the main engine was tested astern, and at 2200 the port anchor was let go in position 54° 40.51'N 001° 00.5'W. The position of the anchor and its location with reference to harbour limits, spoil ground areas and pipelines can be seen in **Figure 1**.

Position of anchor and its location with reference to harbour limits, spoil ground areas and pipelines

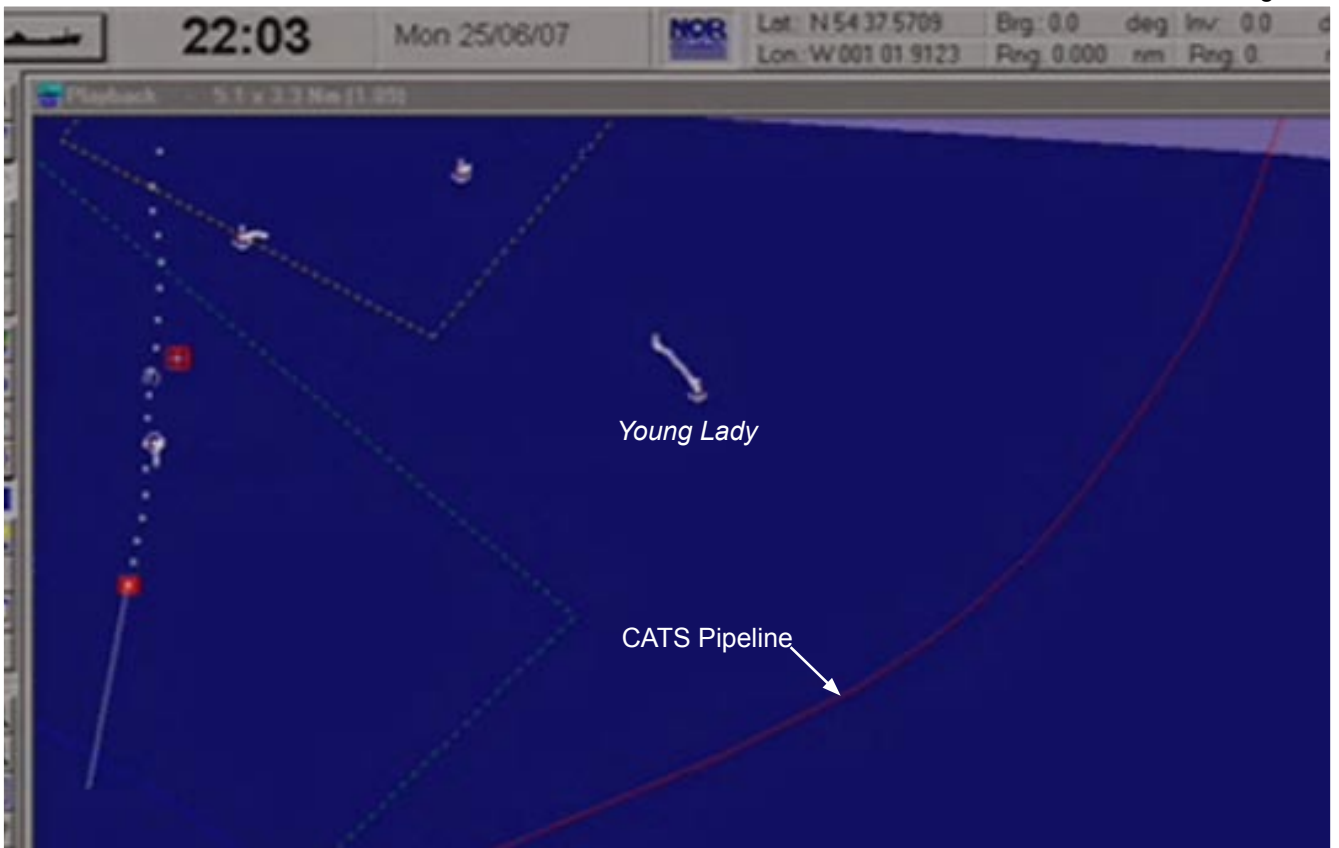
Figure 2

At 2200, the OOW placed a DGPS position on the chart, which showed the vessel lying outside of the swinging circle. He had concerns that the vessel was dragging anchor and called the master at around 2203 (**Figure 2**). The master ordered the third officer to contact the duty engineer to make ready the main engine, and the chief officer to stand by forward. When the master arrived on the bridge he fixed the vessel's position on the chart, and confirmed that *Young Lady* was dragging anchor².

VTS screenshot at 22:03

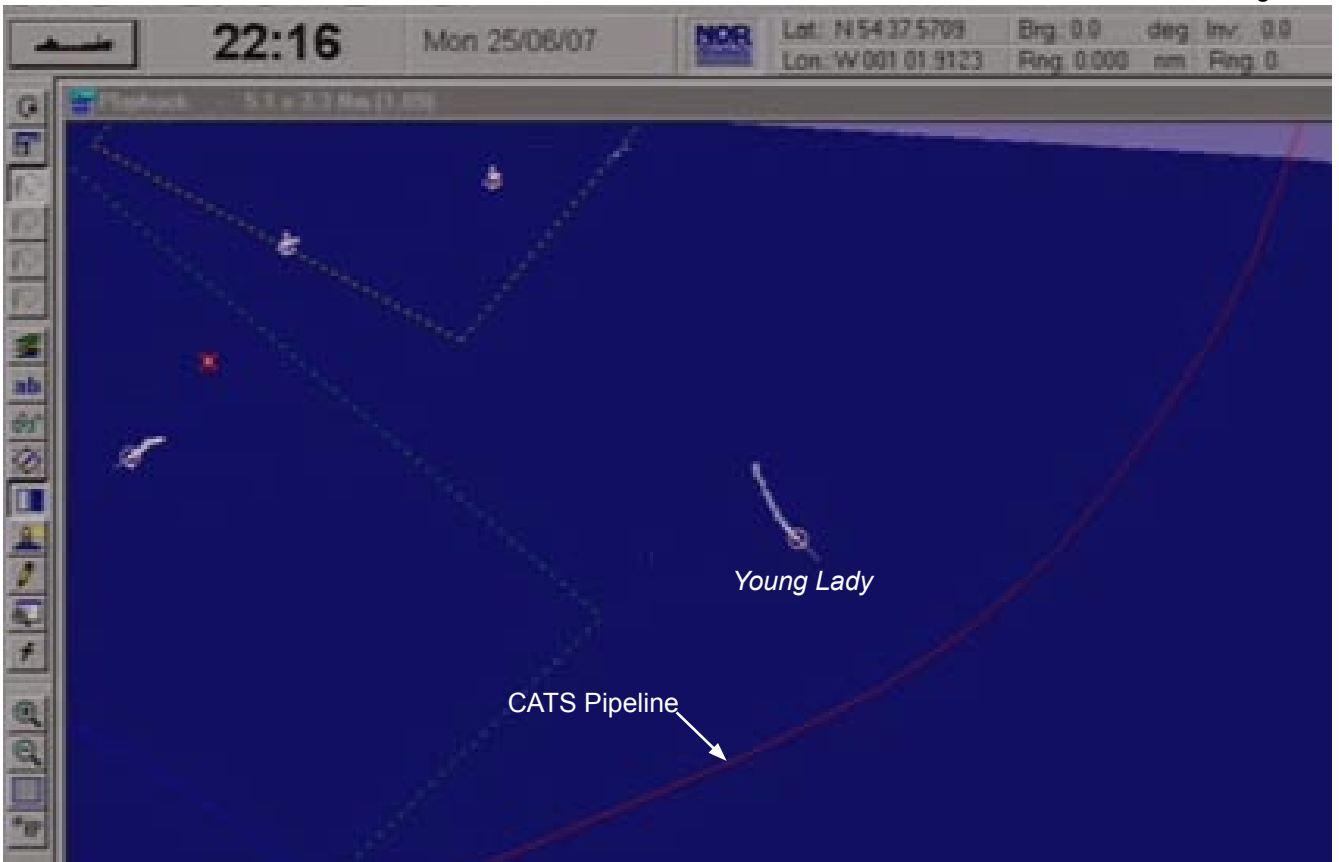
Figure 3

At 2215, the main engine was successfully tested, and at 2216 the engine room was then placed on stand by. Between the times of identifying that the vessel was dragging anchor at 2200, and the main engine being made ready for use at 2216, the vessel had dragged a distance of 0.8 nm at a rate of 3 kts (**Figure 3**).

VTS screenshot at 22:16

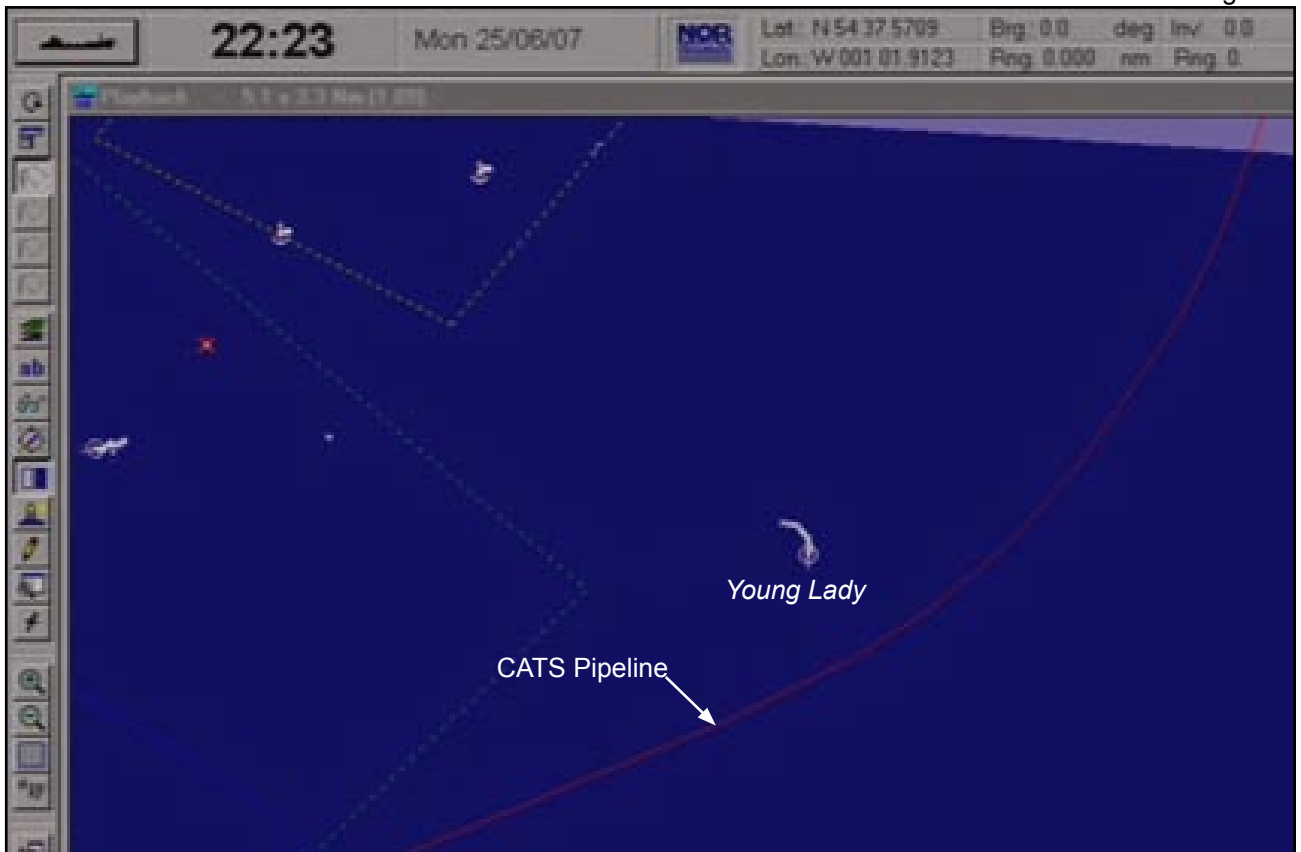
Figure 4

The first engine order was a kick of 'dead slow ahead' recorded at 2223 (**Figure 4**). The chief officer continued to report the direction of the cable which, with the vessel swinging wildly, was leading at very long stay from between starboard 90° to port 180°. The ship's head was recorded as swinging between 068° and 320° over the same period.

VTS screen shot at 22:23

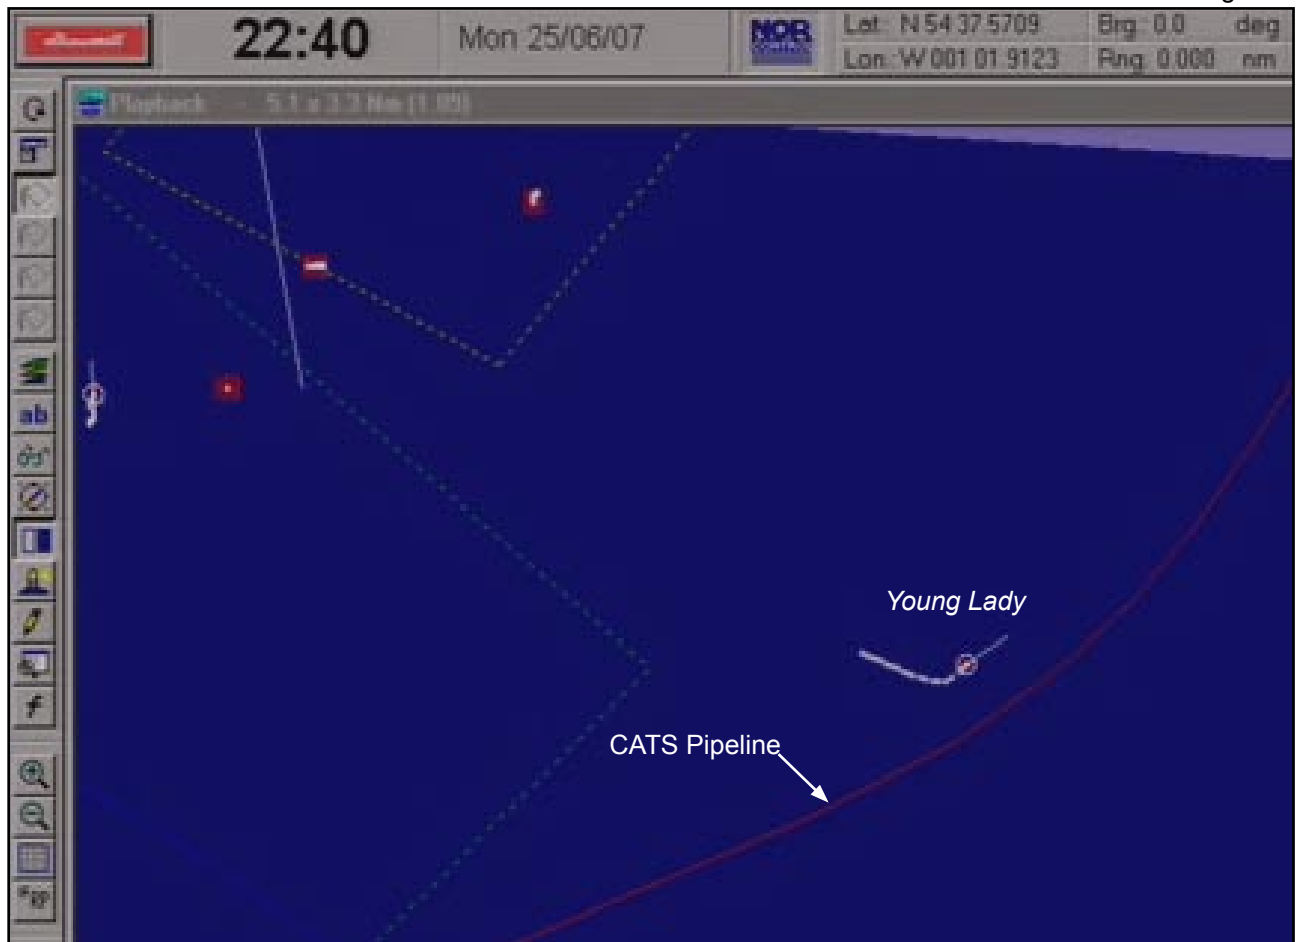
Figure 5

At 2235, the engine was stopped and the rate of drift increased markedly. The next period of engine movements, between 2238 and 2245, succeeded in arresting the drift, and at about 2240 (**Figure 5**) *Young Lady* was stopped over the ground. The vessel had now dragged a total distance of 1.3 nm, and lay only 2 cables north of the charted CATS (Everest) gas pipeline. The wind was steady at about 45 kts from the north-west, and the ship's head was yawing between 310° and 070°. Seas were breaking over the forecastle in the 5m to 6m swell.

VTS screen shot at 22:40

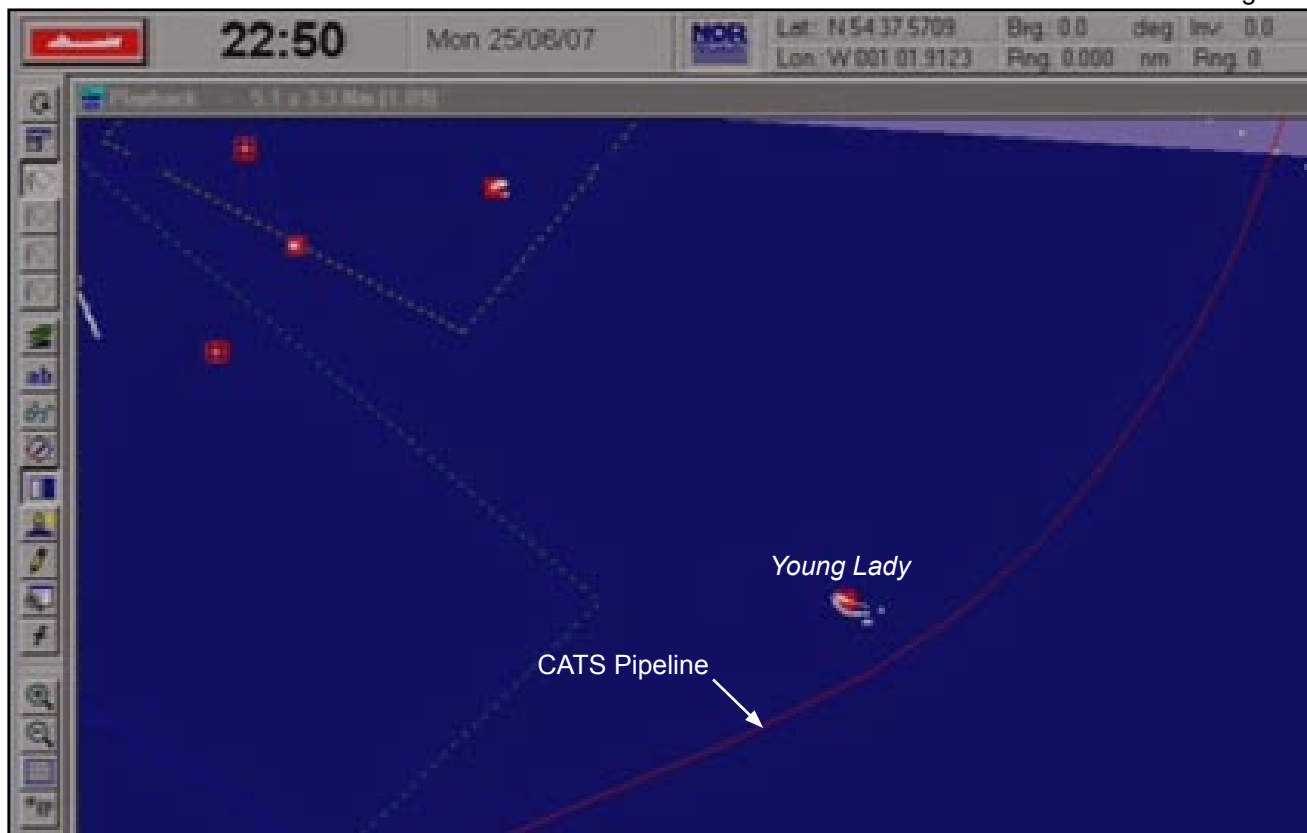
VTS screen shot at 22:50

Following a succession of engine movements up to 'half ahead', the vessel started to make slight headway toward the north-west. At 2250 (**Figure 6**), with the main engine set at 'half ahead' and the third joining shackle visible between the sea and the hawse pipe, the chief officer reported that the cable was leading nearly astern along the port side. The same report advised the bridge that there was too much weight on the cable, and it was the intention to apply the brake and hold on. As the brake was being applied and the crew made the final adjustment, the port windlass, which was still in gear with the control lever in the neutral position, suffered a catastrophic failure of the hydraulic motor unit (**Figure 7**). The cable ran out immediately, the brake lining started to smoke, and sparks from the brake shoe were observed as the lining disintegrated. Hydraulic oil from the windlass motor was spraying over the forecastle at a pressure of 220 bar.

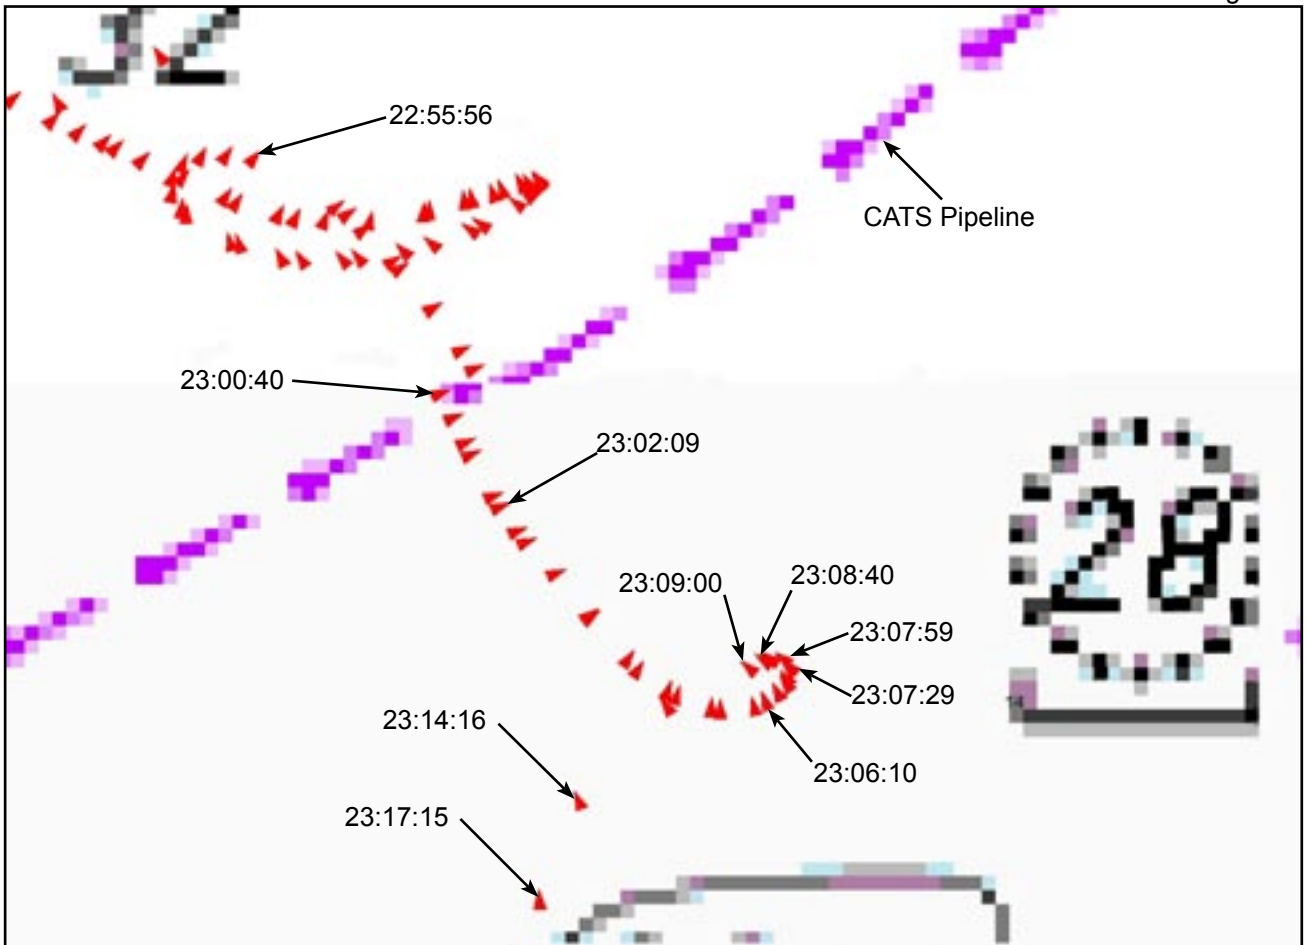
Figure 8

At 2252.5 the main engine was set to 'slow ahead'; at 2253 reduced to 'dead slow', and stopped at 2255. As the port cable payed out to the bitter end, a total of 12 shackles, the vessel drifted quickly to the south, passing over the CATS gas pipeline at 2301. The drift was arrested at 2306 when *Young Lady* was lying 460 m south of the pipeline, a position which corresponded with the port anchor being in the vicinity of the pipeline, some 1.75 nm south-south-east of the original anchor position (**Figures 8 and 9**).

Timings of *Young Lady's* movement over the CATS Pipeline

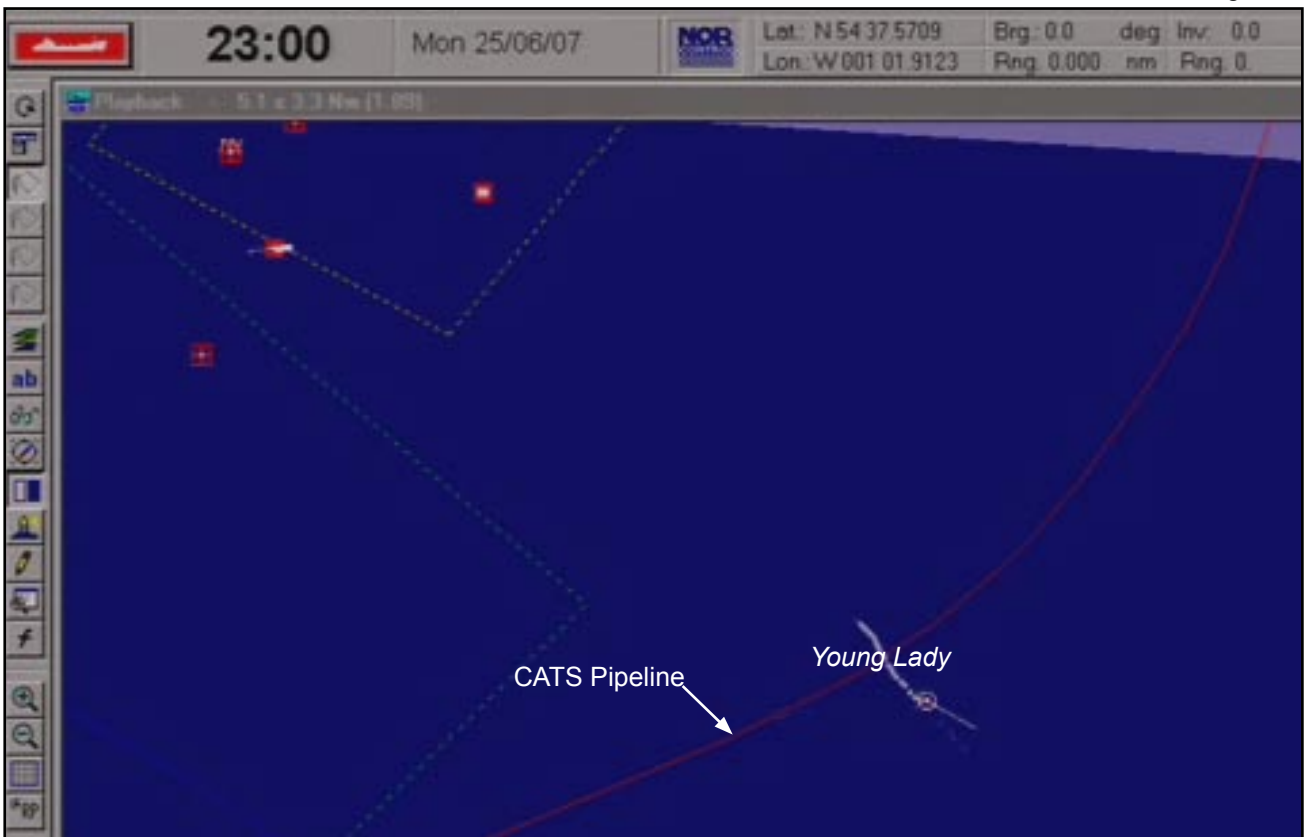
Figure 9

VTS screen shot at 23:00

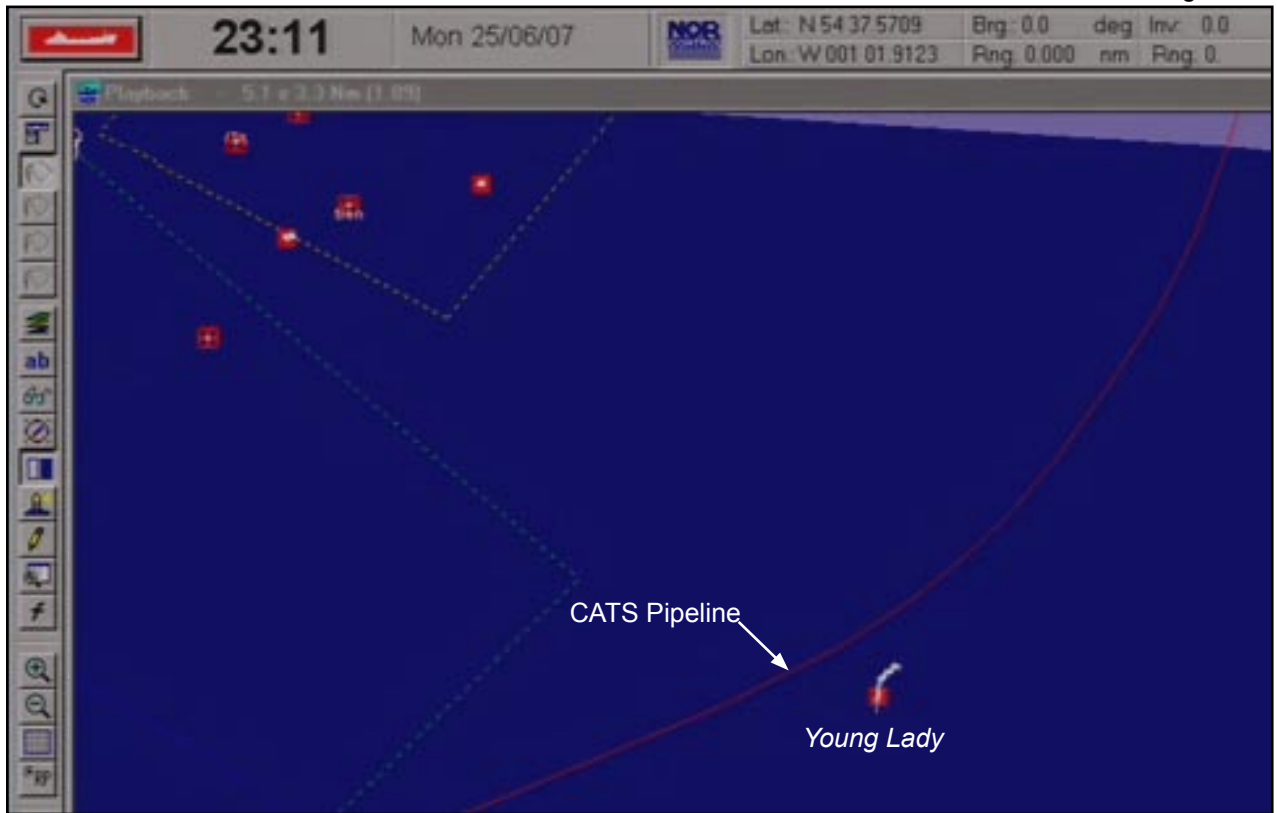
Figure 10

The master, suffering from the effects of shock, was concerned about the dangers faced by the crew working on the forecastle. He was now aware that the vessel had passed over the gas pipeline. The master made a telephone call to the DPA to apprise him of the situation. Between 2301 and 2306.5 engine movements of 'dead slow', and 'slow ahead' were made in an attempt to reduce the weight on the cable, and to control the yawing which was in excess of 100 degrees. At about 2311, when the vessel was at the extremity of a yaw to the north-west, the anchor freed itself from the pipeline and *Young Lady* re-commenced dragging anchor toward the south (**Figure 10**).

VTS screen shot at 23:11

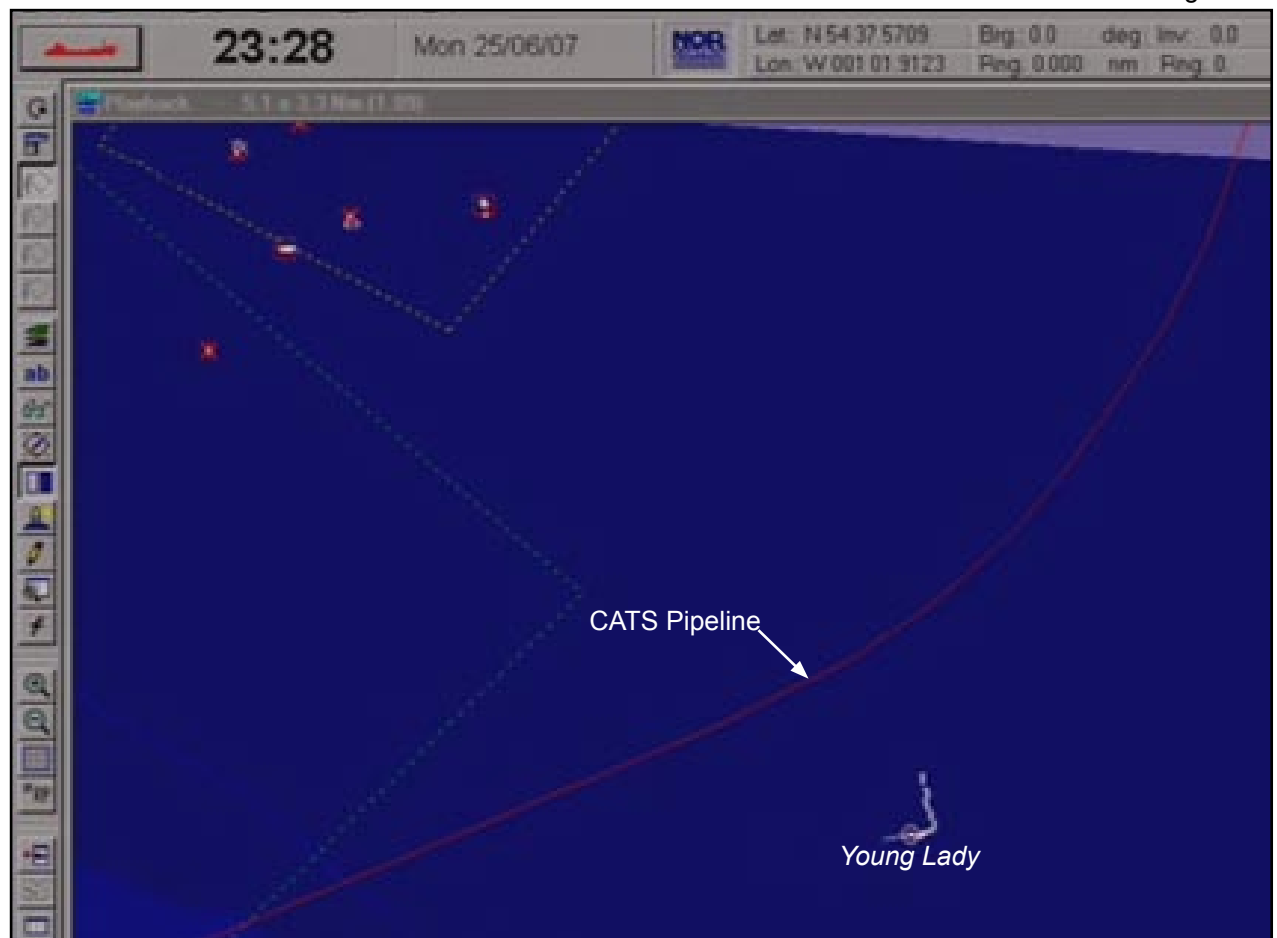
Figure 11

At 2324, the master contacted Tees Ports Control and informed them that the windlass was inoperative and that the cable was now only holding on by the bitter end. Although the master believed that the vessel was no longer dragging, he was conscious of the close proximity of the Salt Scar cardinal buoy. Aware that the vessel was still in the vicinity of the pipeline, it was the master's intention to steam to the north and slip the cable. The main engine was not used throughout this period but, coincidentally as the vessel dragged over a shoaling sea bed, the anchor held and the vessel settled in position 54° 38.55' N 000° 58.9'W at about 2328 (**Figure 11 and 12**).

VTS screen shot at 23:28

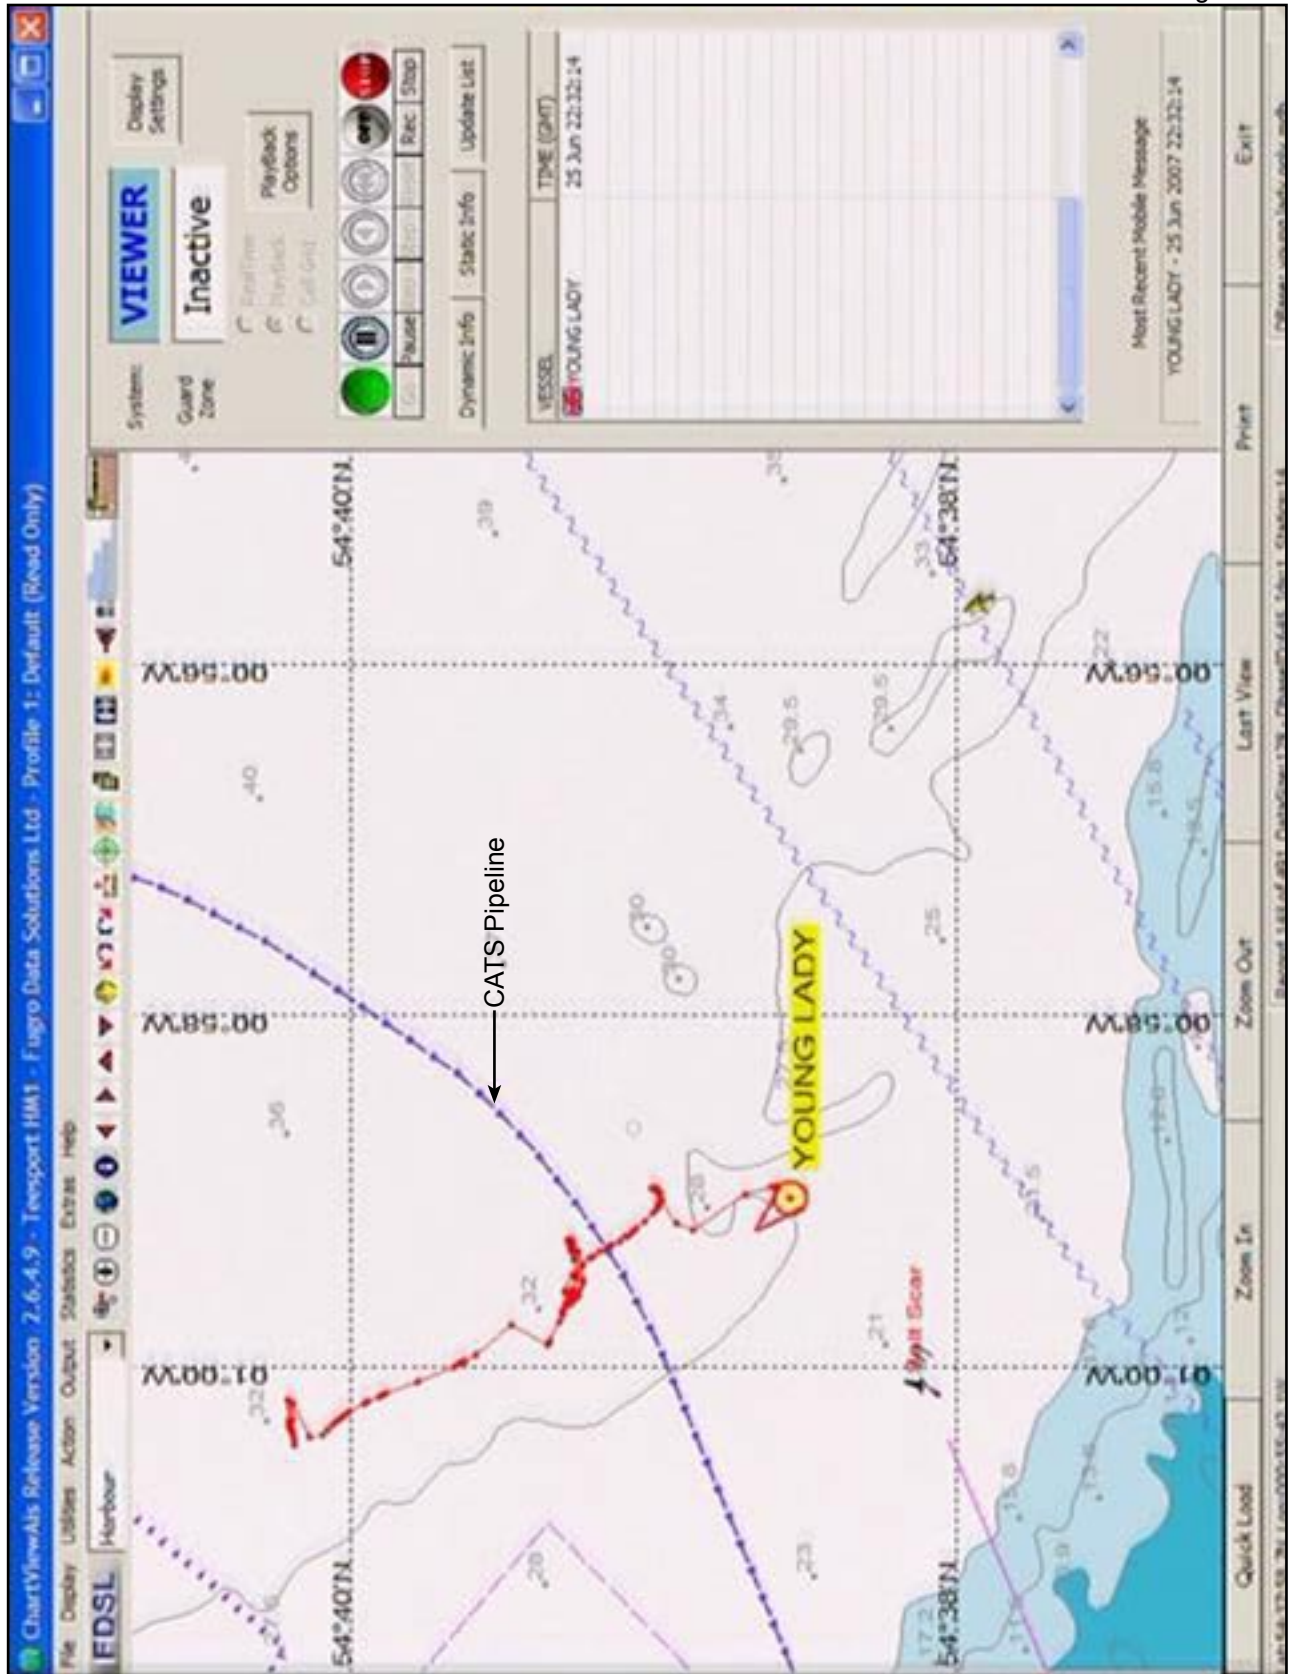
Figure 12

AIS Screen shot, showing Young Lady's movement from 22:00 to 23:32 BST

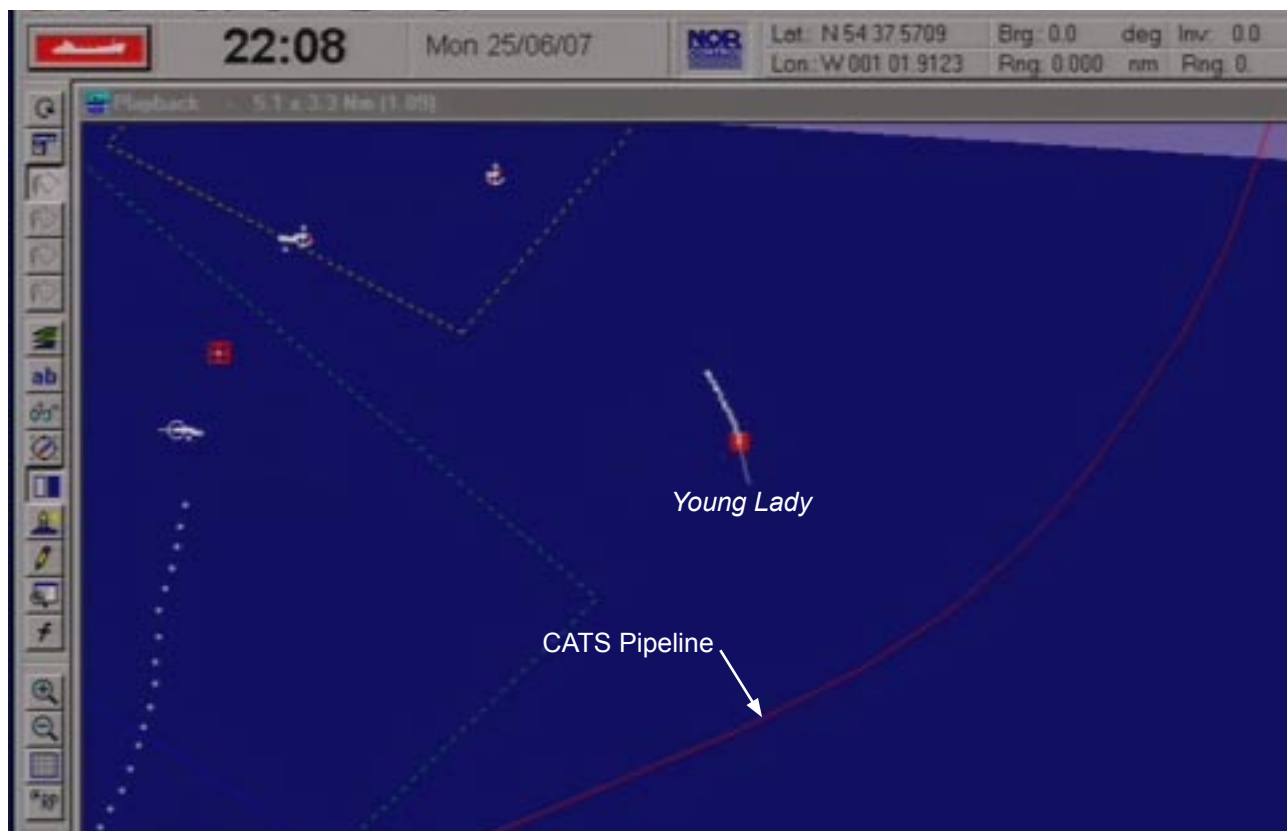
VTS screen shot at 22:08

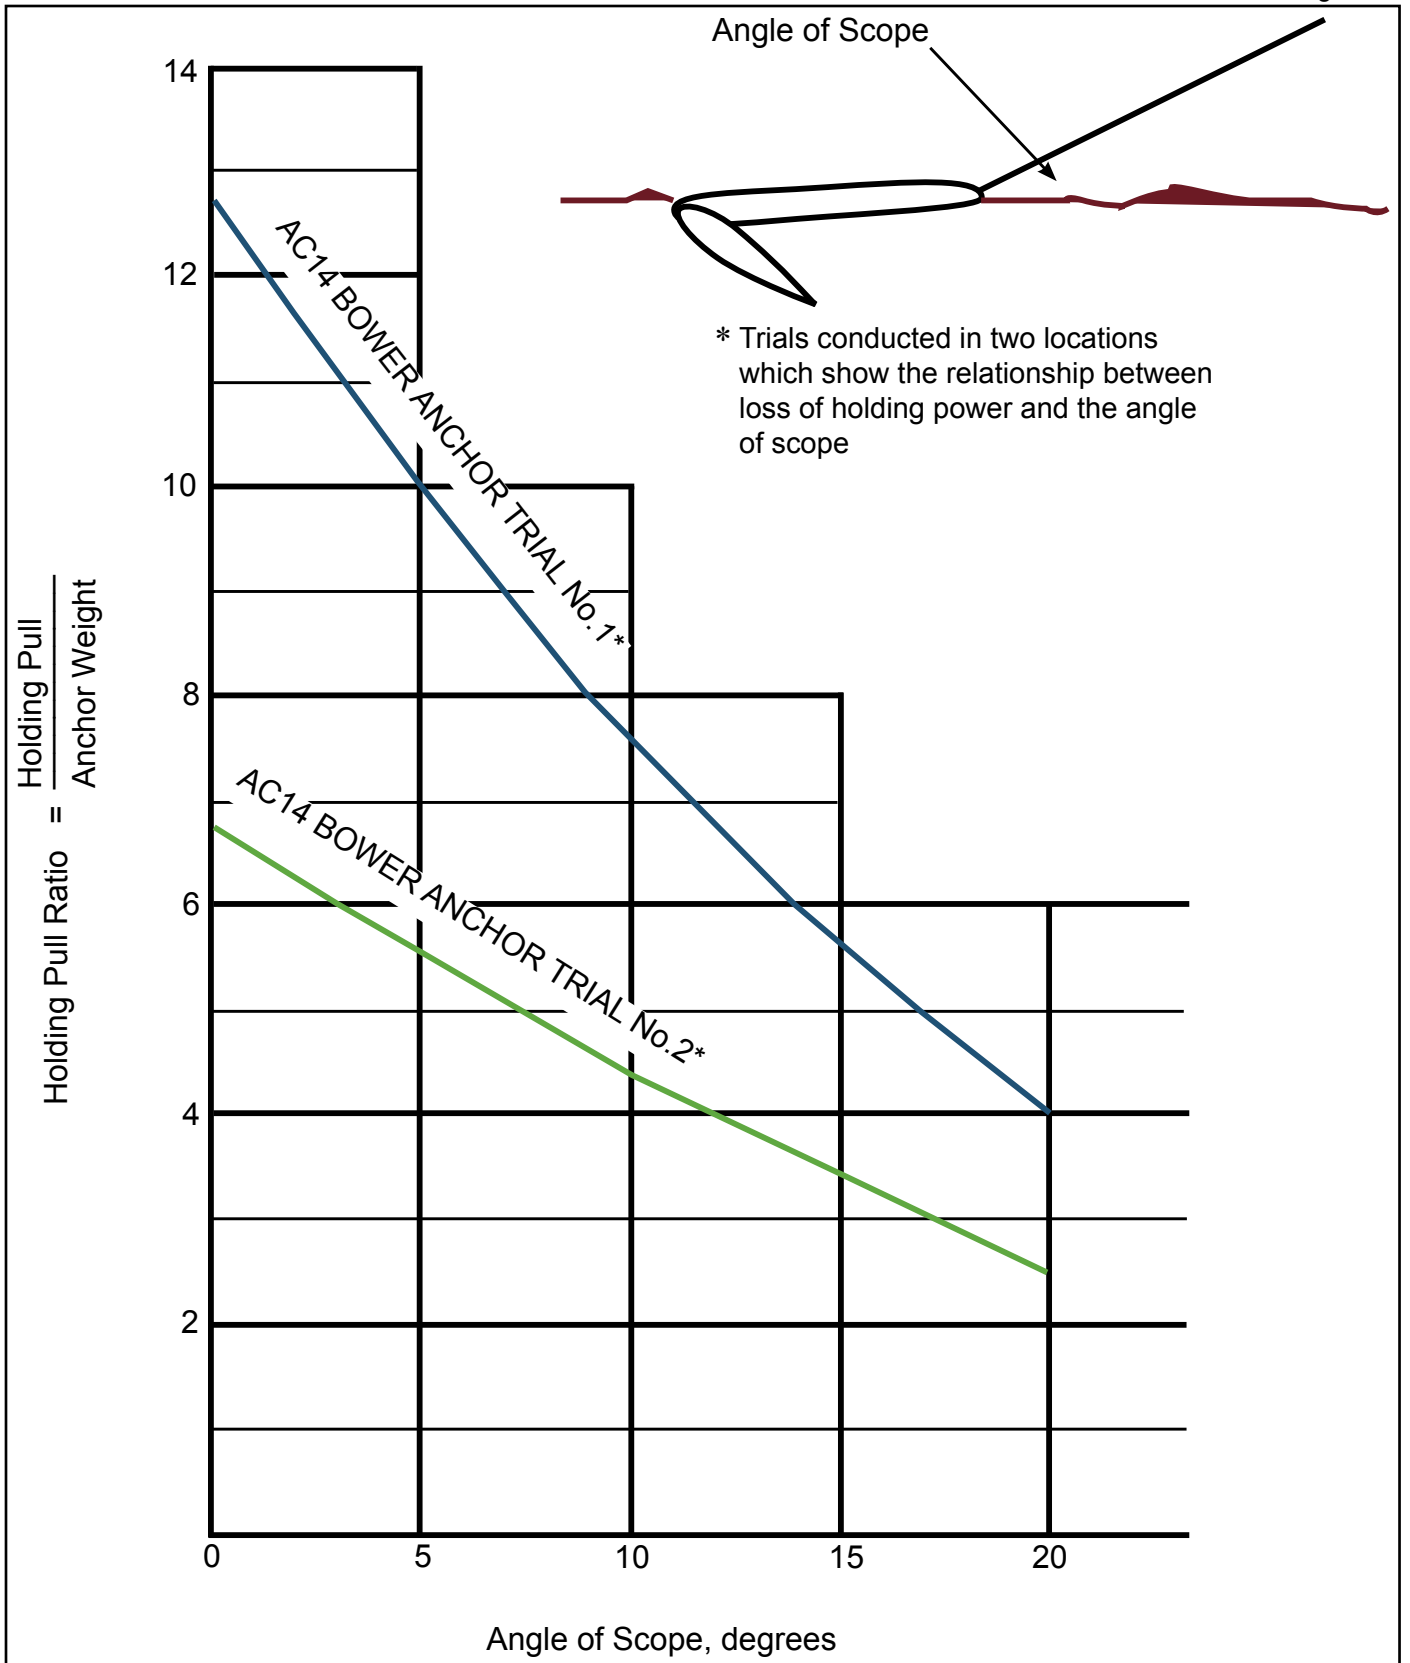
The effect of scope angle on an anchor's holding power

Had the master been fully acquainted with the guidance provided by OCIMF – Anchoring Systems and Procedures for Large Tankers, he would have better understood the requirements for safe anchoring and some of the potential risks that needed to be considered. Had the master been provided with meaningful ship-specific data in respect of anchoring equipment, it might have helped him to recognise earlier that the weather conditions were becoming marginal, and the equipment was reaching its design limitations.
