South Tees Development Corporation

## Former Steelworks Land, South Tees

Outline Remediation Strategy

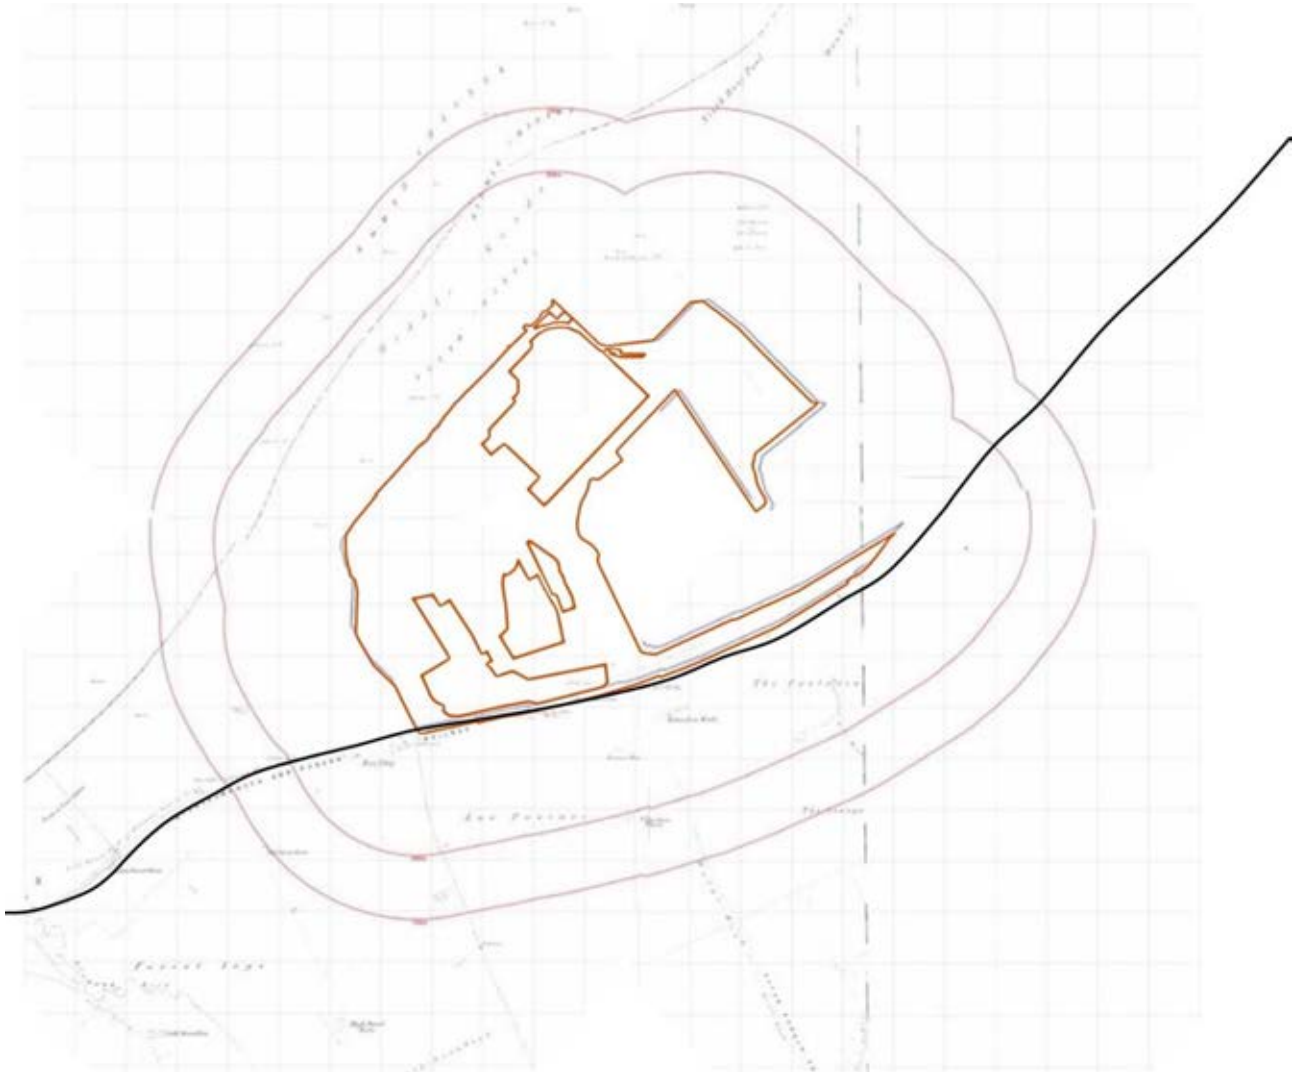
**On-Site:** Earliest historic maps available demonstrate minimal development within the area and surrounding areas. Land was principally constituted of low lying scrub land. In closer proximity to the River Tees to the north of the area large areas of land were constituted of mud, sand and marshes.

**Off-site:** Middlesbrough and Redcar Railway line runs adjacent to the southern boundary of the area (1857). Lands towards the south east of the area is occupied by pasture. A number of becks and streams flow through the area and the surrounding area flowing into the River Tees.

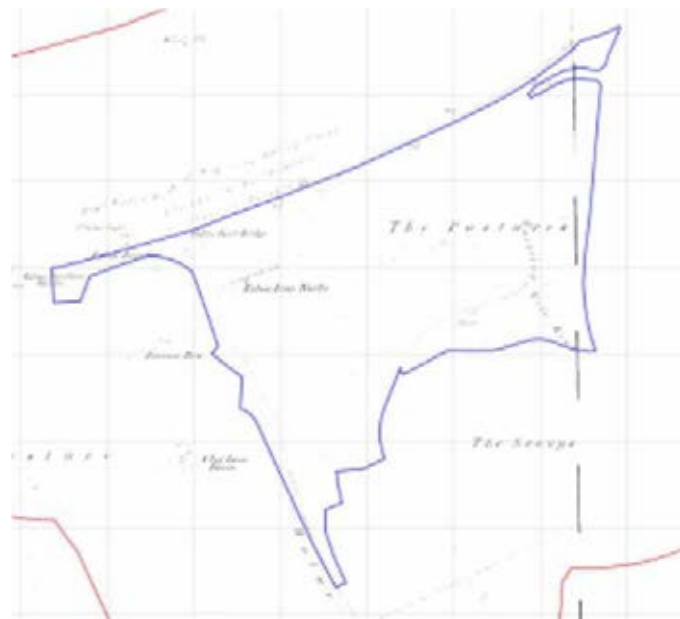
**\*On-Site:** The majority of the area is shown as agricultural land. Eston Iron Works is shown in the west of the area.

**\*Off-Site:** Eston Junction Station and Eston Junction are shown in the vicinity of the northern area boundary.

\*Detail on the map is unclear, and accurate location and description of area features is therefore difficult to determine.

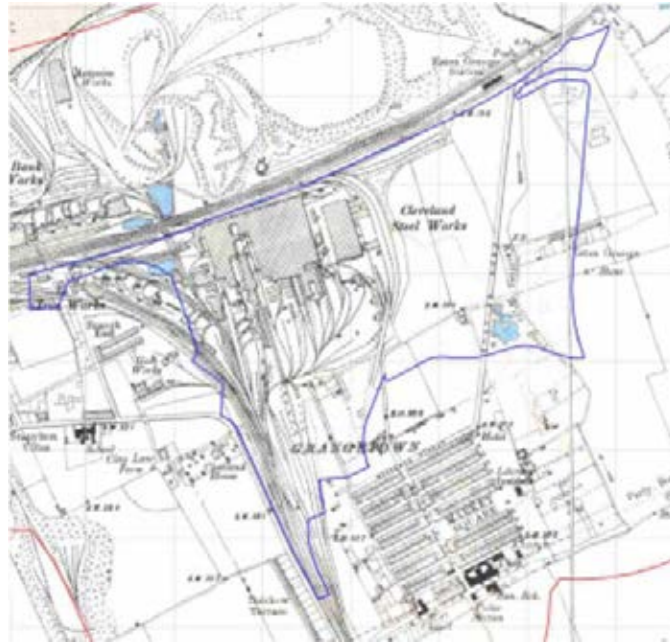
**On-Site:** Cleveland Steel works is present in the north western part of the area. Railway lines are shown entering the steel works from the south. Cleveland Iron Works is present in the far northwest of the area and extends beyond the boundary. Railway lines run between the iron works and steel works. A water body is located in the far northwest of area between the steel and iron works. Two water bodies are located in the south east of the area and Knitting Wife Beck is located further to the east. Station Road runs north to south to the west of the water bodies. Eston Grange Stone is located on the far east of the area and straddles the boundary.

**Off-Site:** A gas works is located approximately 50m to the west of the area. A railway line is present adjacent to the north of the area and demarcates the northern boundary. Beyond the railway line is an extensive area of slag heaps. South Bank Iron Works is located beyond the railway line approximately 50m north west of the area along with two surface water bodies. The Antonien Phosphate Works is located approximately 400m north of the area. An iron and slag works is located approximately 400m west of the area. Eston Grange Station is shown adjacent to the area boundary in the north east of the area. An area of terraced housing labelled as Grangetown and Market Square is shown approximately 25m south east of the area at its closest point.

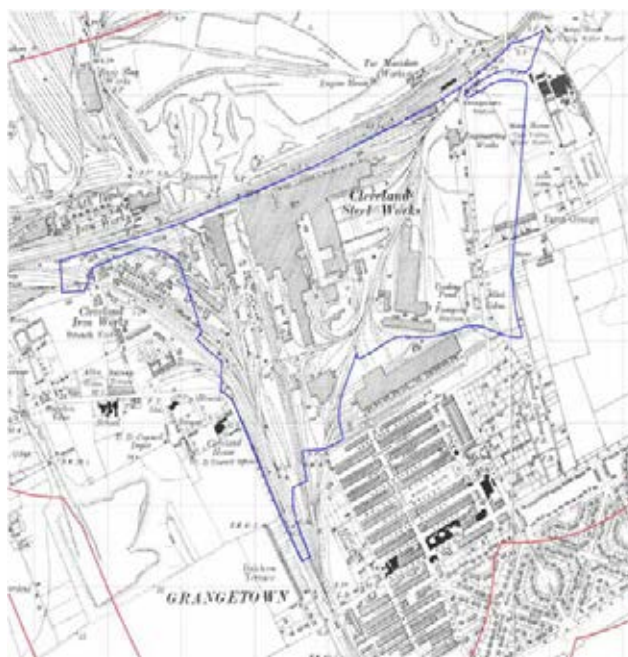
**On-Site:** The Cleveland Steel Works continued to dominate at this time, with expansion of the main works buildings towards the south. An engineering works is now shown in the north east of the area off Station Road. A cooling pond and pumping station are shown in the south east corner of the area.

**Off-Site:** The slag heaps continued to be present to the north of the area, along with the basic slag works. The South Bank Iron Works was now shown to the north of the area. A tarmacadam works is shown approximately 50 north of the area. The athletics track has been replaced by a large building adjacent to the south of the area.

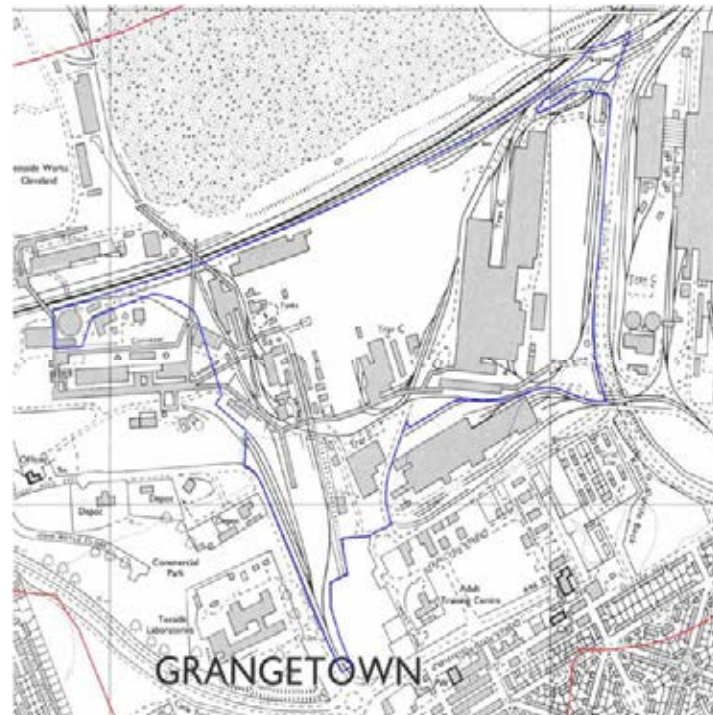
**On-Site:** The large works buildings in the northern central part of the area are no longer shown. Tanks are shown in the north east of the area which are listed as clarifiers on site layout plans. Conveyor belts are shown on the west of the area linking it with the adjacent works. A circular structure is shown in the far north west of the area which is shown as a gas holder on site layout plans. Many of the railway lines and sidings are no longer present. Travelling cranes are also shown within the area. A pipe line is shown in the far south east.

**Off-Site:** Multiple buildings, tanks and travelling cranes are shown beyond the Tees Dock Road adjacent to the east of the area. The market hall to the south of the area is now an adult training centre. The layout of buildings to the south of the north west of the area has changed and site layouts indicate this is a blast furnace plant. There remained a large area of slag heaps to the north of the area.

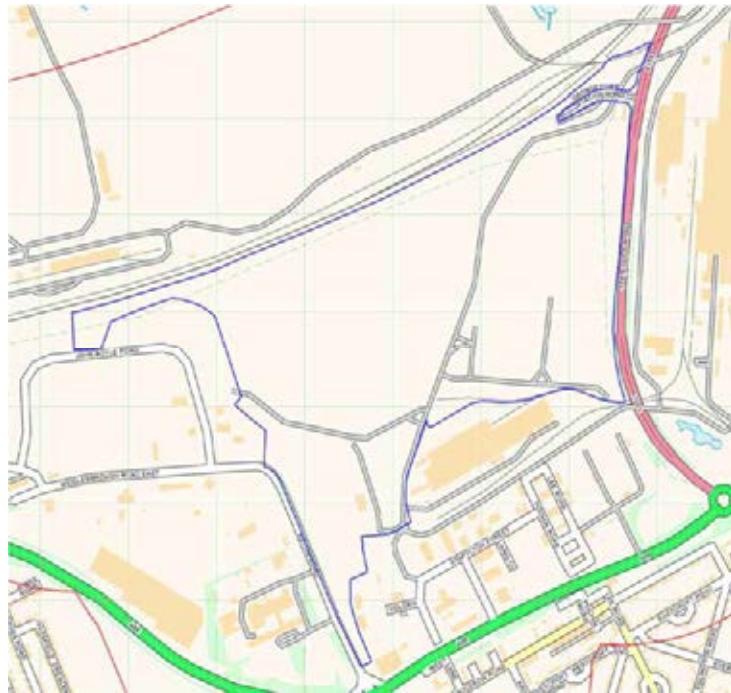
**On-Site:** Further demolition of on-site structures had been carried out. No buildings are present with the exception of one minor building in the south west of the area. Access roads continued to be shown in the southern and eastern parts of the area.

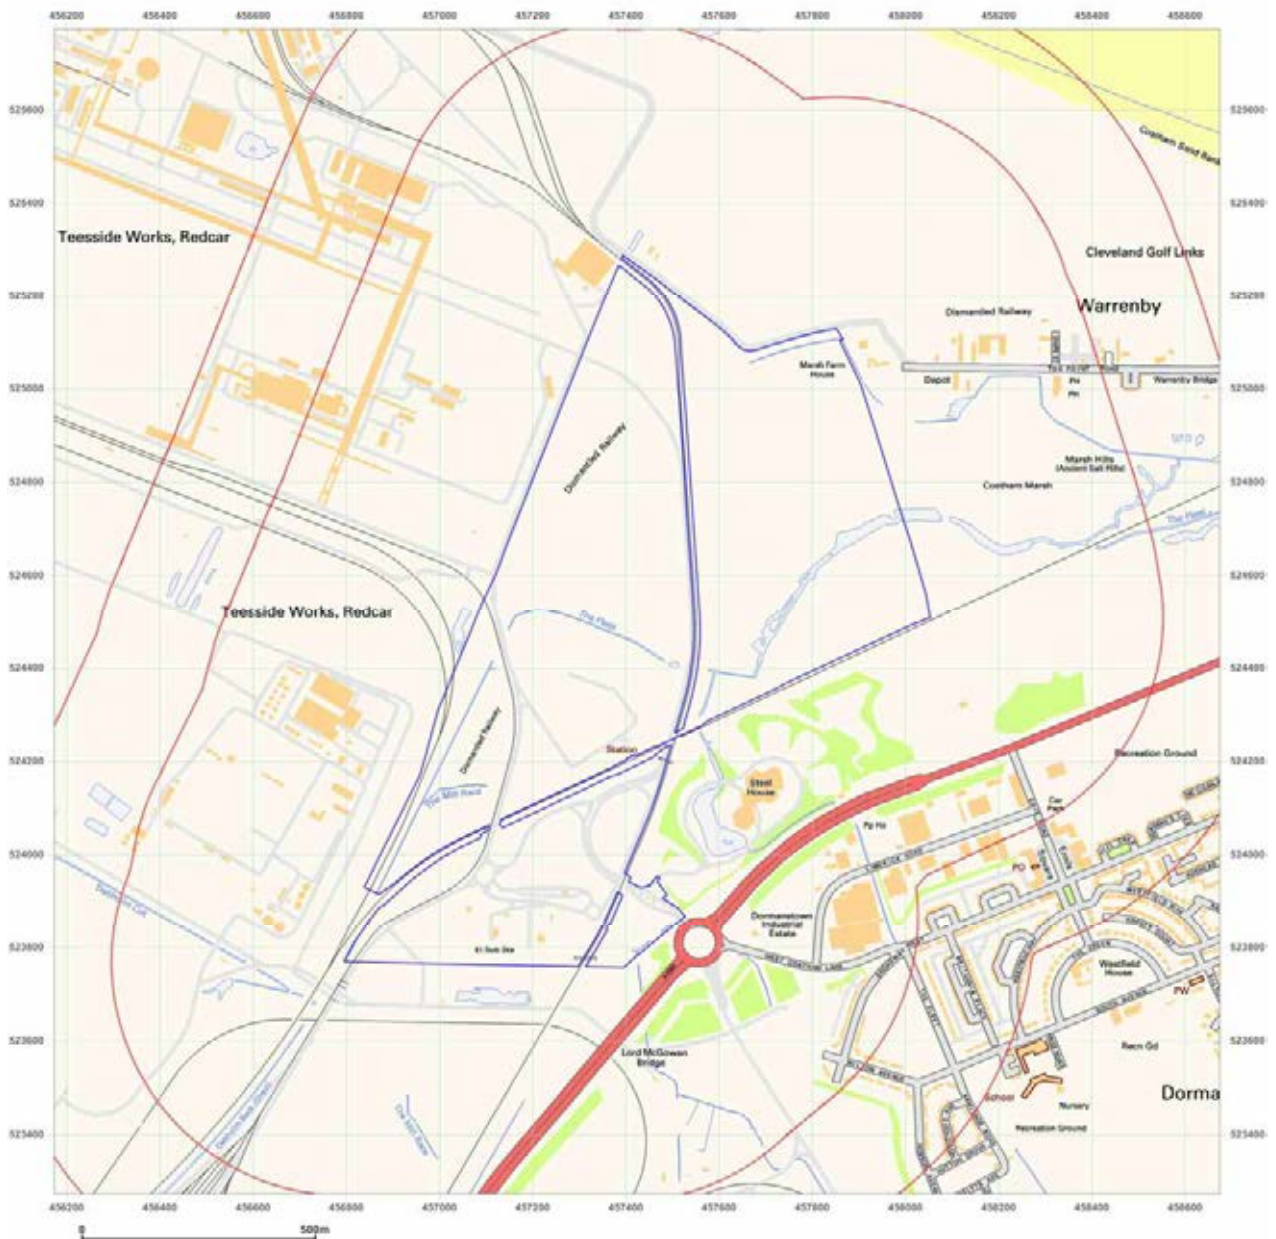
## 2010

**On-site:** Majority of the as area is shown in 2002. In 2006, hard standing area to the west of the substation appears to be covered in waste materials and includes a series of containers and one small building. Some piles of dumped materials are also present adjacent to the western side of the hardstanding. Hardstanding area to the west of the substation gone in 2010 survey.

**Off-Site:** No changes from previous mapping.

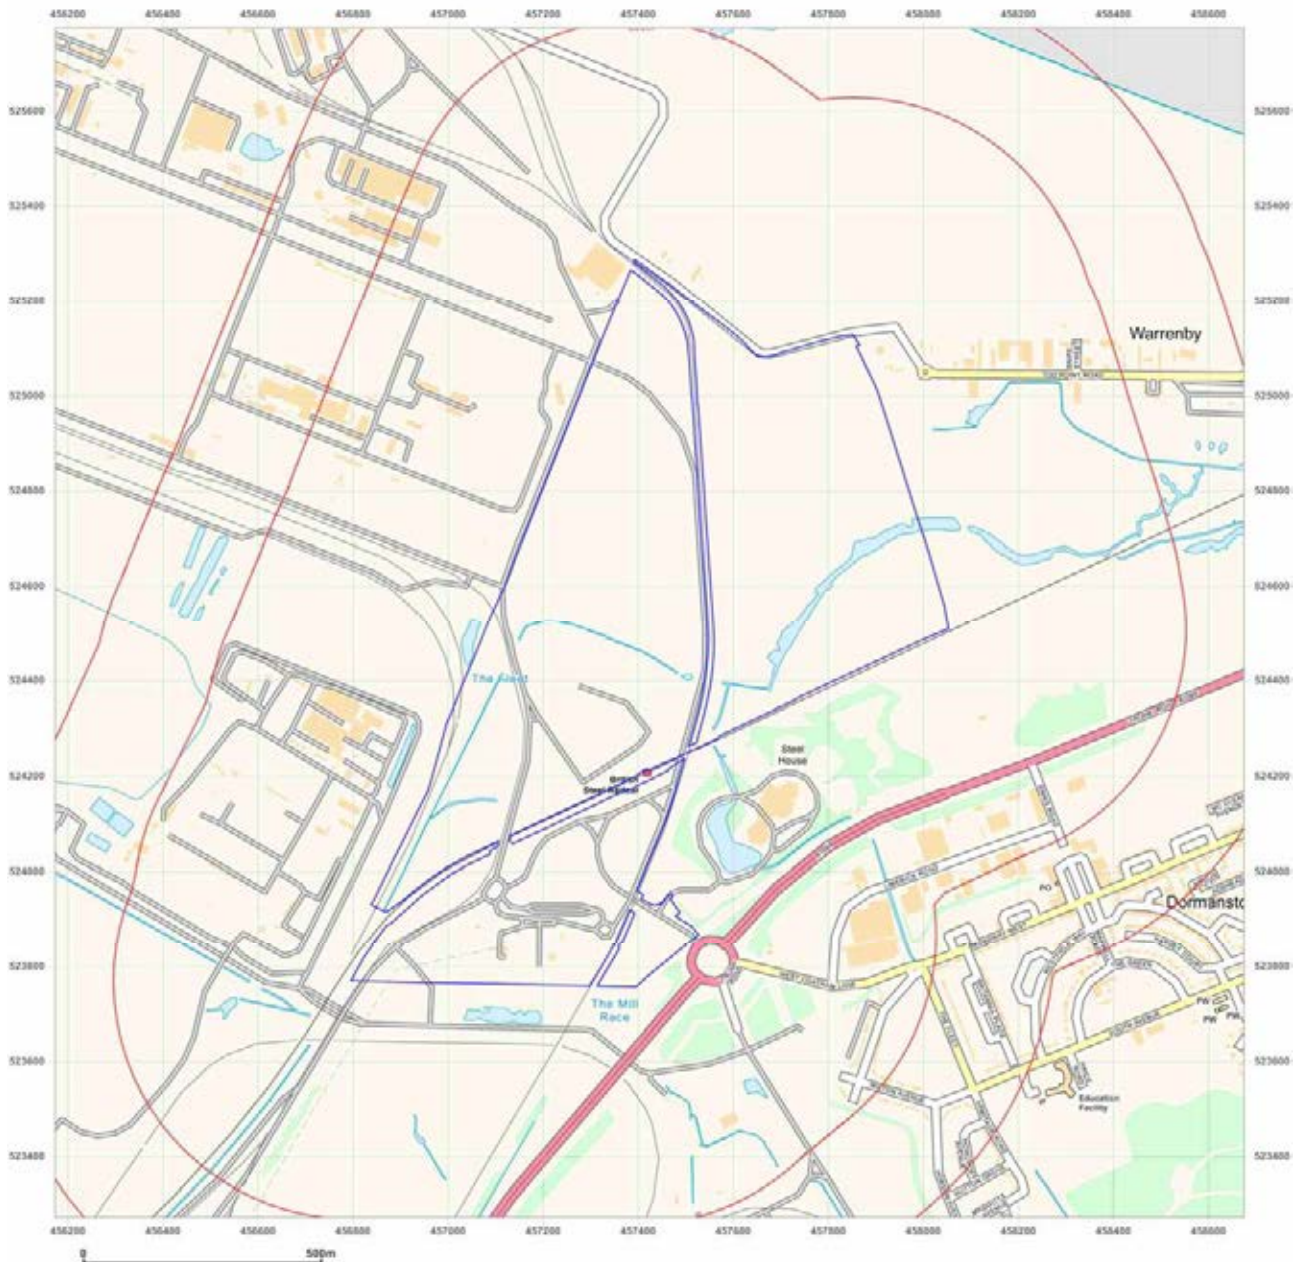
**2014**

**On-site:** No changes from previous mapping.

**Off-site:** No changes from previous mapping.

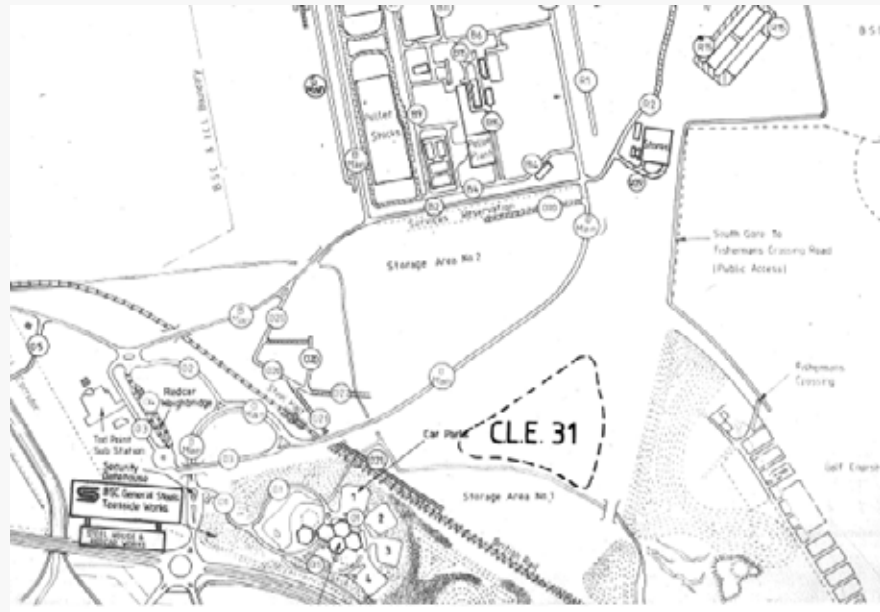
### South Teeside Waste Disposal Sites, Currently Licenced Tips, Drawing No. X-108701 (undated)

This drawing showed the extent of the licenced tipping areas at Warrenby Landfill (Referenced CLE 31). The drawing also indicates that in the south of the site is the Tod Point substation, the Redcar weighbridge, and various access routes. Adjacent to the licensed landfill are shown Storage Area No.1, and Storage Area No.2.
