South Tees Development Corporation

Former Steelworks Land, South Tees

Outline Remediation Strategy

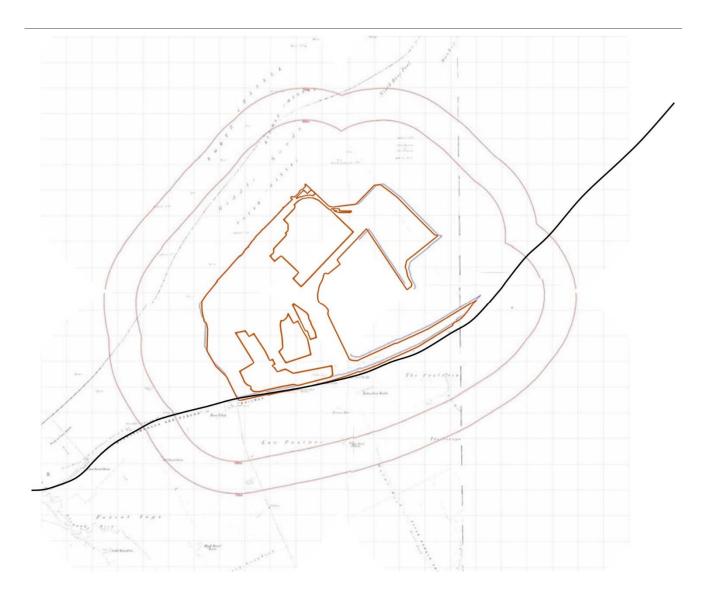
On-Site: Earliest historic maps available demonstrate minimal development within the area and surrounding areas. Land was principally constituted of low lying scrub land. In closer proximity to the River Tees to the north of the area large areas of land were constituted of mud, sand and marshes.

Off-site: Middlesbrough and Redcar Railway line runs adjacent to the southern boundary of the area (1857). Lands towards the south east of the area is occupied by pasture. A number of becks and streams flow through the area and the surrounding area flowing into the River Tees.

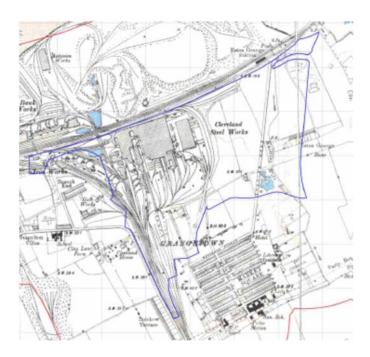
On-Site: Cleveland Steel works is present in the north western part of the area. Railway lines are shown entering the steel works from the south. Cleveland Iron Works is present in the far northwest of the area and extends beyond the boundary. Railway lines run between the iron works and steel works. A water body is located in the far northwest of area between the steel and iron works. Two water bodies are located in the south east of the area and Knitting Wife Beck is located further to the east. Station Road runs north to south to the west of the water bodies. Eston Grange Stone is located on the far east of the area and straddles the boundary.

Off-Site: A gas works is located approximately 50m to the west of the area. A railway line is present adjacent to the north of the area and demarcates the northern boundary. Beyond the railway line is an extensive area of slag heaps. South Bank Iron Works is located beyond the railway line approximately 50m north west of the area along with two surface water bodies. The Antonien Phosphate Works is located approximately 400m north of the area. An iron and slag works are located approximately 400m west of the area. Eston Grange Station is shown adjacent to the area boundary in the north east of the area. An area of terraced housing labelled as Grangetown and Market Square is shown approximately 25m south east of the area at its closest point.

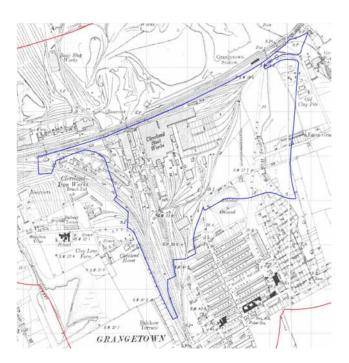
On-Site: Additional railway lines and sidings were constructed to the east and south of the Cleveland Steel Works. Unnamed structures are present to the east and south of the railway lines. The water body in the north west of the area is no longer shown. An athletic ground is shown in the south of the area, the two unnamed water bodies were no longer shown in the south east of the area

Off-Site: A reservoir is shown to the north of the area beyond the railway lines. A salt works is shown within the South Bank Iron Works approximately 100m north. The phosphate works is now shown as a basic slag works. Eston Grange Station has been renamed Grangetown Station.

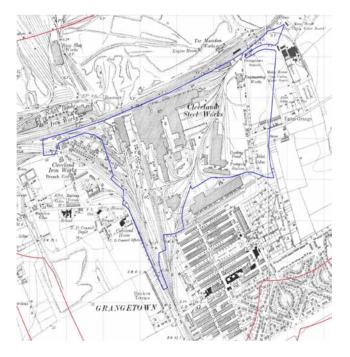
On-Site: The Cleveland Steel Works continued to dominate at this time, with expansion of the main works buildings towards the south. An engineering works is now shown in the north east of the area off Station Road. A cooling pond and pumping station are shown in the south east corner of the area.

Off-Site: The slag heaps continued to be present to the north of the area, along with the basic slag works. The South Bank Iron Works was now shown to the north of the area. A tarmacadam works is shown approximately 50 north of the area. The athletics track has been replaced by a large building adjacent to the south of the area.

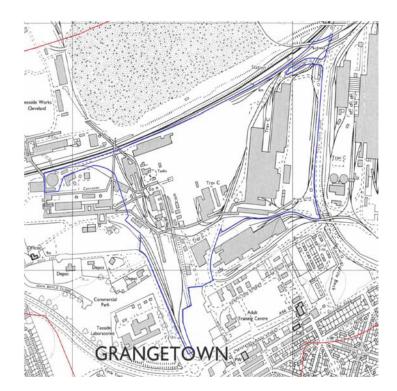
On-Site: The large works buildings in the northern central part of the area are no longer shown. Tanks are shown in the north east of the area which are listed as clarifiers on site layout plans. Conveyor belts are shown on the west of the area linking it with the adjacent works. A circular structure is shown in the far north west of the area which is shown as a gas holder on site layout plans. Many of the railway lines and sidings are no longer present. Travelling cranes are also shown within the area. A pipe line is shown in the far south east.

Off-Site: Multiple buildings, tanks and travelling cranes are shown beyond the Tees Dock Road adjacent to the east of the area. The market hall to the south of the area is now an adult training centre. The layout of buildings to the south of the north west of the area has changed and site layouts indicate this is a blast furnace plant. There remained a large area of slag heaps to the north of the area.

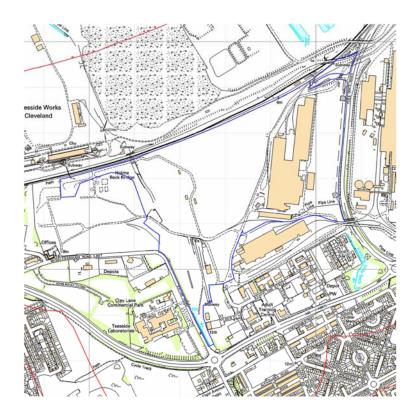
On-Site: Mapping indicates that there had been considerable demolition of site structures in the west and south by this time. Three small unnamed buildings remained in the central part of the area. The large works building in the east of the area is still present, and a pipe line close to the eastern site boundary. Many of the railway lines within the area had been dismantled. Holme Beck Bridge is present on the north western boundary of the area. The south western site boundary was demarcated by a surface water channel.

Off-Site: The works adjacent to the west of the area are no longer present. Land to the west of the area is now occupied as depots, Teesside Laboratories and Clay Lane Commercial Park. Further depots and commercial development had taken place to the south of the area at this time.

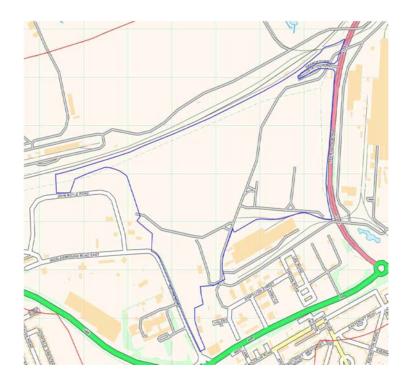
On-Site: Further demolition of on-site structures had been carried out. No buildings are present with the exception of one minor building in the south west of the area. Access roads continued to be shown in the southern and eastern parts of the area.
