South Tees Development Corporation

## Former Steelworks Land, South Tees

Outline Remediation Strategy

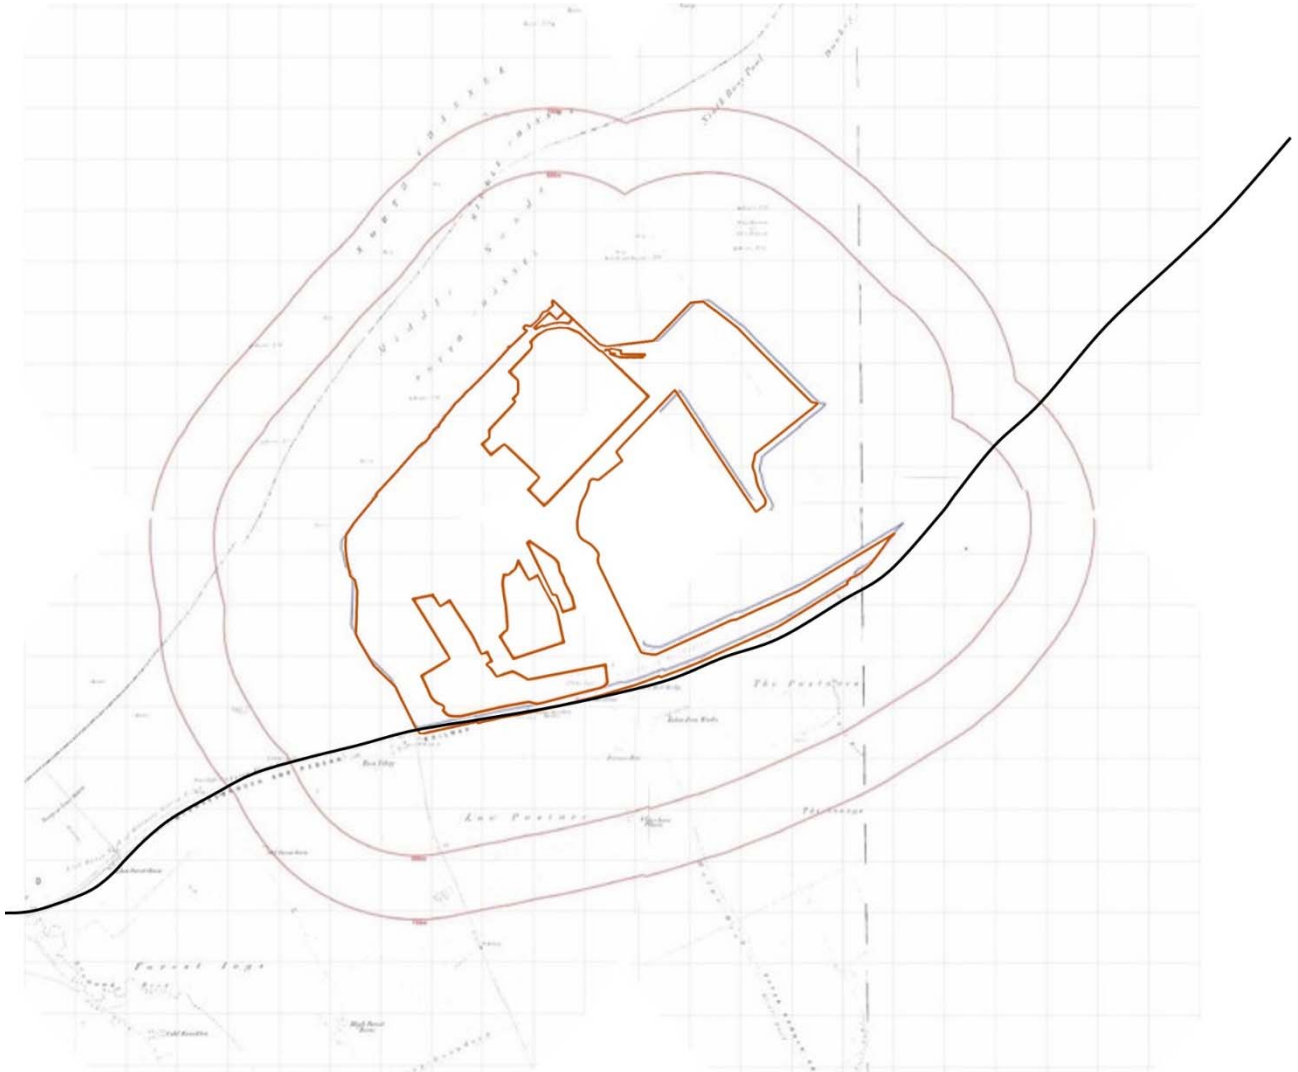
**On-Site:** Earliest historic maps available demonstrate minimal development within the area and surrounding areas. Land was principally constituted of low lying scrub land. In closer proximity to the River Tees to the north of the area large areas of land were constituted of mud, sand and marshes.

**Off-site:** Middlesbrough and Redcar Railway line runs adjacent to the southern boundary of the area (1857). Lands towards the south east of the area is occupied by pasture. A number of becks and streams flow through the area and the surrounding area flowing into the River Tees.

Large scale historic maps are available between 1856 and to 2014. Since 1856 the area has undergone significant development following land reclamation between 1897 and 1913.

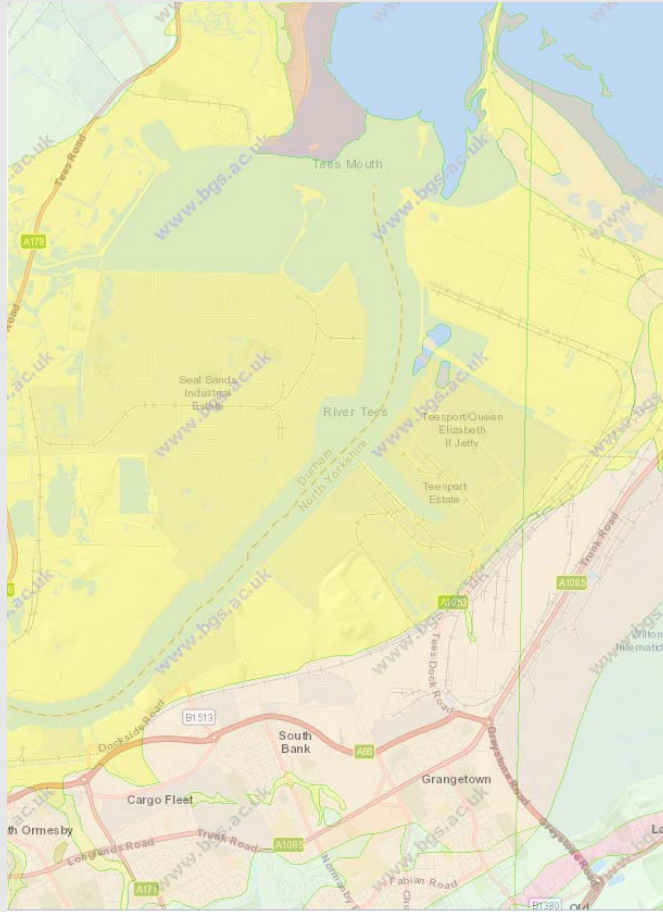
#### Drift Geology

Contains British Geological Survey materials © UKRI 2019

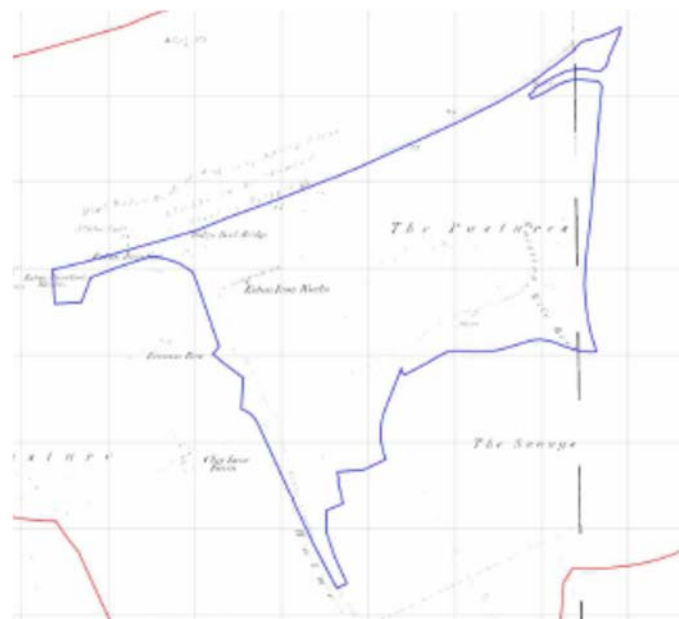
Extract for 1857 From Groundsure (Appendix A)

**\*On-Site:** The majority of the area is shown as agricultural land. Eston Iron Works is shown in the west of the area.

**\*Off-Site:** Eston Junction Station and Eston Junction are shown in the vicinity of the northern area boundary.

\*Detail on the map is unclear, and accurate location and description of area features is therefore difficult to determine.

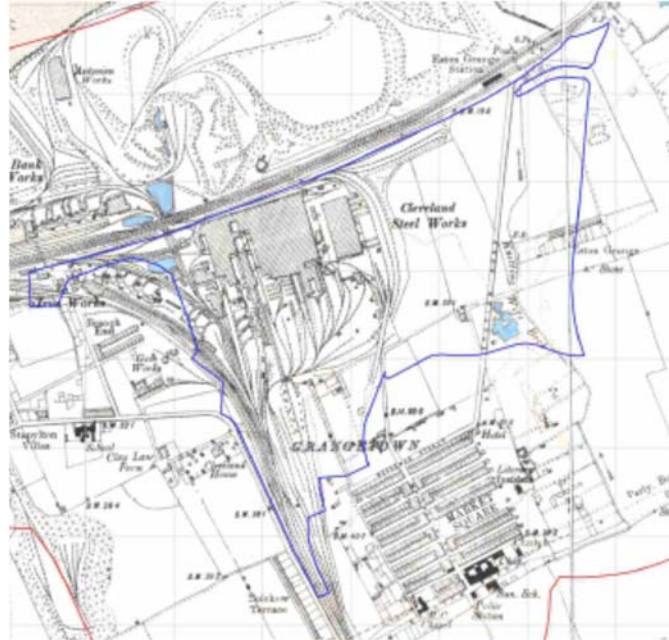
Extract for 1893 From Groundsure (Appendix A)

**On-Site:** Cleveland Steel works is present in the north western part of the area. Railway lines are shown entering the steel works from the south. Cleveland Iron Works is present in the far northwest of the area and extends beyond the boundary. Railway lines run between the iron works and steel works. A water body is located in the far northwest of area between the steel and iron works. Two water bodies are located in the south east of the area and Knitting Wife Beck is located further to the east. Station Road runs north to south to the west of the water bodies. Eston Grange Stone is located on the far east of the area and straddles the boundary.

**Off-Site:** A gas works is located approximately 50m to the west of the area. A railway line is present adjacent to the north of the area and demarcates the northern boundary. Beyond the railway line is an extensive area of slag heaps. South Bank Iron Works is located beyond the railway line approximately 50m north west of the area along with two surface water bodies. The Antonien Phosphate Works is located approximately 400m north of the area. An iron and slag works is located approximately 400m west of the area. Eston Grange Station is shown adjacent to the area boundary in the north east of the area. An area of terraced housing labelled as Grangetown and Market Square is shown approximately 25m south east of the area at its closest point.

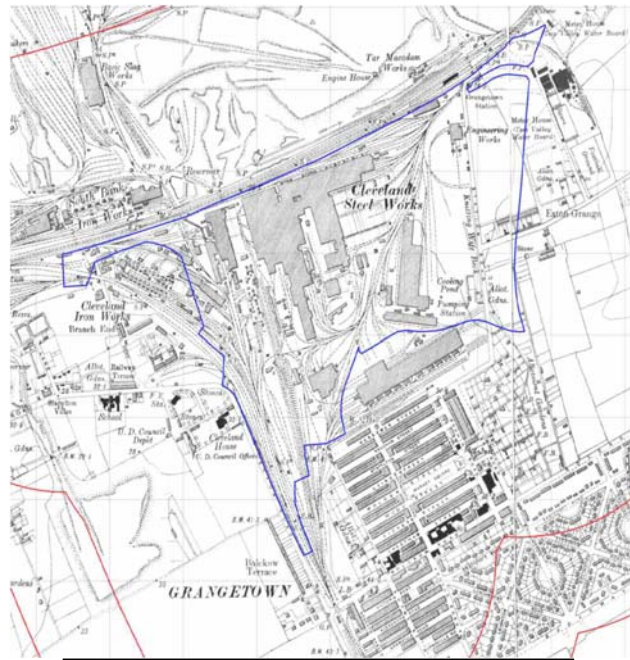
Extract for 1930 From Groundsure (Appendix B)

**On-Site:** The Cleveland Steel Works continued to dominate at this time, with expansion of the main works buildings towards the south. An engineering works is now shown in the north east of the area off Station Road. A cooling pond and pumping station are shown in the south east corner of the area.

**Off-Site:** The slag heaps continued to be present to the north of the area, along with the basic slag works. The South Bank Iron Works was now shown to the north of the area. A tarmac works is shown approximately 50 north of the area. The athletics track has been replaced by a large building adjacent to the south of the area.

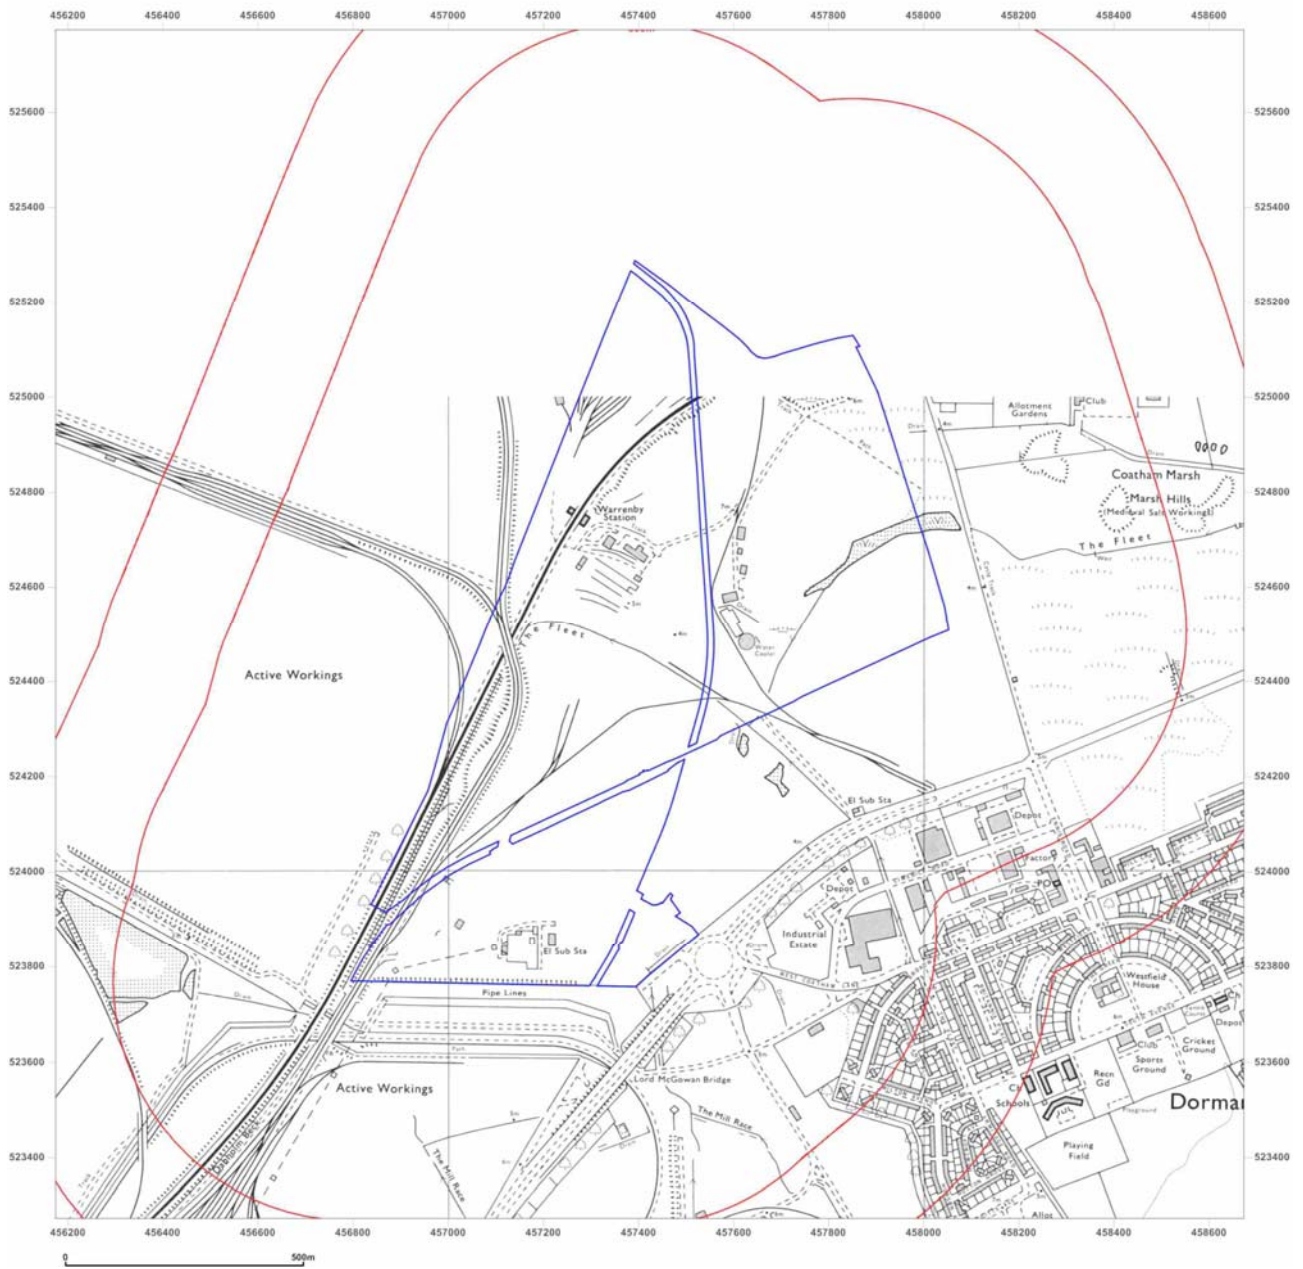
1974

**On-site:** Much of the development in the centre of the area associated with the historic Coatham Iron Works are now gone, as well as most of the tracks. Additional rail lines shown along the western boundary.

**Off-site** The surrounding areas remain the same.

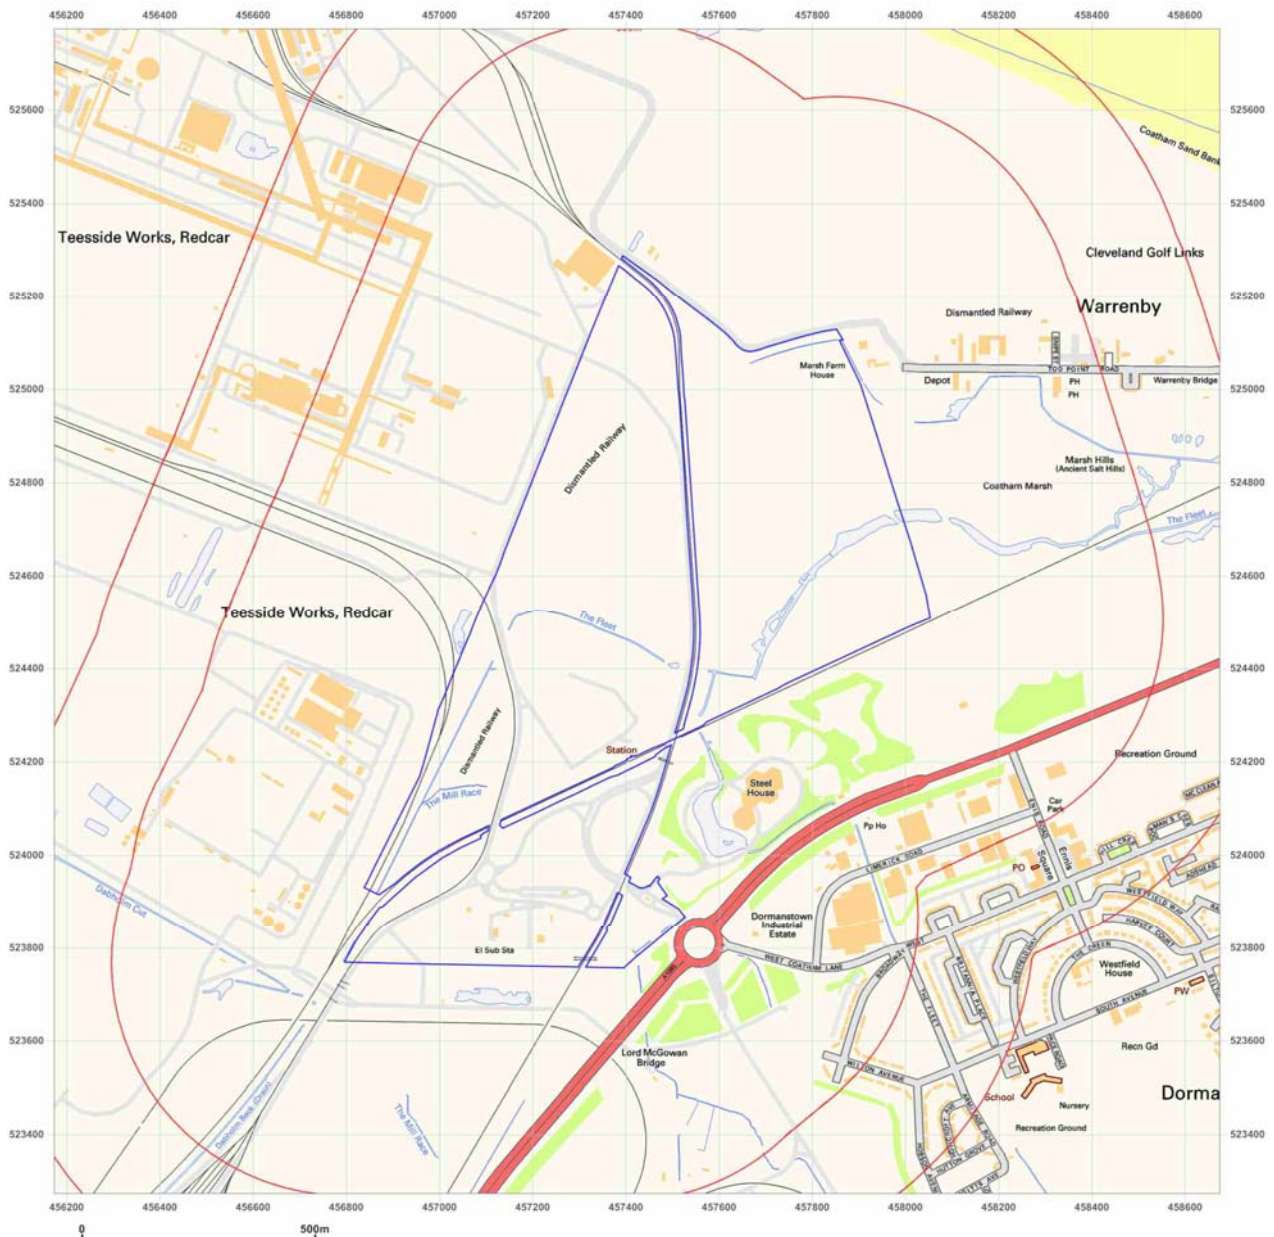
**On-site:** Majority of the as area is shown in 2002. In 2006, hard standing area to the west of the substation appears to be covered in waste materials and includes a series of containers and one small building. Some piles of dumped materials are also present adjacent to the western side of the hardstanding. Hardstanding area to the west of the substation gone in 2010 survey.

**Off-Site:** No changes from previous mapping.
