South Tees Development Corporation

Former Steelworks Land, South Tees

Outline Remediation Strategy

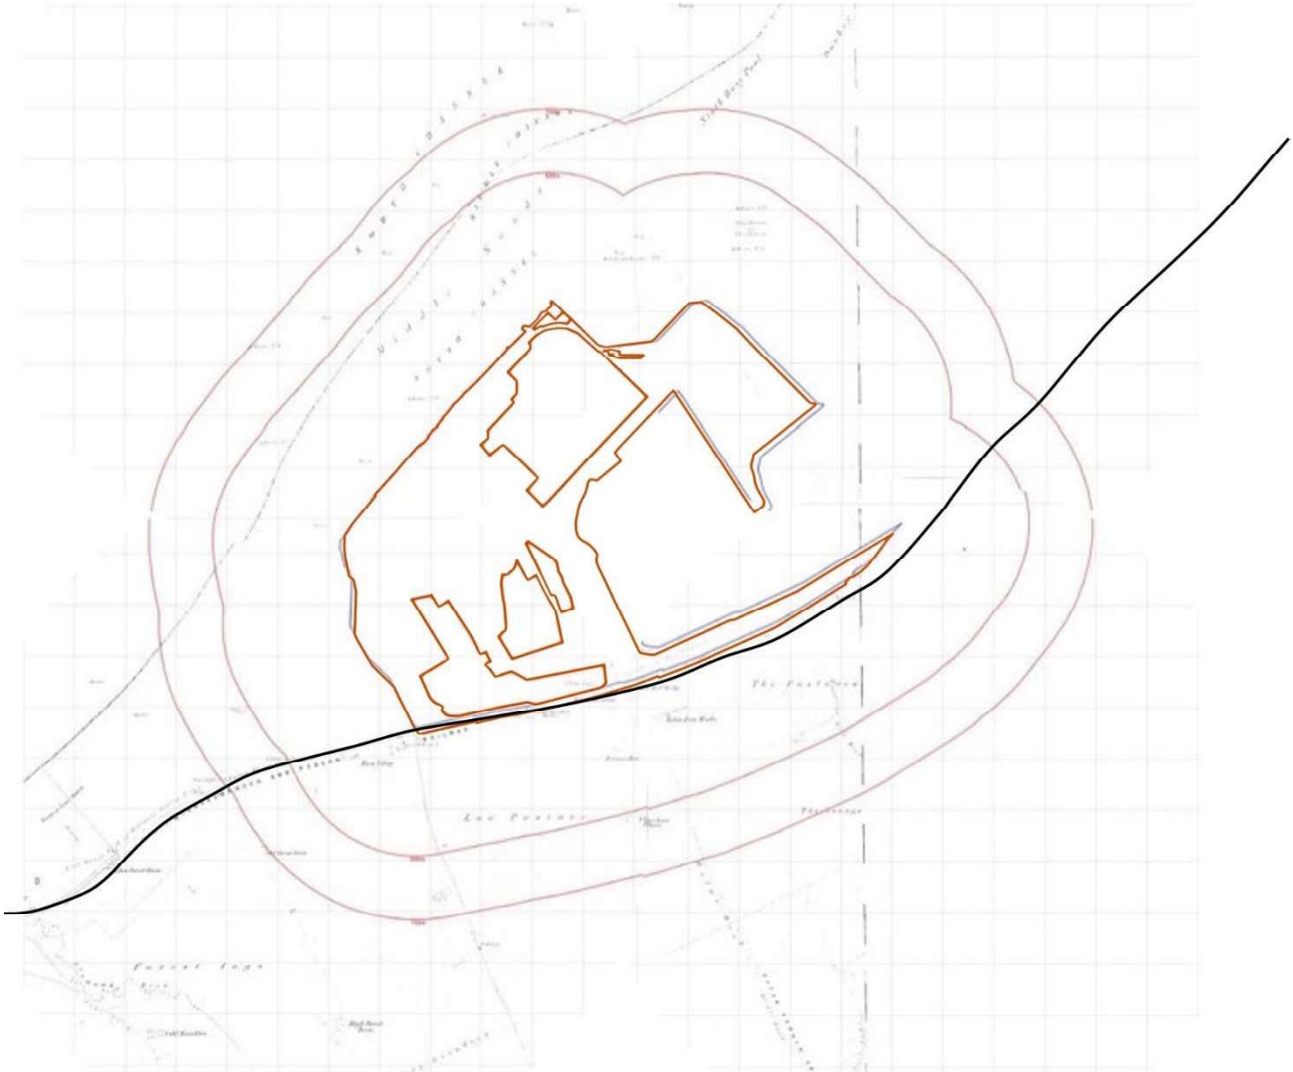
On-Site: Earliest historic maps available demonstrate minimal development within the area and surrounding areas. Land was principally constituted of low lying scrub land. In closer proximity to the River Tees to the north of the area large areas of land were constituted of mud, sand and marshes.

Off-site: Middlesbrough and Redcar Railway line runs adjacent to the southern boundary of the area (1857). Lands towards the south east of the area is occupied by pasture. A number of becks and streams flow through the area and the surrounding area flowing into the River Tees.

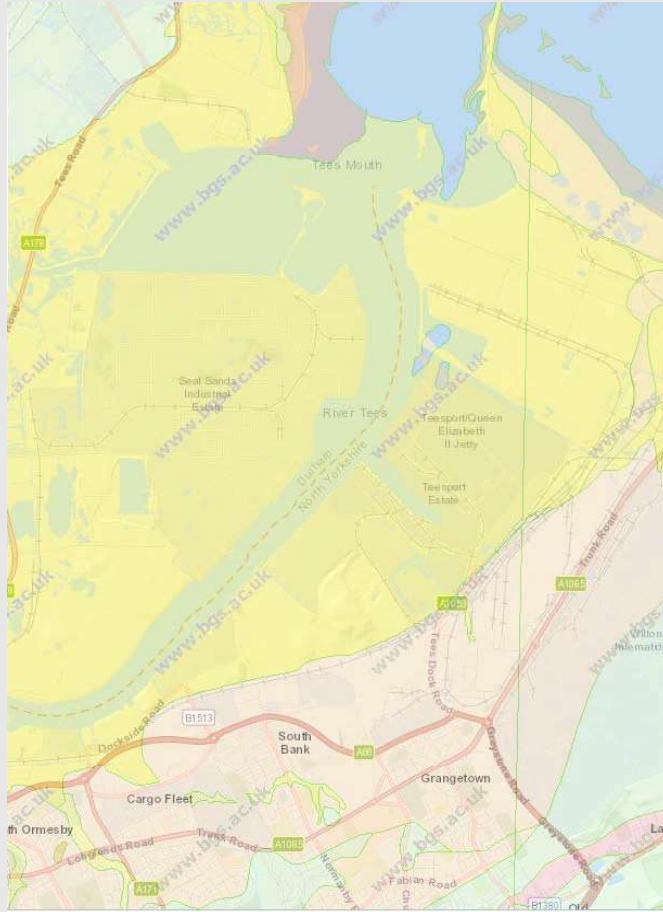
Drift Geology

Legend
Blown Sand
Tidal Flat Deposits
Glaciolacustrine Deposits
Glacial Till

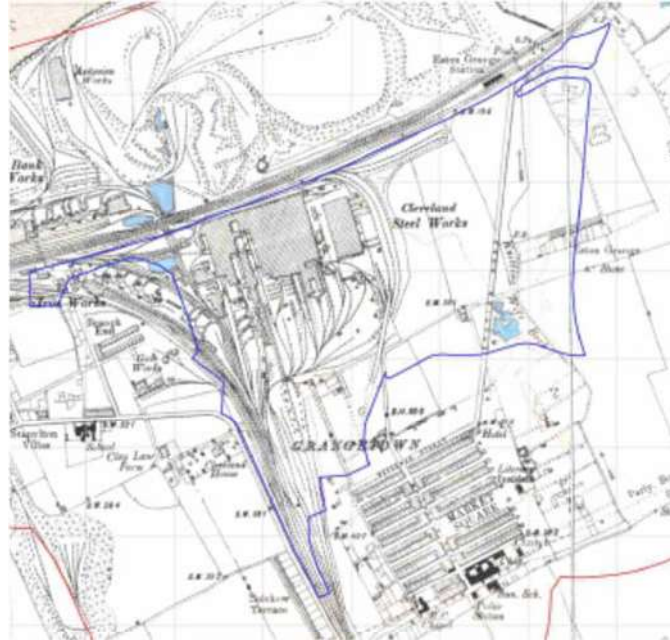
Extract for 1893 From Groundsure (Appendix A)

On-Site: Cleveland Steel works is present in the north western part of the area. Railway lines are shown entering the steel works from the south. Cleveland Iron Works is present in the far northwest of the area and extends beyond the boundary. Railway lines run between the iron works and steel works. A water body is located in the far northwest of area between the steel and iron works. Two water bodies are located in the south east of the area and Knitting Wife Beck is located further to the east. Station Road runs north to south to the west of the water bodies. Eston Grange Stone is located on the far east of the area and straddles the boundary.

Off-Site: A gas works is located approximately 50m to the west of the area. A railway line is present adjacent to the north of the area and demarcates the northern boundary. Beyond the railway line is an extensive area of slag heaps. South Bank Iron Works is located beyond the railway line approximately 50m north west of the area along with two surface water bodies. The Antonien Phosphate Works is located approximately 400m north of the area. An iron and slag works is located approximately 400m west of the area. Eston Grange Station is shown adjacent to the area boundary in the north east of the area. An area of terraced housing labelled as Grangetown and Market Square is shown approximately 25m south east of the area at its closest point.

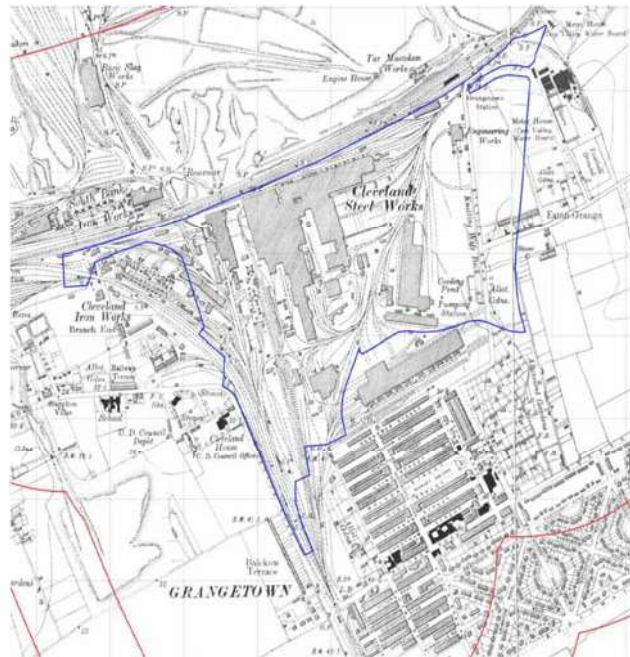
Extract for 1930 From Groundsure (Appendix B)

On-Site: The Cleveland Steel Works continued to dominate at this time, with expansion of the main works buildings towards the south. An engineering works is now shown in the north east of the area off Station Road. A cooling pond and pumping station are shown in the south east corner of the area.

Off-Site: The slag heaps continued to be present to the north of the area, along with the basic slag works. The South Bank Iron Works was now shown to the north of the area. A tarmacadam works is shown approximately 50 north of the area. The athletics track has been replaced by a large building adjacent to the south of the area.

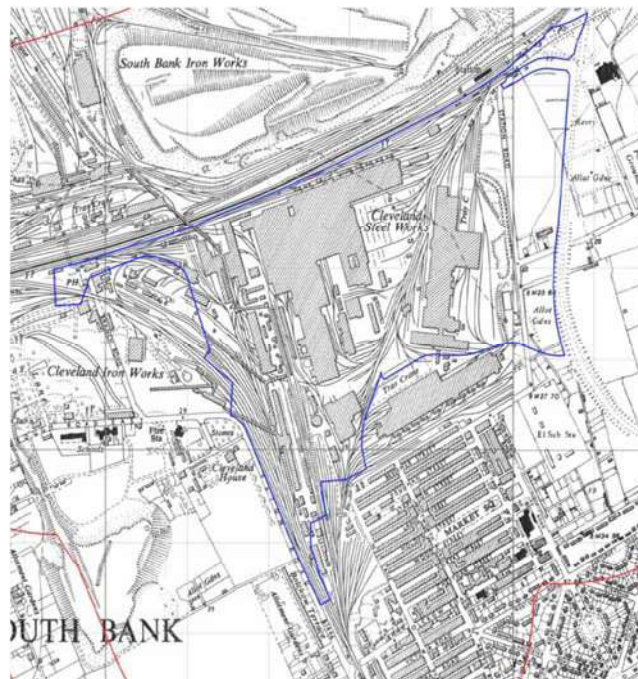
Extract for 1955 From Groundsure (Appendix B)

On-Site: The Cleveland Steel Works had expanded, and the building footprint occupied the majority of the central area. The development included boilers, blast furnaces and a cooling tower as shown on site layout plans. A travelling crane is shown in the east of the area. The engineering works in the east of the area was no longer shown.

Off-Site: The South Banks works remained in the area north of the area, comprising works buildings, slag heaps and railway lines. A tarmacadam works is shown approximately 50m north of the area. The athletics track has been replaced by a large works building adjacent to the south of the area. The phosphate works to the north of the area is no longer shown.

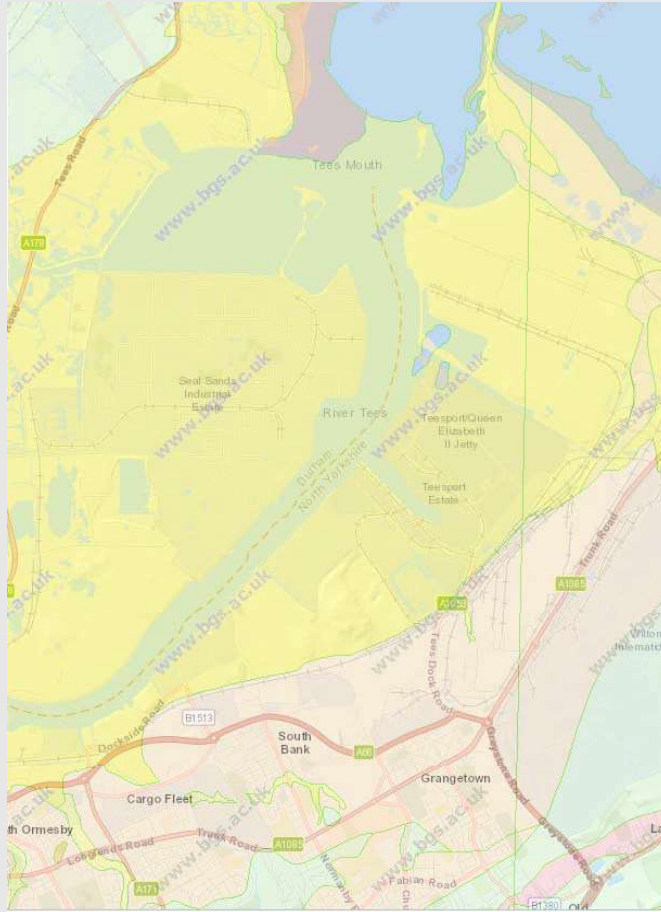
Drift Geology

Information taken from British Geological Survey on-line mapping (<http://www.largeimages.bgs.ac.uk/iip/mapsportal.html?id=1001513>) and the British Geological Survey on-line geoviewer (<http://mapapps.bgs.ac.uk/geologyofbritain/home.html>), previous reports and the Groundsure report included in Appendix A.

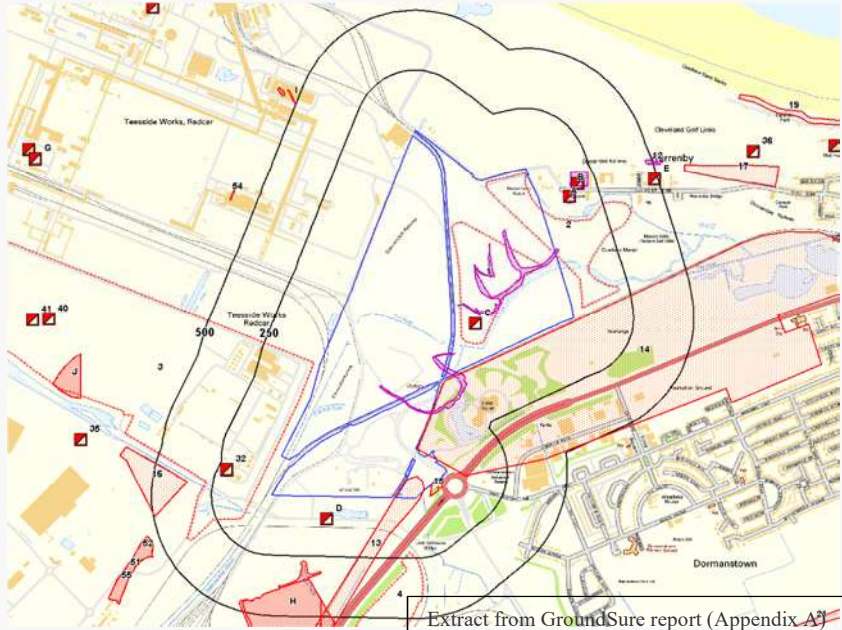
Activity	On-Site	0-250m	Details
			<p>Distance: 30m Operator: York Potash Processing & Ports Limited Landfill Type: A02: Other Landfill Site taking Special Waste</p> <p>Distance: 230m Operator: I C I Chemicals & Polymers Ltd Landfill Type: A07: Industrial Waste Landfill (Factory curtilage)</p>

<p>Extract from GroundSure report (Appendix A)</p>
Sites handling hazardous or explosive substances (inc COMAH or NIHHS) planning hazardous consents	3	3	<p>Three COMAH & NIHHS sites within the area:</p> <p>Company: British Steel Corporation Ltd Operational Status: Historical NIHHS Site Tier: -</p> <p>Company: Sahaviriya Steel Industries UK Limited Operational Status: Historical COMAH Site Tier: COMAH Upper Tier Operator</p> <p>Company: South Tees Site Company Limited Operational Status: Current COMAH Site Tier: COMAH Upper Tier Operator</p>
Mineral Extraction and Coal Mining Activities	N/A	N/A	<p>No mining coal mining activities within 75m of the area.</p> <p>No non-coal mining activities within 50m of the area.</p>

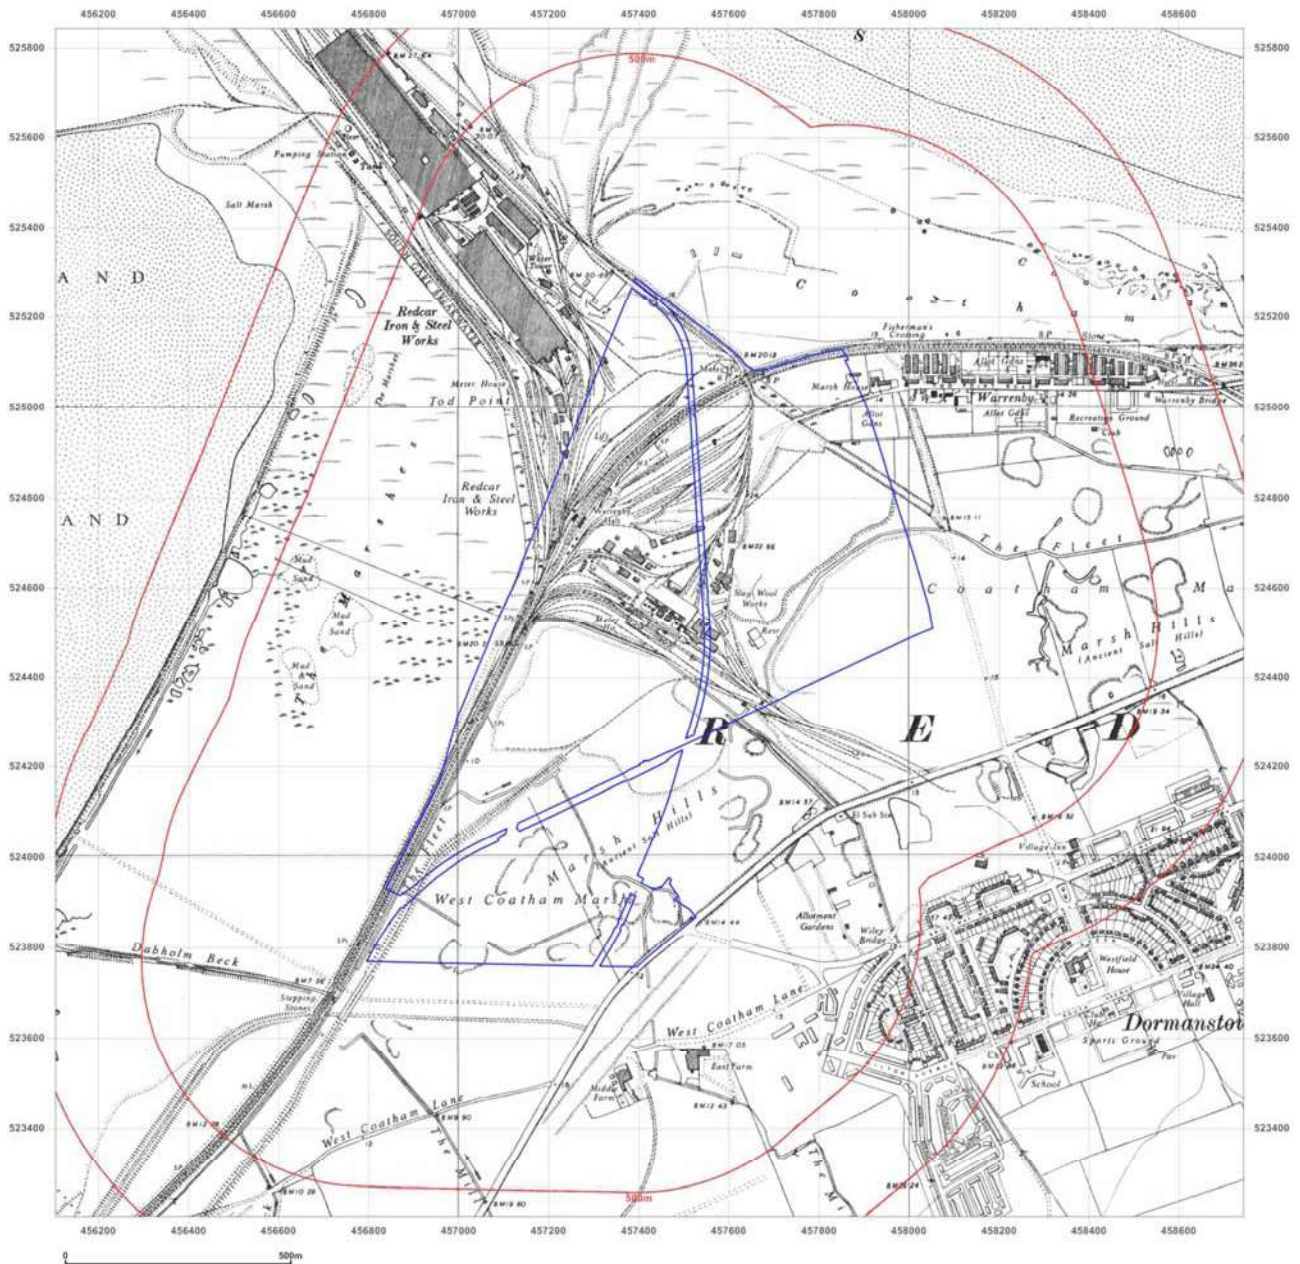
1953

On-site: Main blast furnaces redeveloped into single large building, with associated railway/ tram lines. An extensive area of infilling was shown extending from the site towards the south east, resulting in amendment to the surface water drainage channels. Redevelopment included water coolers and a water tank east of the main steelworks buildings. The Mill Race surface water entered the area in the south.

The majority of the changes are in the eastern sections of the area. Along the northern boundary, a large tip body has been pushed out from Redcar Ironworks/steelworks into the site. The rail development includes some possible building structures, a conveyor and a platform. The circular features noted on the 1929 edition are confirmed as ponds. In addition, on the northern edge of the main drain crossing, the site an electricity substation has been constructed. The drain is now annotated 'The Fleet'. The road to the south of the area has been upgraded and appears as a dual carriageway. The construction of a roundabout is partially completed along the southern section of the site. Within the southern and southwest sector of the area, the drainage pattern has been amended. This includes 'The Mill Race' that flows in a northerly

Off-site: Further development of the rail lines are shown to the east of the area but it is noted that these have been truncated by the road along the southern boundary.

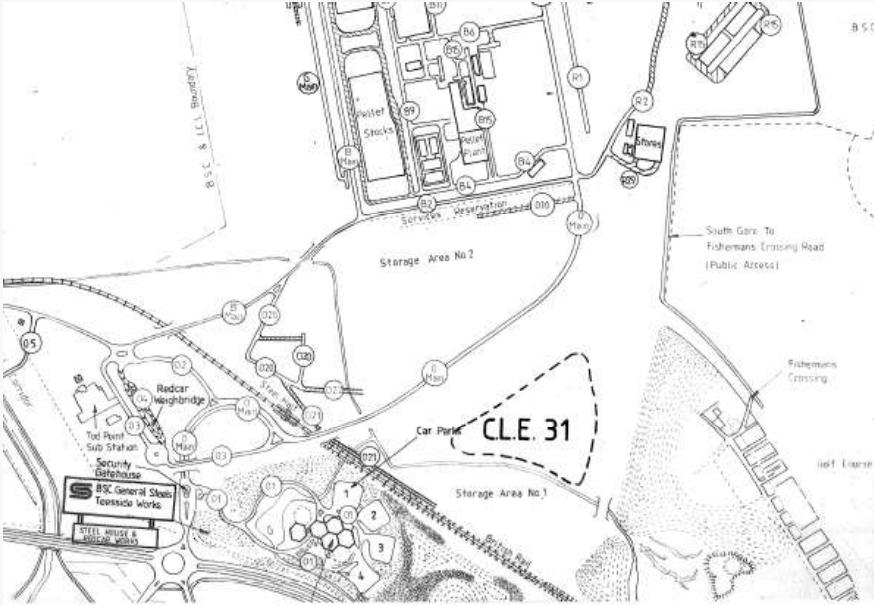
Previous Report Ref	Comments
Waste Disposal Licence, CLE 31/2 Cleveland County Council, 1980	This document was the waste disposal licence, under the CPOA 1974, relating to the deposit of wastes at Warrenby landfill at approximate NGR NZ 580245. The permit allowed deposition of slag, clay, subsoil and topsoil (max 1430 tonnes per day) and paper / canteen wastes (max 20 tonnes per day).
South Teeside Waste Disposal Sites, Currently Licenced Tips, Drawing No. X-108701 (undated)	This drawing showed the extent of the licenced tipping areas at Warrenby Landfill (Referenced CLE 31). The drawing also indicates that in the south of the site is the Tod Point substation, the Redcar weighbridge, and various access routes. Adjacent to the licensed landfill are shown Storage Area No.1, and Storage Area No.2.

<p>The drawing is a detailed site plan of Warrenby Landfill. It shows two main storage areas: Storage Area No.1 and Storage Area No.2. A central area is designated as CLE 31, which is the licensed tipping area. To the south of the site, there is a 'Car Park' and a 'Security Gatehouse'. Further south, the 'Tod Point Sub Station' and 'Redcar Weighbridge' are marked. The plan also shows 'Fishermen's Crossing' and 'South Gate To Fishermen's Crossing Road (Public Access)'. Various buildings and structures are depicted, including 'Steel Works & Blast Furnaces' and 'BSC General Steels Teeside Works'. The drawing includes numerous numbered points and lines indicating access routes and boundaries.</p>
