# GRANGETOWN PRAIRIE AREA, FORMER STEELWORKS, REDCAR

Phase II Environmental Site Assessment

South Tees Development Corporation

REPORT NO. 10035117-AUK-XX-XX-RP-ZZ-0062-02-Prairie\_ESA

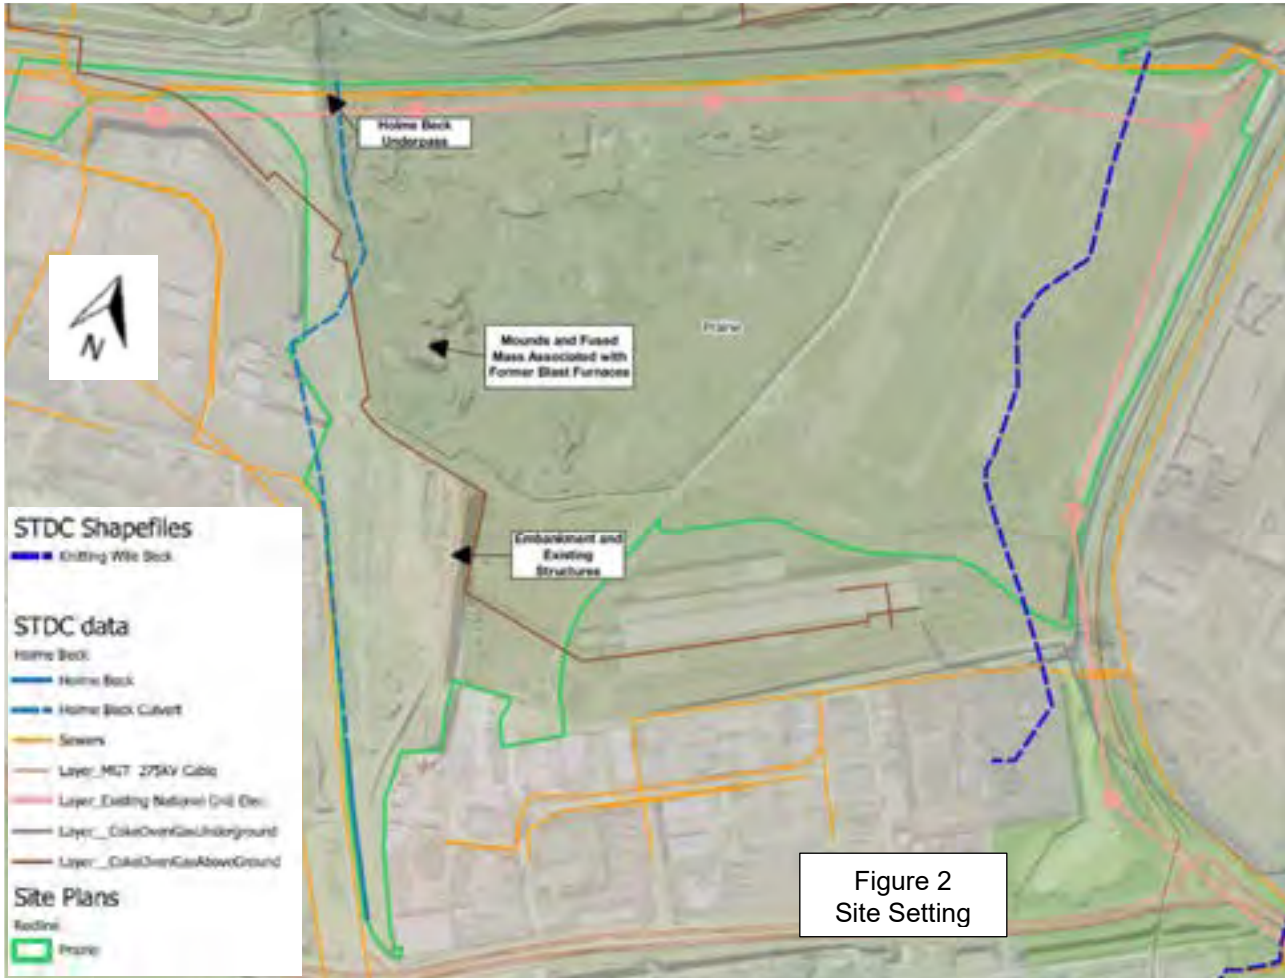
With the exception of a small relic Oxygen Plant and a former Loco Repair Shop, the site has been demolished to slab level with concrete foundations, roadways and crushed aggregate including steelmaking wastes forming the bulk of the site surfacing, which is covered by scrub in places. The site is broadly level with the exception of isolated bunds and mounds (particularly associated with the former blast furnaces, where a large metal rich boulder is present and the coke ovens) and two prominent features, namely:

- A large embankment running north-south in the south west of the site which reaches a height of approximately 15m above the surrounding land. This embankment formerly carried railway tracks to blast furnaces. The remaining structures (Oxygen Plant and Loco Repair Shop) are sited at the base of the embankment; and,
- A depression running north south adjacent to the main western boundary where the topography dips down to an underpass beneath the railway.

Two surface water features are culverted beneath the site; Holme Beck in the west and the Knitting Wife Beck in the east. A number of utilities are present on site including the Redcar Steelworks Coke Oven Gas (COG) main which crosses the site above ground from south east to north west. The GOC main is currently in the process of being decommissioned but at the time of writing is still considered a top tier COMAH asset. Overhead pylons run along the northern and eastern edge of the site and a Northumbrian Water Sewer runs along the northern edge of the site.

The site setting and layout are shown on Figure 2 and in Appendix A.

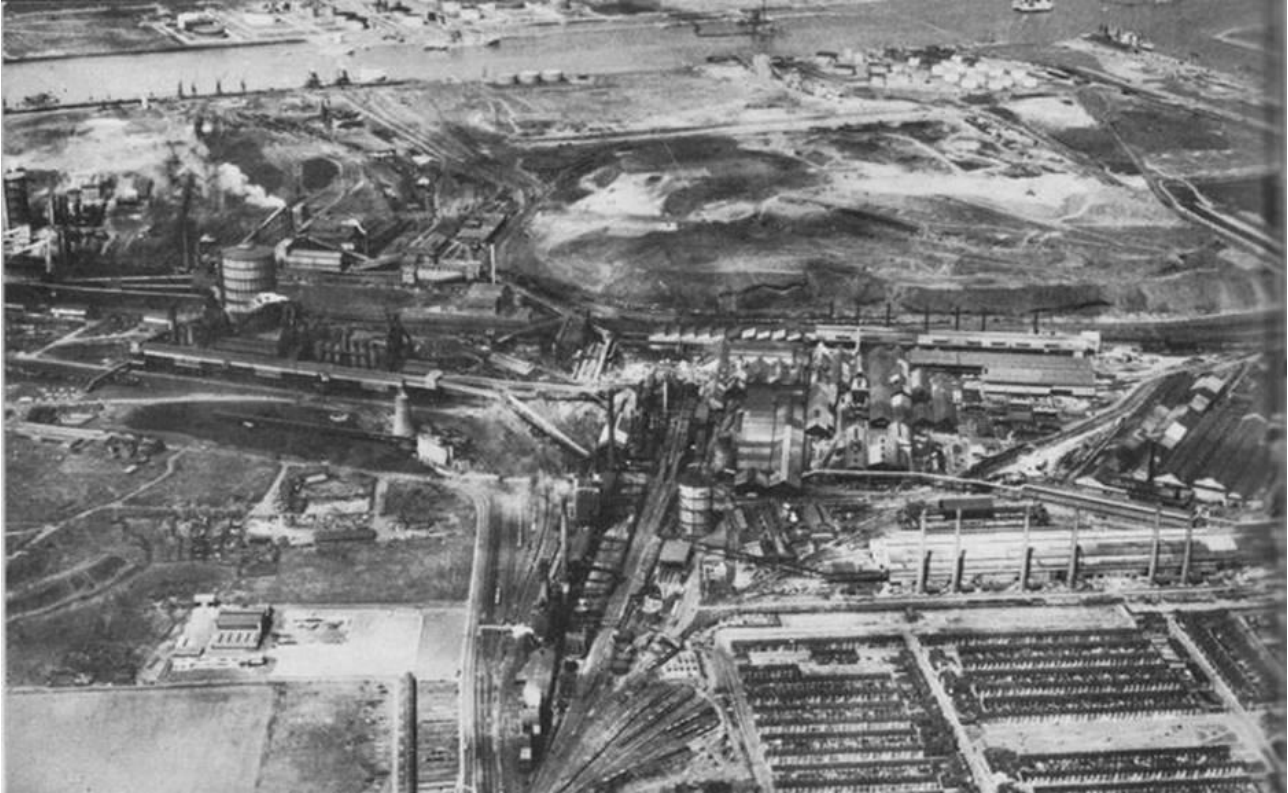
Plate 1 – Site circa 1924

- In 1857 the site was predominantly agricultural land. Railways ran along the northern boundary of the site (in the location of the current Darlington to Saltburn line) and also down the western edge of the site within the current site boundary. A small iron works (Eston Iron Works) is shown in the north west of the site. The Tees Estuary was located to the north of the site beyond the railway.
- Mapping from 1893 shows the Cleveland Steel Works to occupy the western half of the site; the Cleveland Iron Works extends onto the far western areas of the site. Small water bodies are shown on the site. By 1913 the steelworks has expanded further into the eastern half of the site and the water bodies are no longer shown. Estuary reclamation is shown to the north of the site.

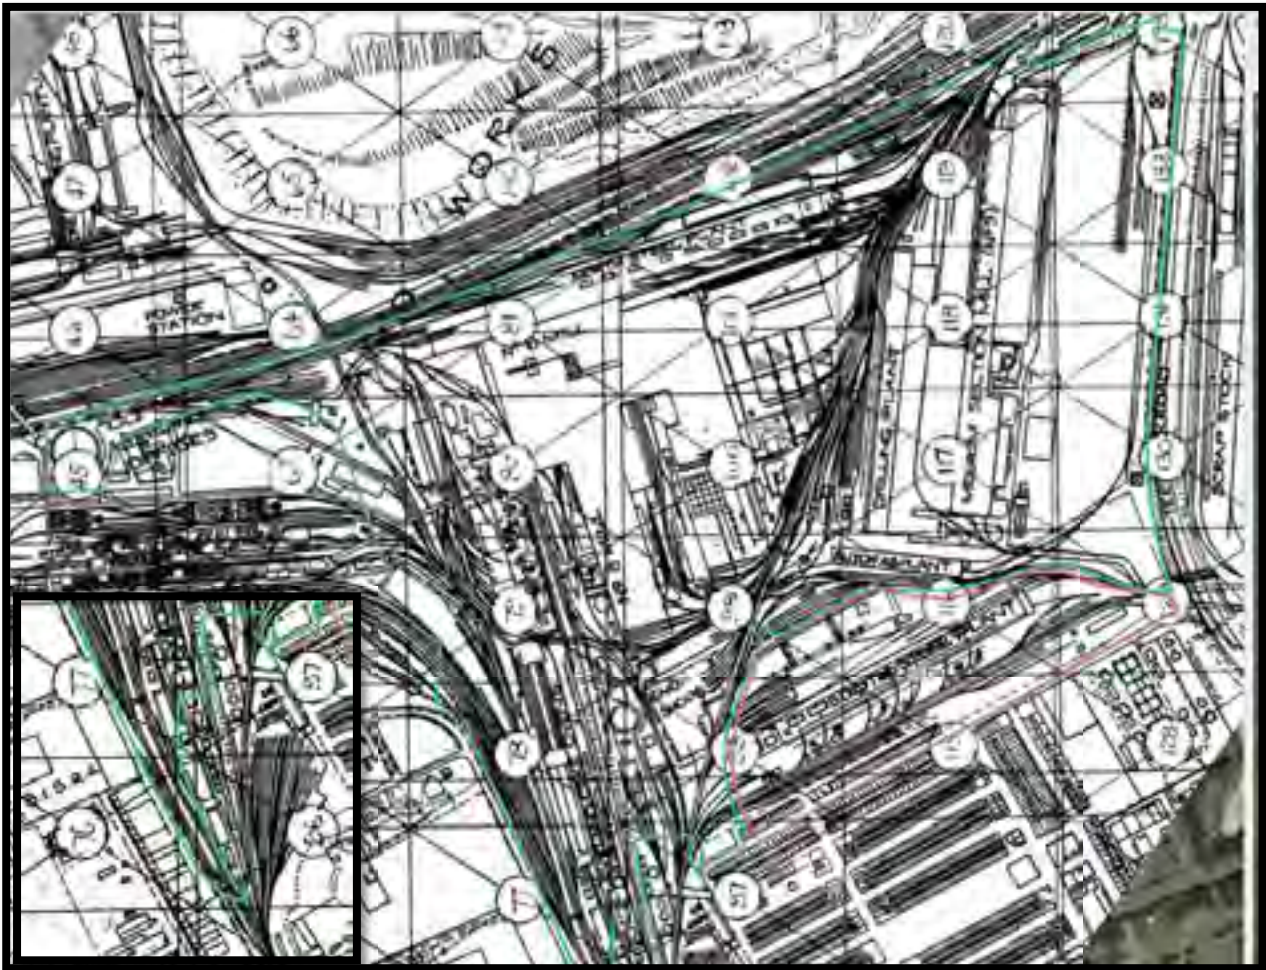
Figure 3 – Site layout circa 1960

- From 1924 further development has occurred on the eastern half of the site with additional large structures shown. A structure is shown to the south of the site in the location and with the approximate outline of the current TLRS (understood at this time to be the South Steel Plant). Plate 1 provided by STDC is understood to show the site in 1924.
- By 1952 the Cleveland Coke Ovens and biproducts plant have been constructed in the south west of the site. In the east of the site further expansion of structures has taken place, the largest of these is understood to have been known as the Colliery Arch Plant and Medium Section Mill (information provided by STDC, drawing 1x5971). The site layout at circa. 1960 is shown on drawing 1x5947 (Figure 3).

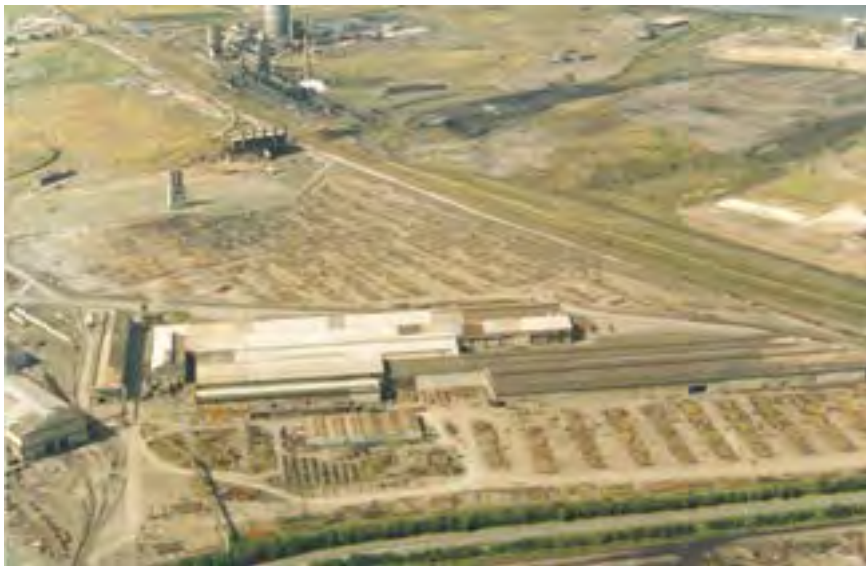
Plate 2 – Site Circa 2010

- Mapping from the 1970's to the 1990's indicates progressive demolition of the majority of structures on the western half of the site. Based on information provided by STDC the bulk of the facilities on site became obsolete after the construction of the BOS and CONCAST plants in the 1970's. The Colliery Arch plant is shown on mapping until 2010 after which it no longer appears. The site was used as a steel stocking yard following structure demolition. Plate 2 provided by STDC shows the Colliery Arch Plant prior to demolition in 2010; the large structure in the mid ground is the former Power Station (now also demolished), with the South Bank Coke Ovens off site in the background.

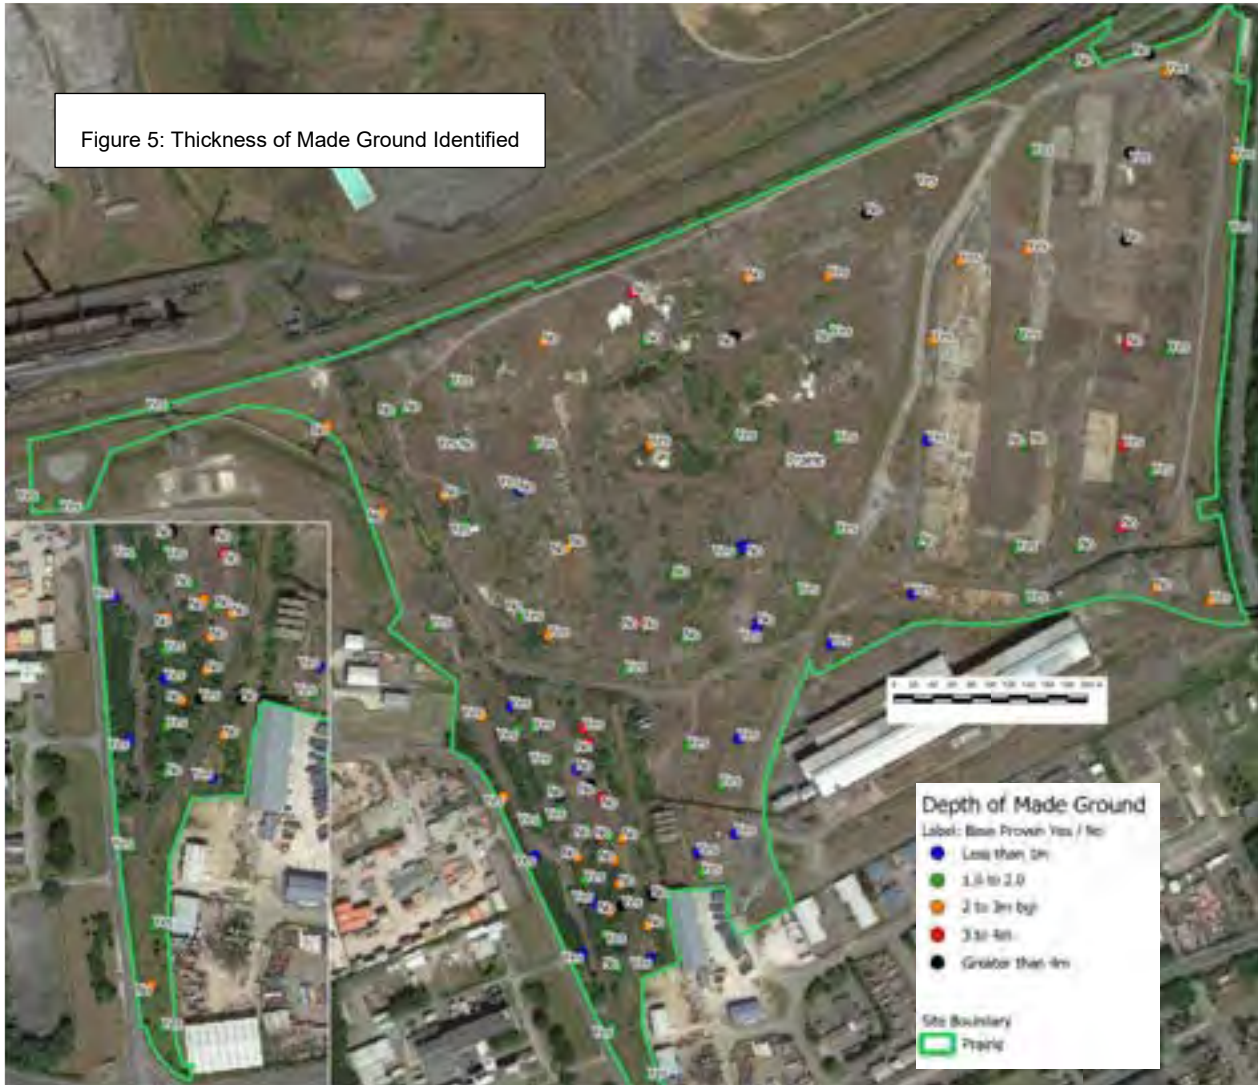
Made Ground was encountered in all intrusive locations and proven to a maximum thickness of at least 5m (Prairie\_AUK\_TP199). The base of the Made Ground was not proven in 58 of the 122 trial pits therefore, greater thickness of material may exist across the site. The distribution of the thickness of Made Ground is presented as Figure 5 and in Appendix A.

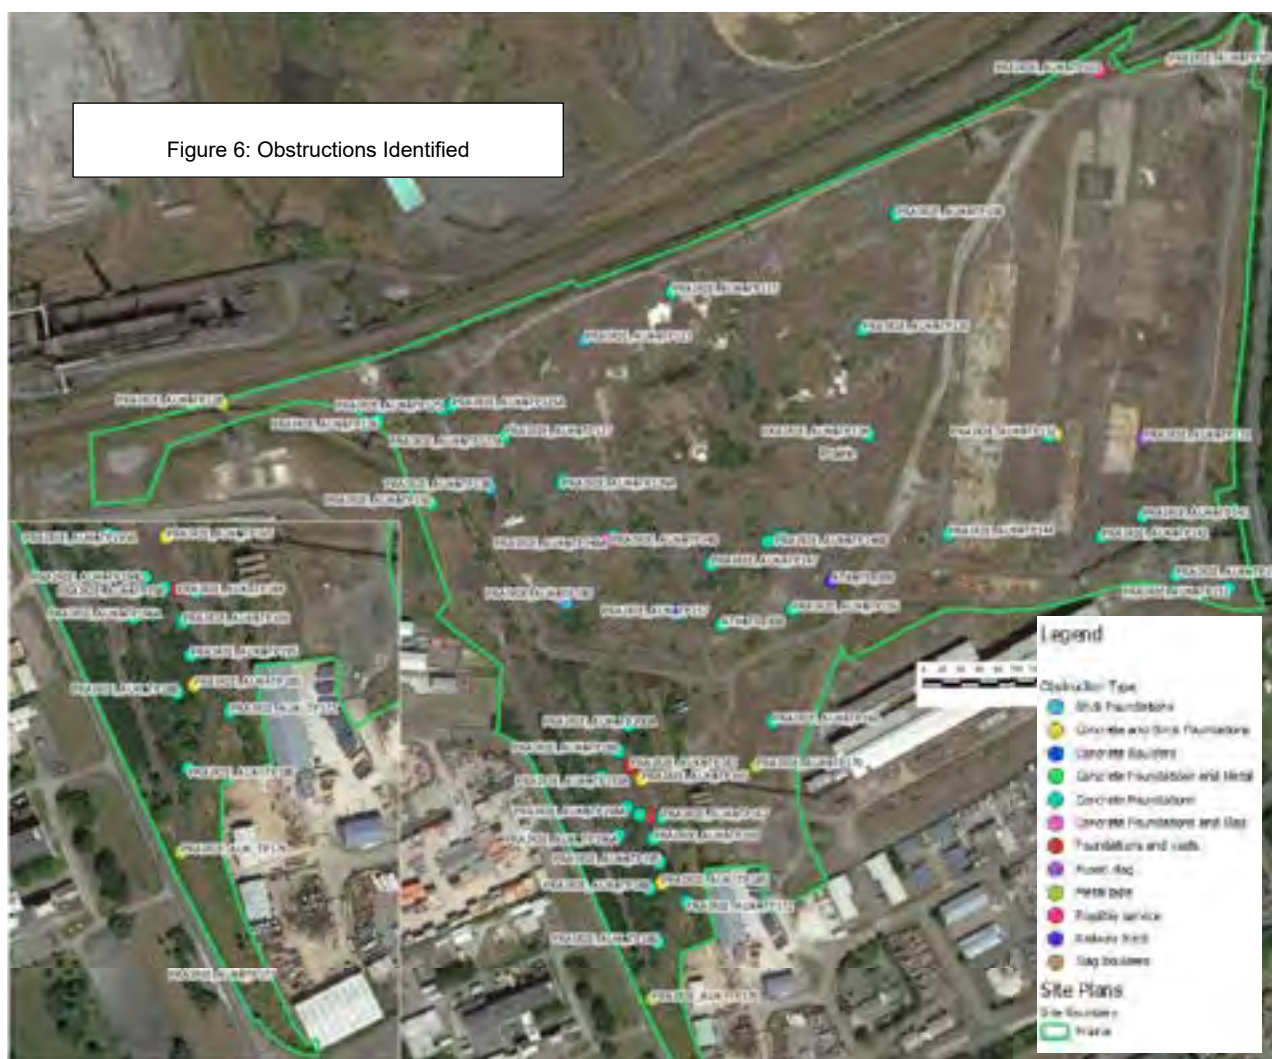
In addition to the boulders of slag, occasional fused slag and demolition rubble which presented issues with progression of a number of the exploratory holes, further buried obstructions were identified during the course of the investigation. Detail on the obstructions is presented on the trial pit logs and summarised on Figure 6 and in Appendix A.

It should be noted that further obstructions may be encountered in areas not investigated.

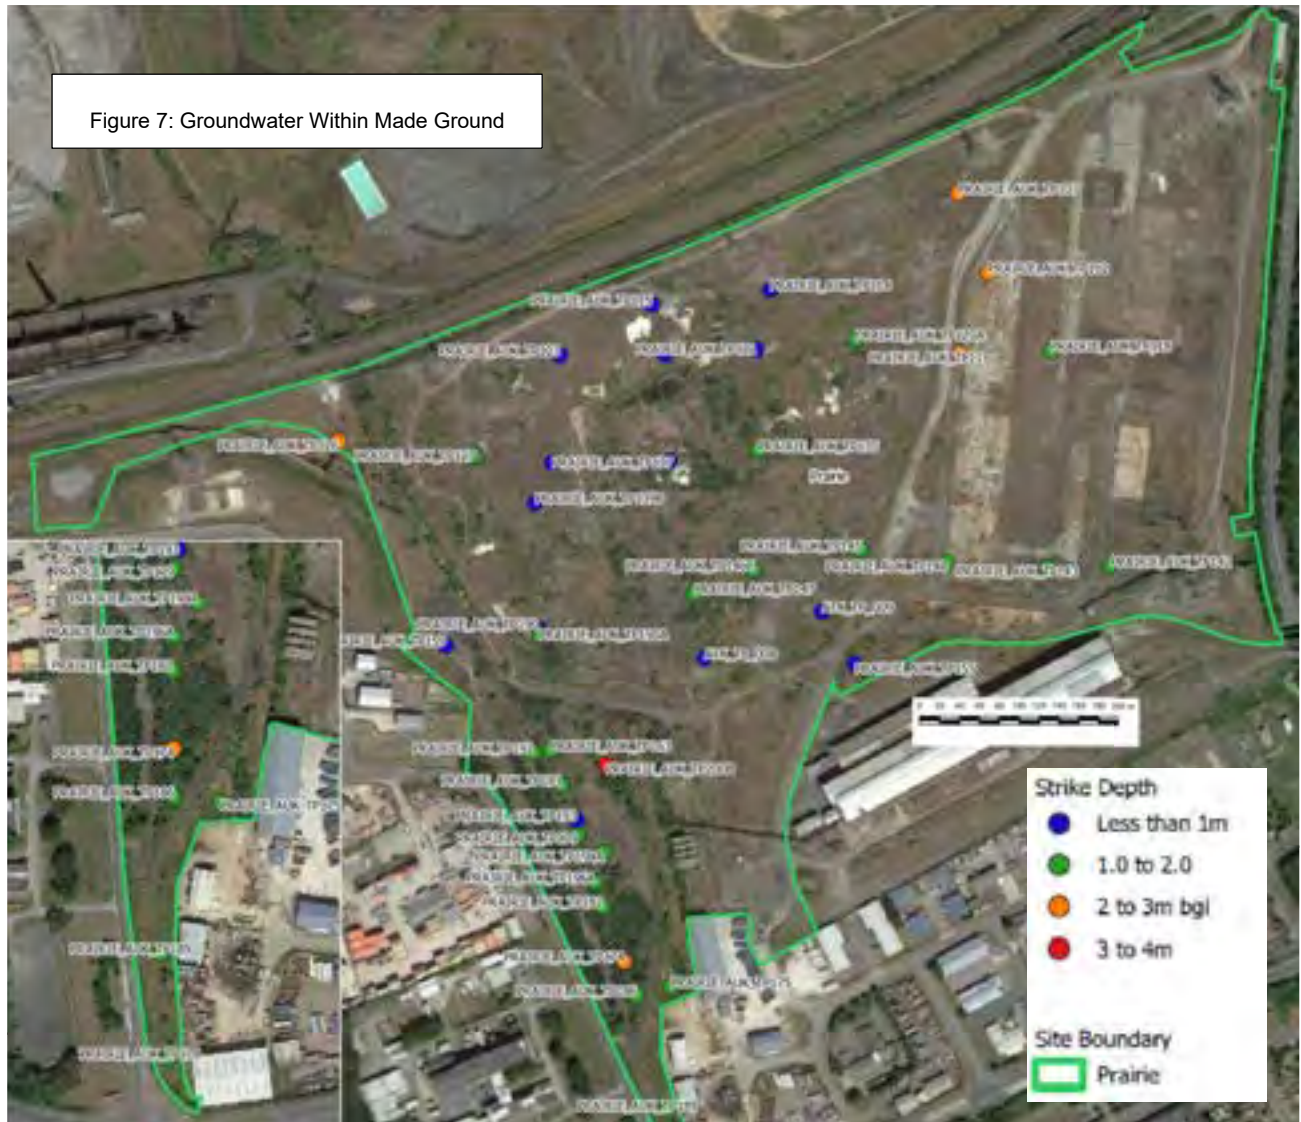
Groundwater was encountered in 56 out of 112 trial pits at depths of between 0.3m and 3.5m bgl, and noted to be associated with the Made Ground with infiltration rates into the pits ranging between “low” to “heavy”. Groundwater is believed to be perched within the more granular horizons (and also within sub surface structures) and flow dictated by localised preferential pathways. It was noted that groundwater levels within the Made Ground showed considerable variation between adjacent trial pits indicating that groundwater is not continuous in Made Ground across the site. Detail on the groundwater observations noted within trial pits is presented on the trial pit logs and summarised on Figure 7 and in Appendix A.

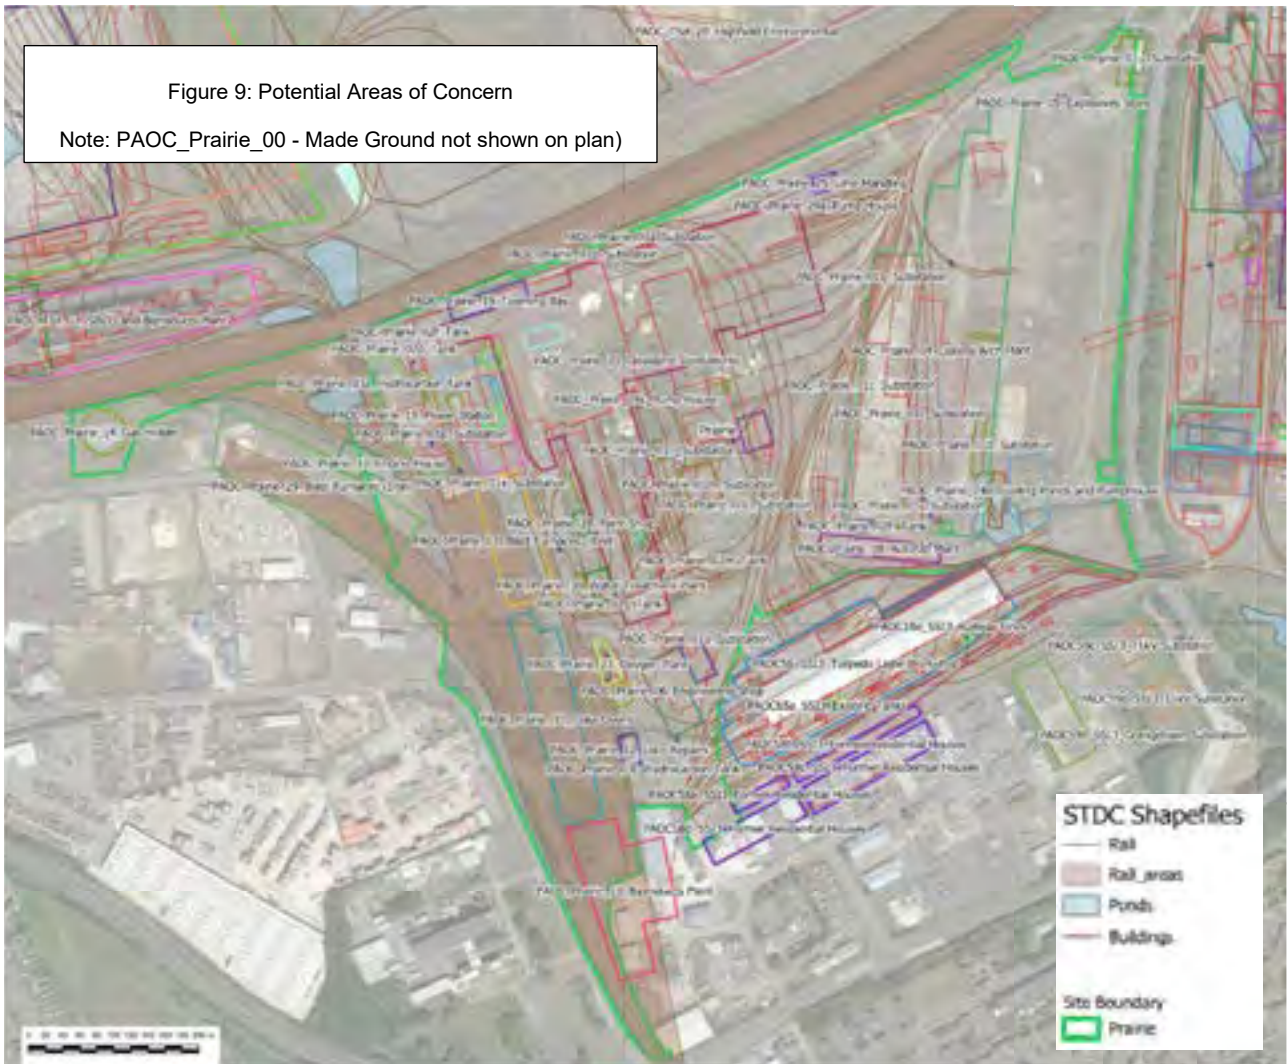
Figure 9: Potential Areas of Concern  
Note: PAOC\_Prairie\_00 - Made Ground not shown on plan)

Given the site history and surroundings numerous potential areas of concern (PAOC) have been identified for the site. An exhaustive review is not considered proportionate. Therefore, based on a review of the documents listed in this section, historical mapping (including site plans), and the DEFRA Magic Website <https://magic.defra.gov.uk/MagicMap.aspx> accessed 19th May 2020 the following PAOC have been identified. These are considered to include the PAOC considered to be of highest concern both on and off the site. The PAOC are summarised on Figure 8 and in Appendix A.

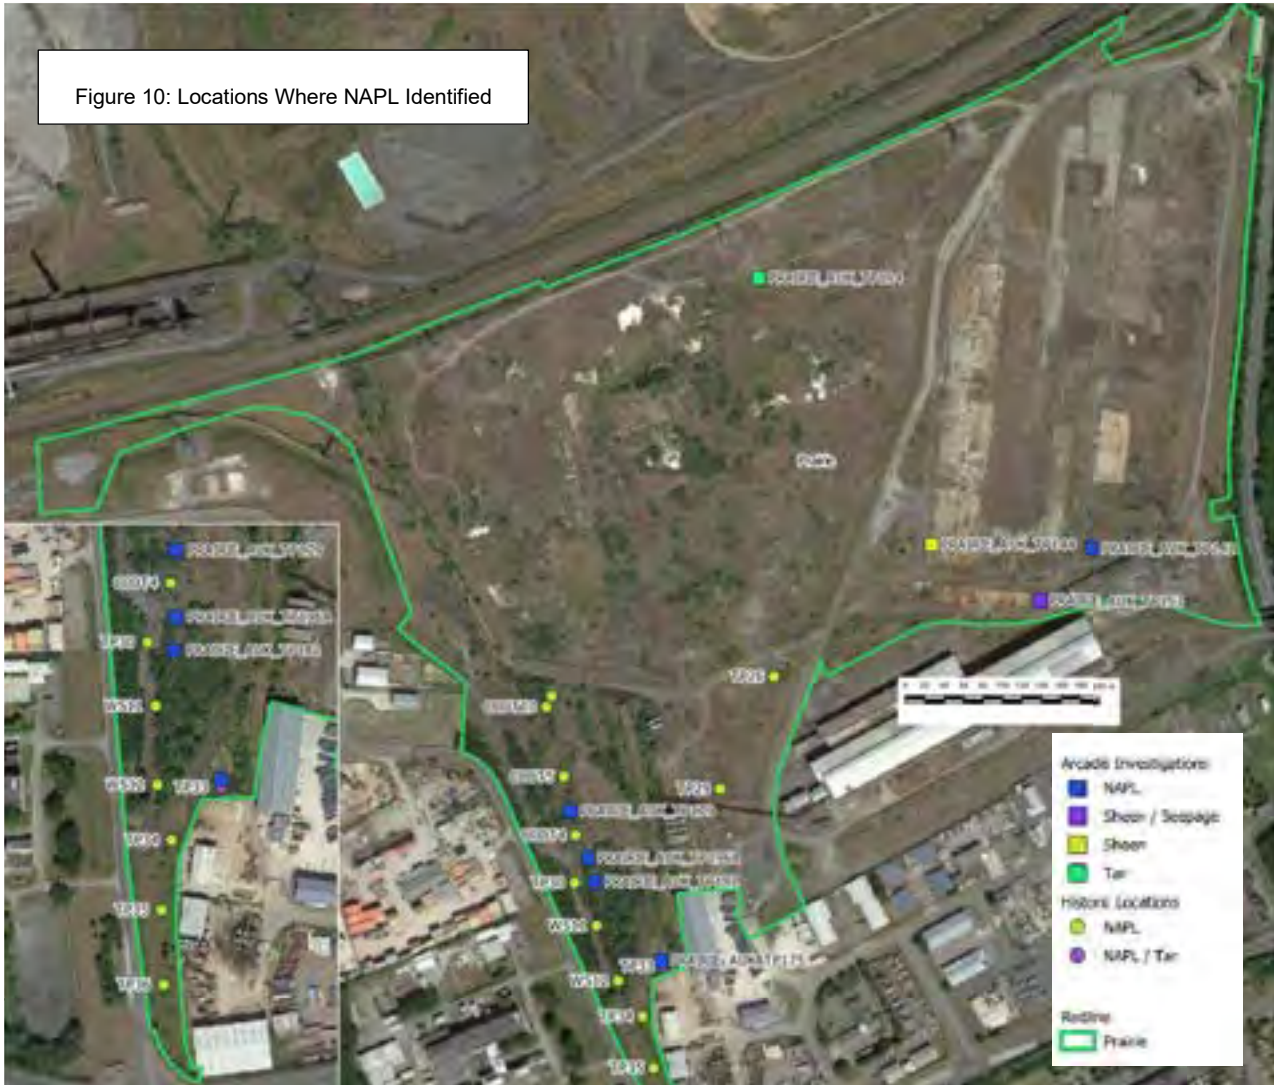
Figure 10: Locations Where NAPL Identified

A non-aqueous phase liquid (NAPL) was identified in the following locations during the site investigation.

Location	Geology	Description
Prairie_AUK_TP114 (0.9m bgl)	Made Ground	Tar noted within and surrounding a clay pipe
Prairie_AUK_TP142 (1.5m bgl)	Made Ground	Globules of oil noted in perched water. Water perched on fine silt overlaying concrete slab.
Prairie_AUK_TP175 (0.6mbgl)	Made Ground	Tar noted within and surrounding a clay pipe
Prairie_AUK_TP179 (1.4mbgl)	Made Ground	NAPL noted at the base of the made ground potentially associated with a relic slab / railway structure adjacent to the coke oven slab (Plate 3).
Prairie_AUK_TP182 (0.9mbgl)	Made Ground	NAPL noted at the base of the made ground potentially associated with a relic slab / railway structure adjacent to the coke oven slab.
Prairie_AUK_TP194A (1.4mbgl)	Made Ground	NAPL noted at the base of the made ground

A plan showing the locations where NAPL was identified is presented as Figure 9 and in Appendix A. Sheens were noted in the following locations by Enviro in 2007: TP12, TP13, TP17, and TP19.

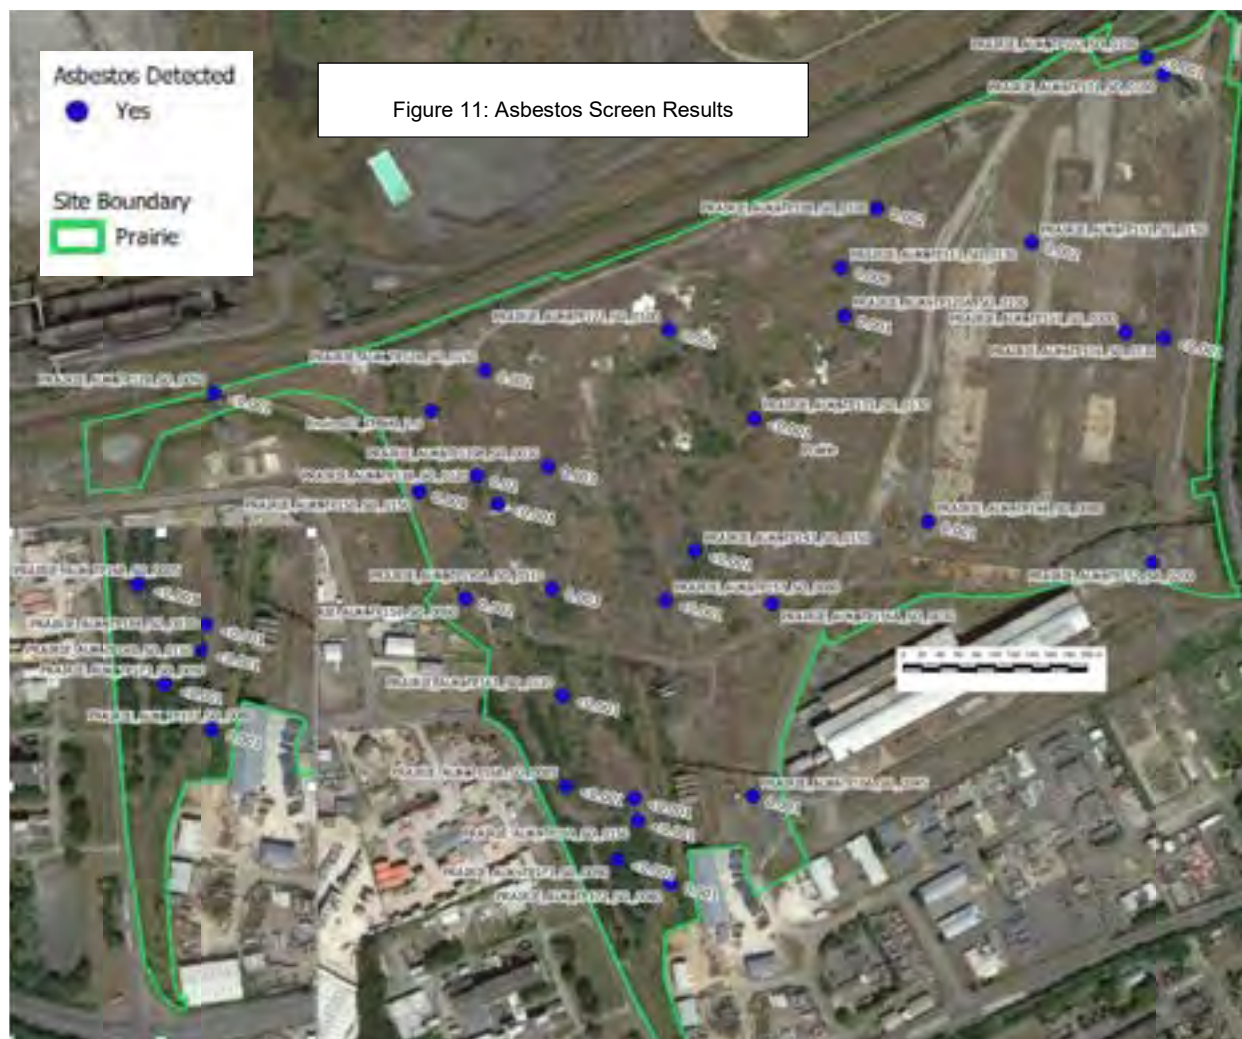
Asbestos was identified in thirty one samples of Made Ground , and was quantified at between <0.001 and 0.02%.. A plan showing the asbestos detections at the site is presented as Figure 10 and in Appendix A.

Soil containing more than 0.1% m/m asbestos, if disposed of off-site, may be classified as hazardous waste and attract significantly higher disposal costs. Additional testing would be required to confirm the quantity of asbestos and delineate any areas above the threshold.

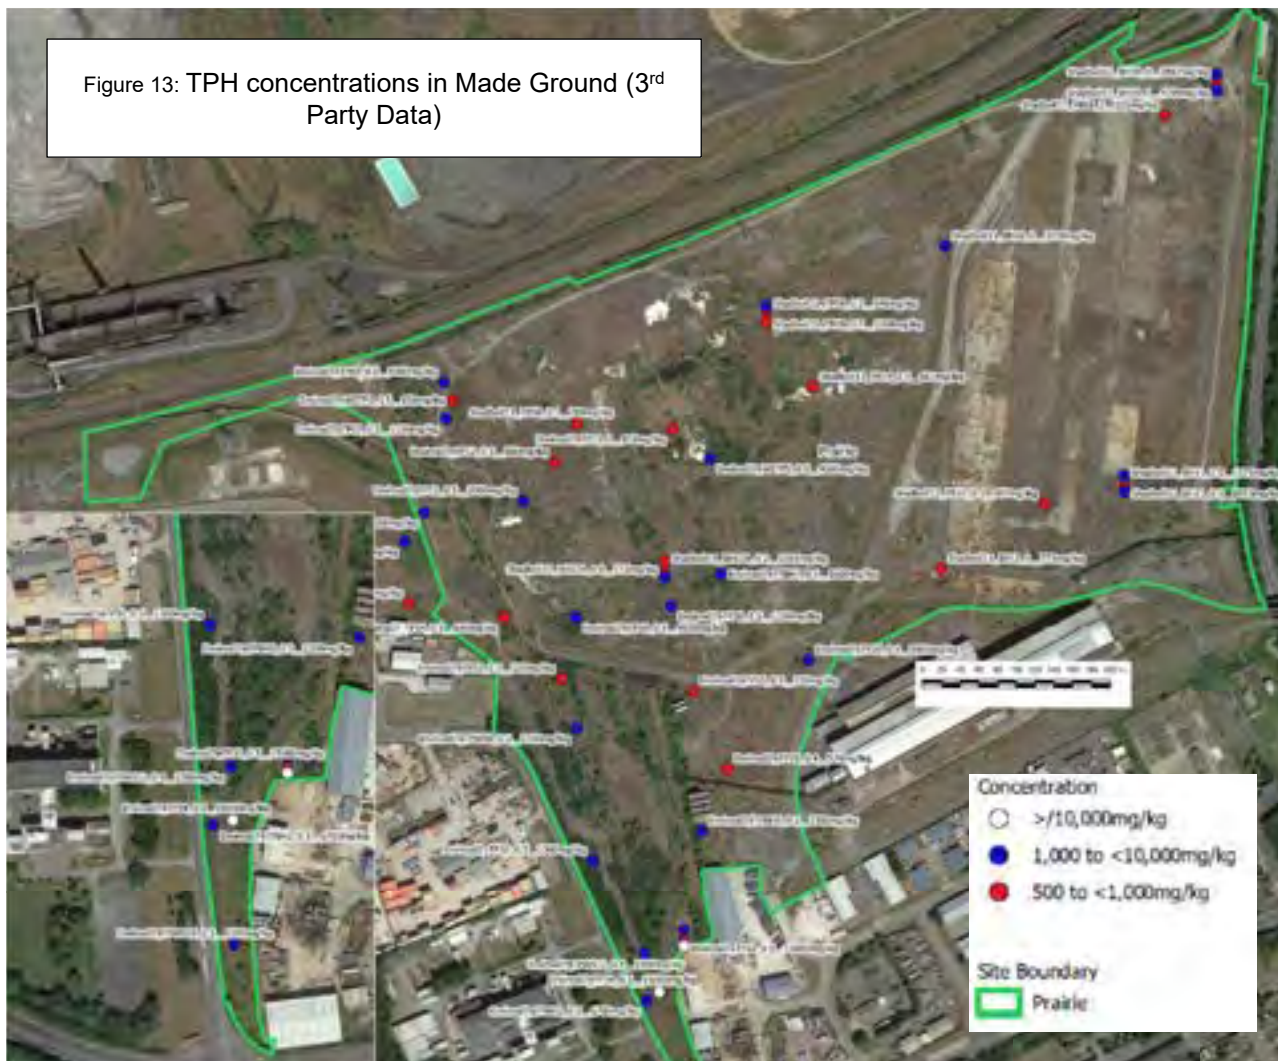
Figure 13: TPH concentrations in Made Ground (3<sup>rd</sup> Party Data)

The locations of elevated TPH C<sub>10</sub> to C<sub>35</sub> and extractable petroleum hydrocarbons C<sub>10</sub> to C<sub>40</sub> (EPH) in historical third party data are shown on Figure 13 and in Appendix A.

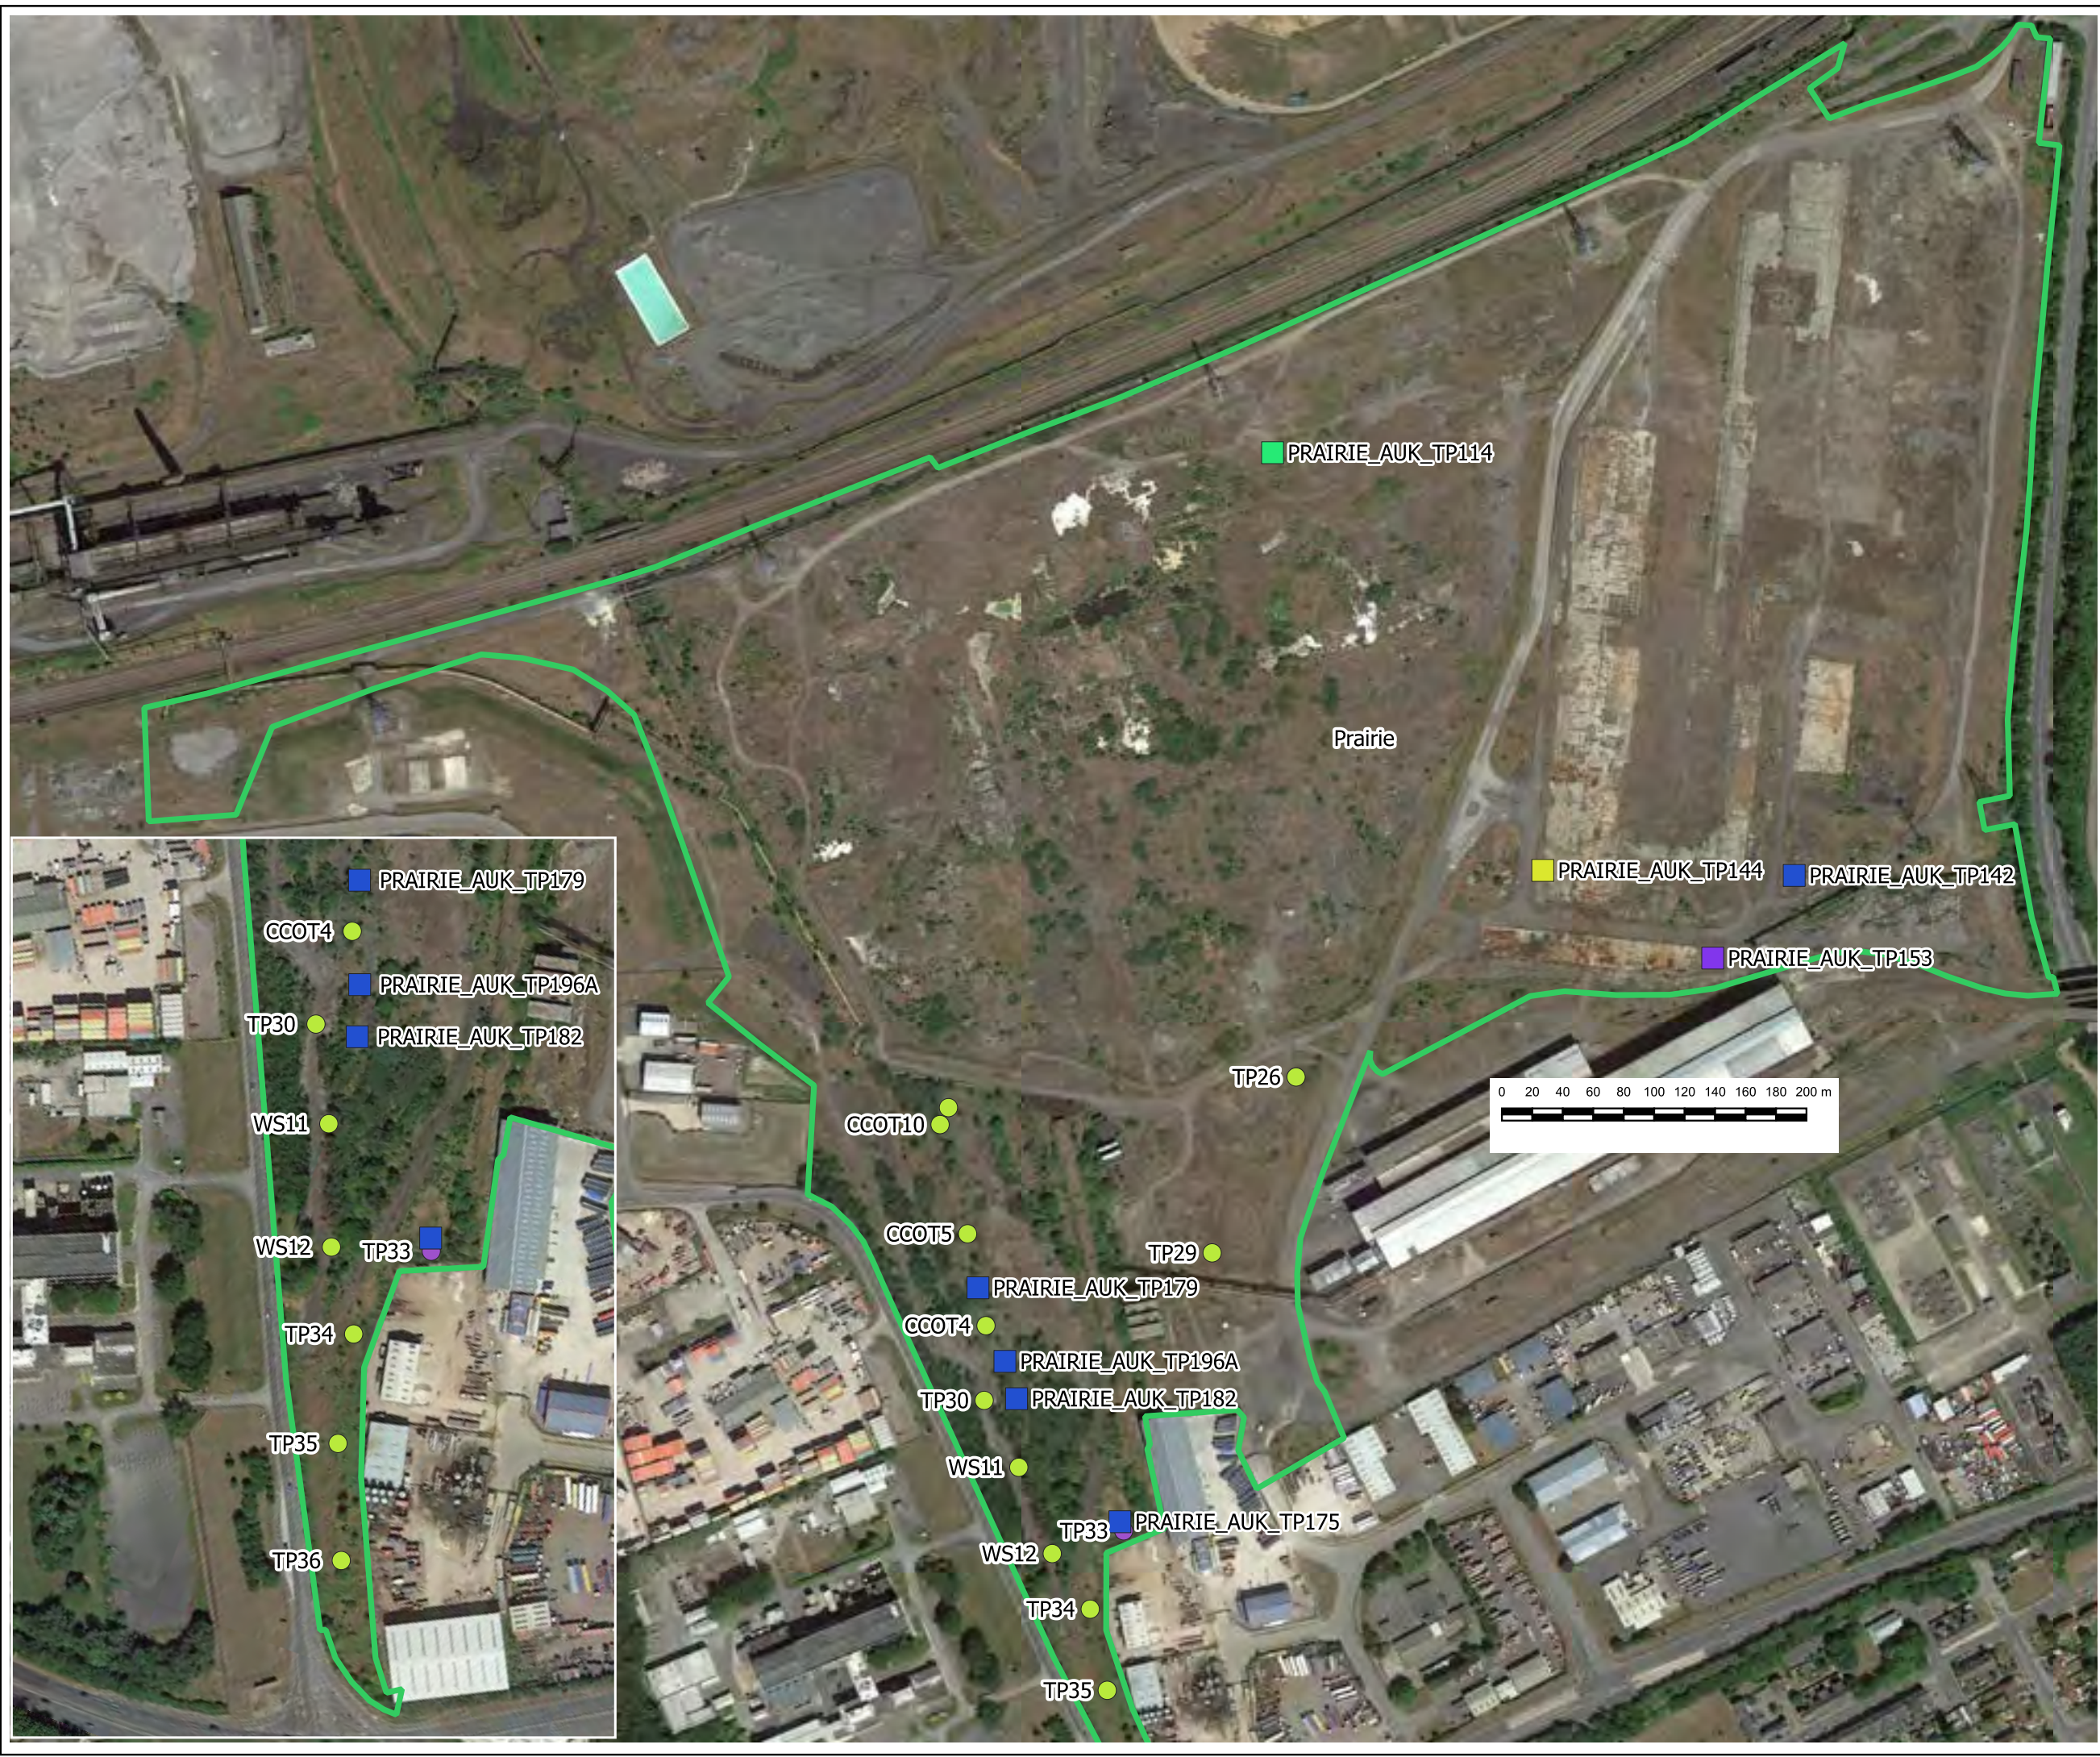
**Title:** Prairie - Locations Where NAPL Identified

NAPL: Non-aqueous Phase Liquid
